# Health & Safety

## Site Visit Report.

| <b>Report For:</b> | Harborne House |
| <b>Date Conducted:</b> | 12/09/2024 |

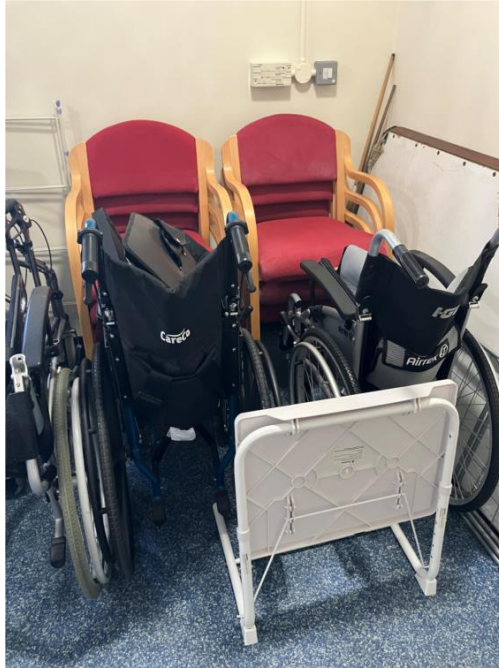
Wheelchairs are available. Although regular inspections are carried out these are not documented.

[Wheelchair - documented inspections recommended](#)

It is recommended that you document the regular visual inspections of the wheelchairs so as to demonstrate that an inspection regime is in place.

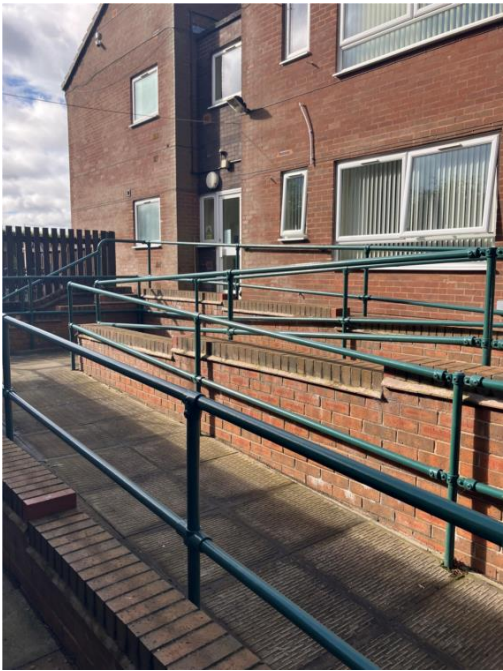
It was good to see a disabled ramp leading to the building with suitable hand rails.

Ramps to building

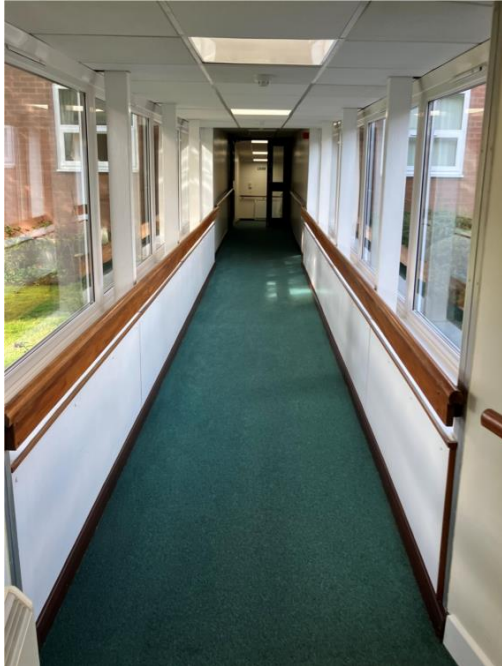
There are also handrails on corridors internally.

[Hand rails on corridors](#)

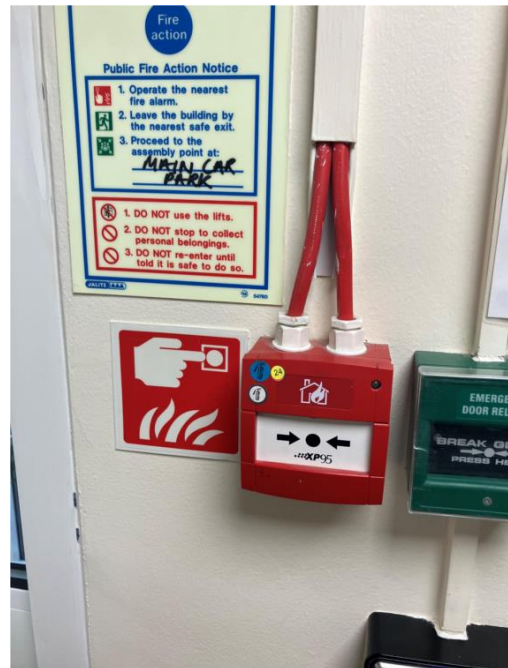
Appropriate 'flame and finger' signs and fire action notices were seen in an easy to view position, close to the call/activation points to ensure that they can be spotted quickly in an emergency.

[Fire Alarm call point clear signage](#)

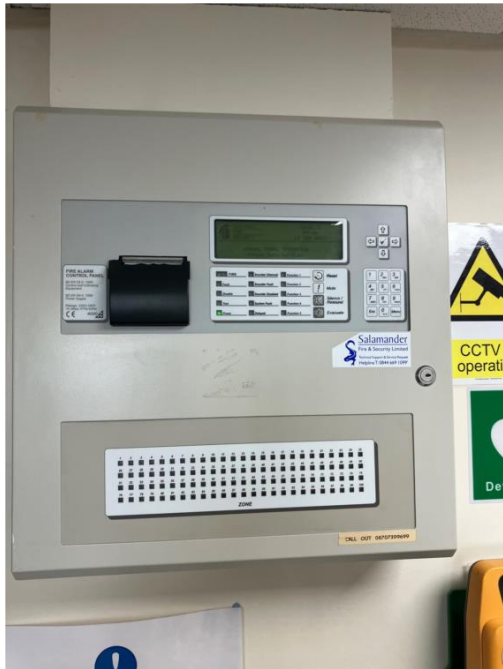
The fire alarm panel was free from faults at the time of inspection.

[Fire Alarm panel no faults](#)

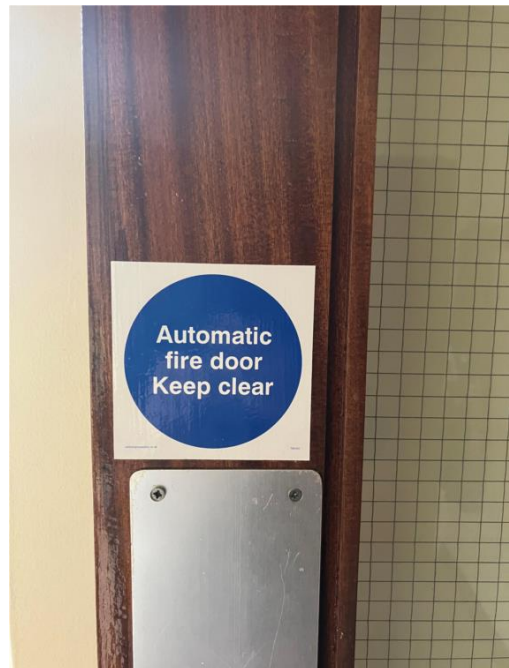
Fire Doors have been installed and have suitable signs stating: "Fire door keep shut", "Fire door keep clear" and "Automatic fire door keep clear"

[Automatic fire door sign](#)

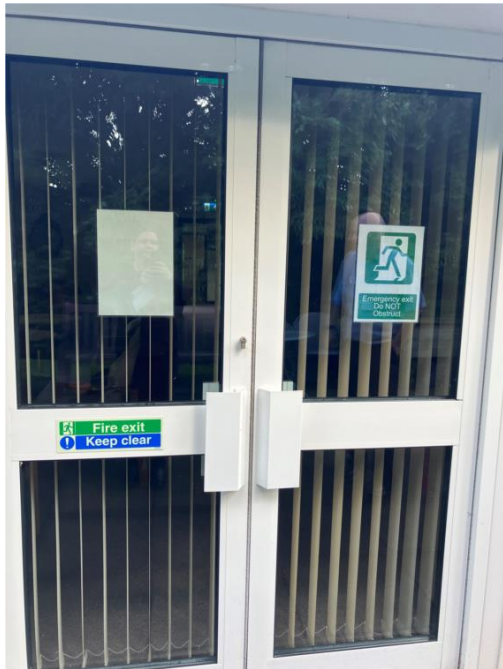
Fire exits have signage to the outside to prevent obstruction.

[Fire Exit - clear signage on both sides of door](#)

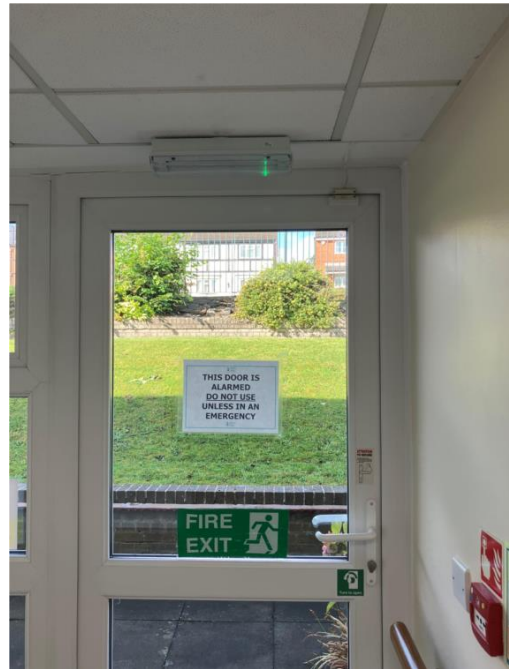
Fire exits were free from obstruction and were unlocked. single turn thumbs locks are fitted

[Fire Exit - Thumb turn lock](#)

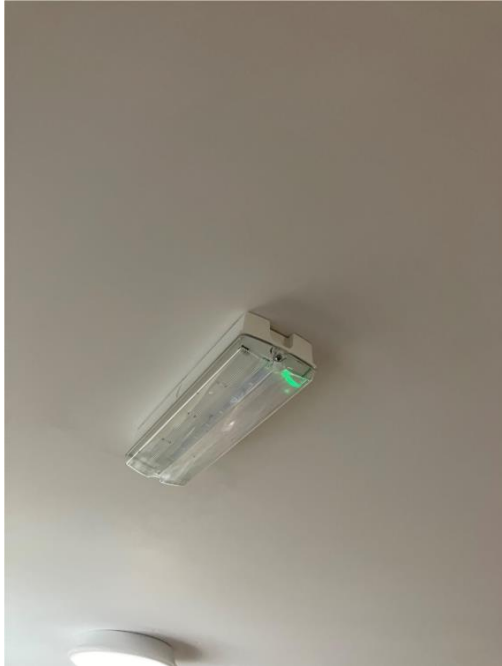
Emergency lighting has been installed within the building.

[Emergency lighting installed](#)

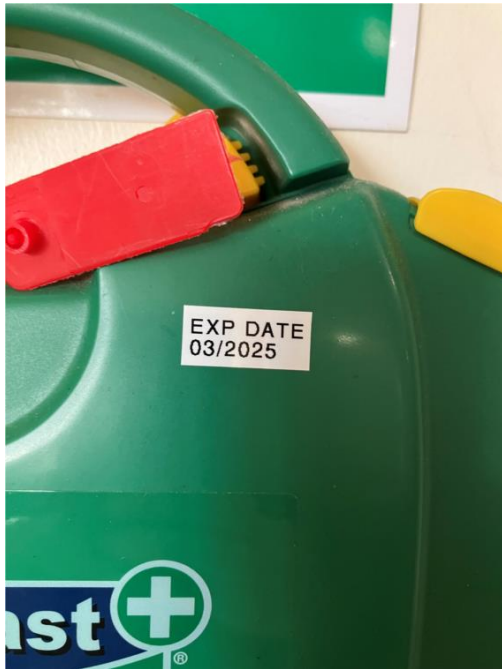
A well-stocked first aid kit is provided. It was contained in suitable containers which was free from damage, damp and dust. The kit checked was seen to be sealed and had a label indicating when items expire.

[First aid kit sealed with label indicating expiry March 2025](#)

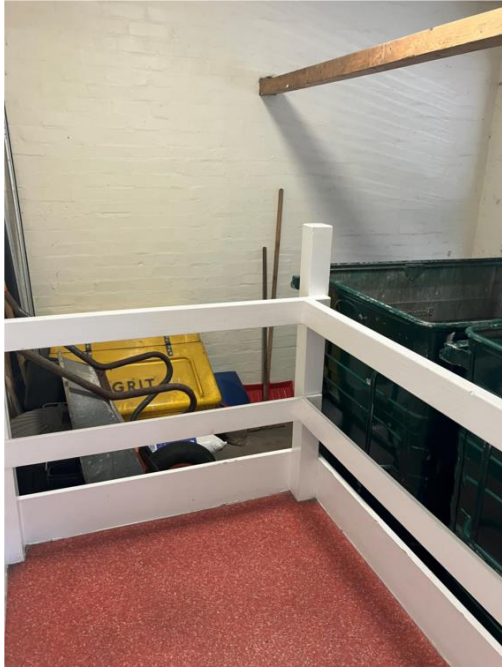
[Edge protection bin store](#)
