# MANAGEMENT ASBESTOS SURVEY

| <b>Site</b> | Dore House, 56a Lordswood Road, Harborne, B17 9DA. |
| <b>Date report issued</b> | 5/7/2013 |
| <b>Survey reference</b> | S073/HAR9/4 |

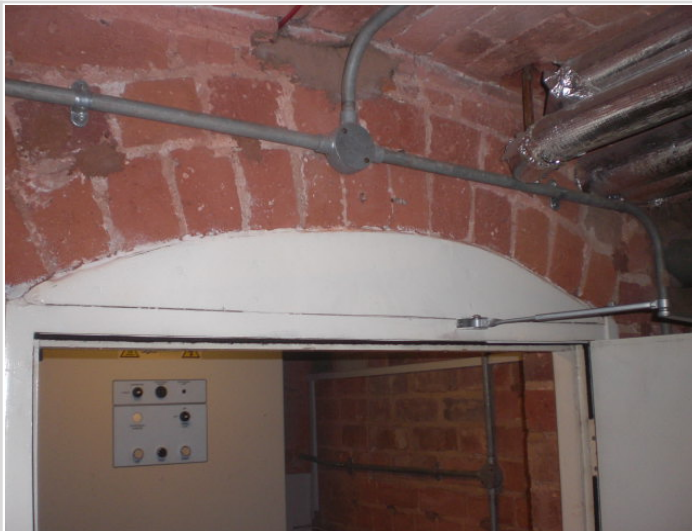
| Sample reference number | S073/HAR9/4/001 |

Comments / recommendation: Sample analysed no asbestos detected no further action required Both sides

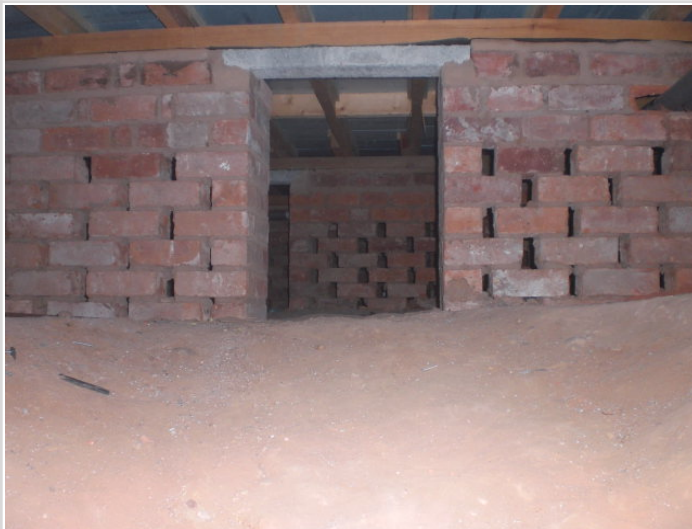
| Sample reference number | Item Ref 1 - Presumed |

| Sample ref no | Building | Floor level | Room | Position | Item | Access level |
|---|---|---|---|---|---|---|
| Item Ref 1 - Presumed | Communals | Basement | Void below Flats | | | No Access |

Comments / recommendation: No access Presume asbestos until proven otherwise

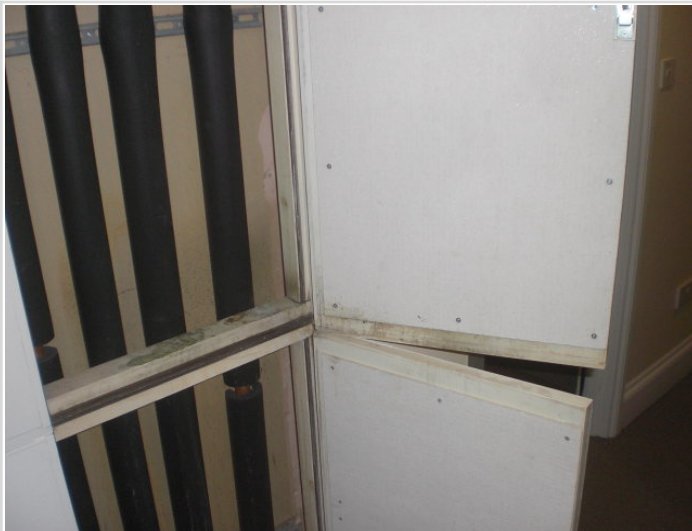
| Sample reference number | S073/HAR9/4/002 |

| ROOM | | CORRIDOR RISER 1 | | ROOM DESCRIPTION | | | | 'Plaster render to walls Plasterboard to ceiling Concrete to floor Fibreglass to pipes' | | | | 4.2.3.4 |
|---|---|---|---|---|---|---|---|---|---|---|---|---|
| S073 / HAR9 / 4 / 002 | To rear of doors | Insulating board | N/A | N/A | N/A | 0N/A | No Asbestos Detected | 0 | N/A | N/A | N/A | |
| Sample analysed no asbestos detected no further action required | | | | | | | | | | | | |

Comments / recommendation: Sample analysed no asbestos detected no further action required

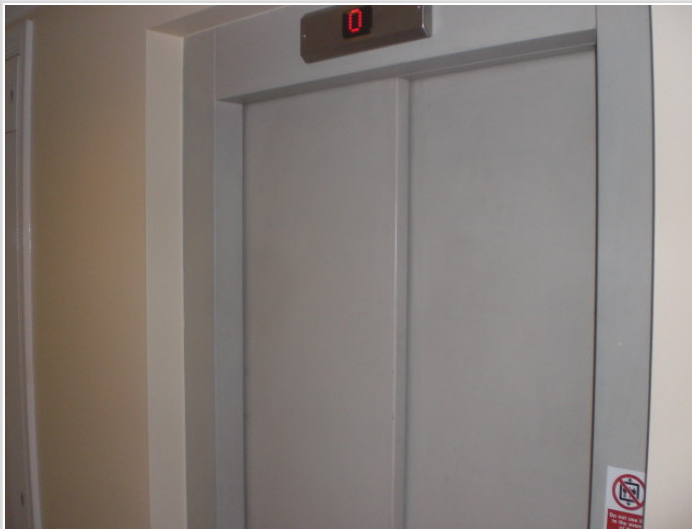
| Sample reference number | Item Ref 2 - Presumed |

| Sample ref no | Building | Floor level | Room | Position | Item | Access level |
|---|---|---|---|---|---|---|
| Item Ref 2 - Presumed | Communals | Ground Floor | Lift shaft | | | No Access |

Comments / recommendation: No access Live lift no engineer on site Presume asbestos until proven otherwise

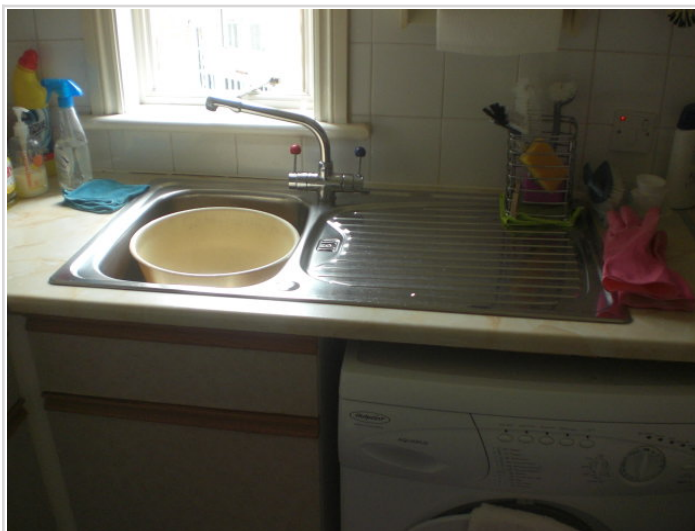
| Sample reference number | S073/HAR9/4/003 |

Comments / recommendation: Sample analysed no asbestos detected no further action required
