## Quinquennial Inspection Report

Dore House,  
56a Lordswood Road, Harborne,  
Birmingham B17 9DA

6<sup>th</sup> September 2024

Project number: 1253C-02

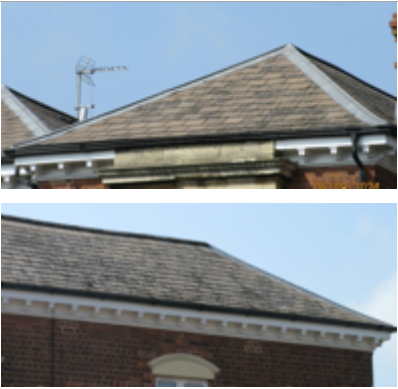
| | Condition | <p>The covering is faded – this was a common problem with this type of slate but appears to be an aesthetic problem only at the moment. It may be necessary to replace the covering if they deteriorate further but this may not be needed. The slates do not appear to be substantially worse than seen on the previous Quinquennial Inspection and the degree of fading seen may be the limit.</p> <p>There is some minor moss growth to the front slope although this is not currently causing any problems.</p> | |

| | Repair needs | Replace roof covering if required. | 4 |
| | | Clear moss growth. | 3 |

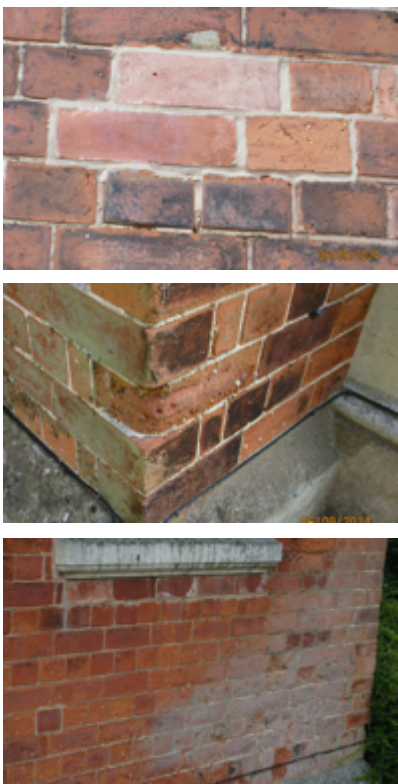
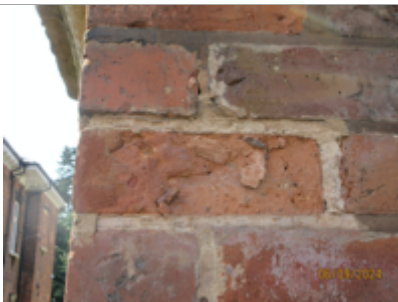
| | Condition | <p>Older bricks are relatively soft and they appear to have been handmade and were originally pointed with lime putty; the pointing, some of which probably dates from the 1994 works, appears to be Portland cement mortar and, as a result, is much harder than the bricks. This means that when the bricks become wet, water can no longer evaporate out of the joints and is retained in the bricks themselves, frost action then expands the water and causes the faces to fall off.</p> <p>The situation is much the same as seen on the previous Quinquennial Inspection, although a few more bricks have spalled and areas of pointing deteriorated.</p> <p>Whilst the bricks give a poor appearance the majority are in good condition – cutting out</p> | |

| | | <p>the bricks is probably too drastic and would cause more damage than good but any new mortar should be carefully matched to ensure it is softer than the bricks.</p> <p>The hard mortar can be removed where it is loose enough to do so by hand but again cutting out the mortar would be likely to cause damage to the bricks.</p> | |

| | Repair needs | <p>Test areas of potentially loose stonework.</p> <p>Repoint isolated areas of brickwork.</p> <p>Replace isolated spalled bricks.</p> | <p>1</p> <p>3</p> <p>3</p> |

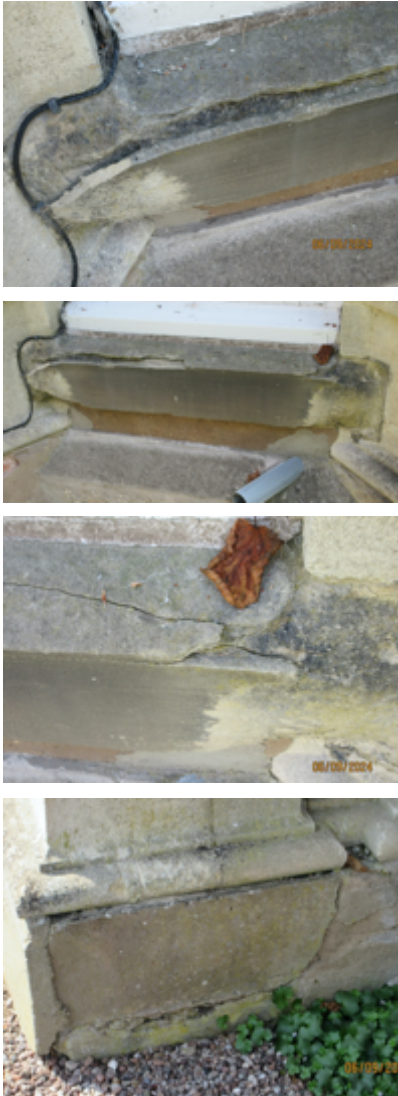
| | <p>Condition</p> | <p>A small section of stone finial has become detached from the top of one of the windows and fallen. Other stone features show signs of wear, some cracking and age related deterioration although without carrying out a physical 'hammer test' it is impossible to say how sound these are. From a visual survey only, any missing sections look to be in reasonable condition.</p> <p>Other stonework is blackened but cleaning is not a particular necessity.</p> <p>A few areas of stone are chipped and missing but most of this appears to be longstanding, there is delamination to some stone sills.</p> <p>A programme of stone cleaning and renewals would be desirable but not required at the present time.</p> <p>The situation is slightly worse than that seen on the previous Quinquennial Inspection.</p> | |

| Repair needs | | <p>Test areas of potentially loose stonework.</p> <p>A programme of stone cleaning and restoration is nevertheless recommended as a prudent measure.</p> | <p>2</p> <p>3</p> |

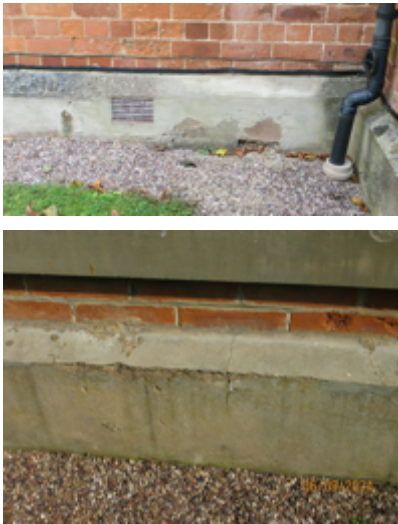
| | Condition<br> | The plinth render is cracked and has been patched in places but with no major defects.<br><br>British Standard 7913: 2013 lists a number of actions to be taken in the case of rising damp in an old building. | |

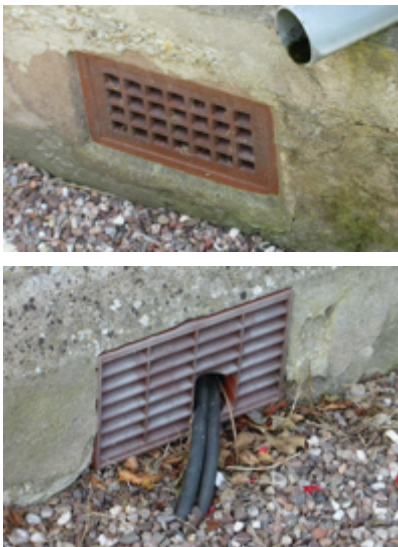
| | Condition<br> | Good or fair, one plastic airbrick has been cut to run cables through, forming a possible entry point for vermin. | |

| | Repair needs | Re-route cables and replace airbrick. | 3 |

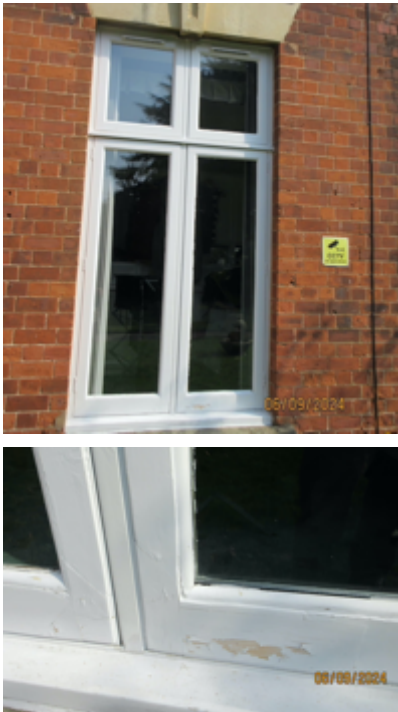
| | <p>Condition</p> | <p>The resident in Flat No. 1 reported problems with the right hand French door.</p> <p>Doors are now 30 years old and although generally in good condition some minor issues exist. They are not so badly defective that replacement is needed but some repairs are.</p> <p>Replacement in softwood would be more appropriate to preserve the character of the building although modern softwood is often poorly seasoned and has a limited life, so there is little advantage in replacement at the present time. Repair is both a more environmentally benign solution and probably more cost effective even in the long run.</p> <p>External decorations are considered in section 3.5.</p> | |

| | Repair needs | Ease and repair door. | 2 |

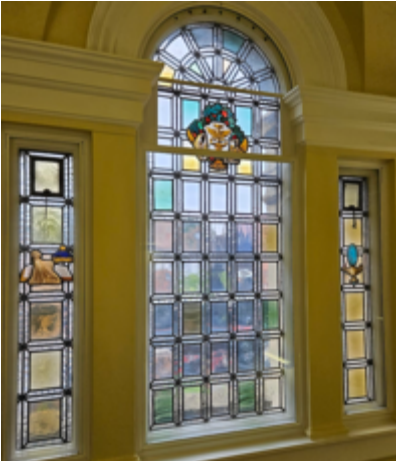
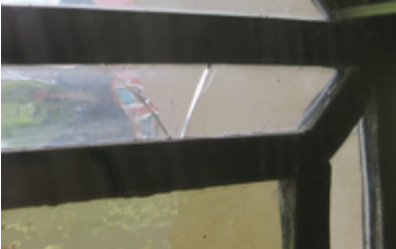
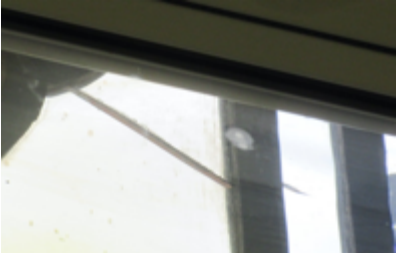
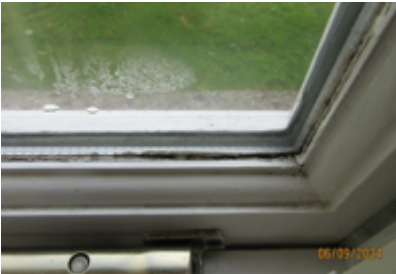
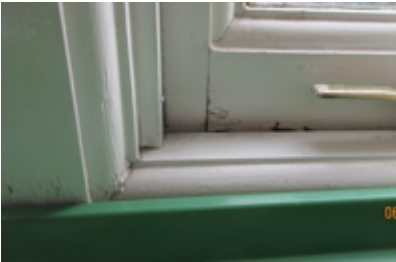
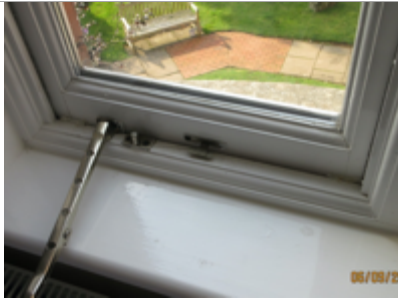
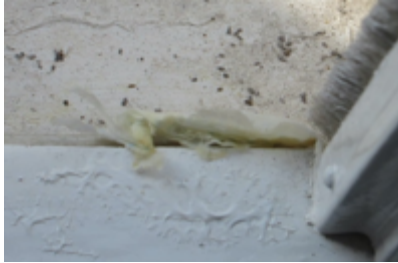
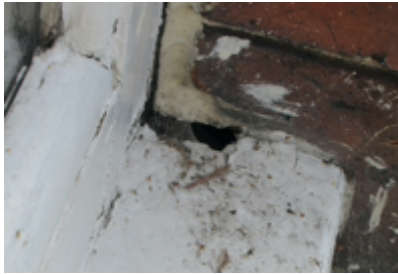
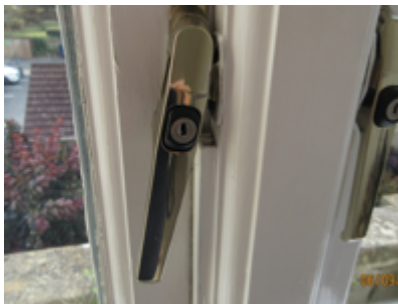
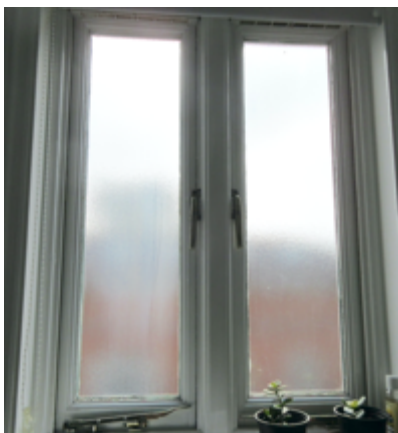
| | <p>Condition</p> <p>Hallway</p> <p>No. 3</p> | <p>Generally good, four panes of glass are cracked to the window above the staircase but the glass is intact. One pane is bowed – the yellow glass above the left hand lamp.</p> <p>There is very minor mould to the window in the living room and bedroom of No. 3, the seal to the double glazed unit has also failed. There is slight wear to the kitchen window.</p> <p>The resident in No. 4 has stated the living room window is draughty, there is kitchen paper stuck in the gaps and there is a hole adjacent to the sill externally. The casement fastener in the bedroom does not work, the trickle vent covers are loose and ineffective. The seal to the double glazed unit in the bathroom window has failed.</p> <p>As with the doors, windows are now 30 years old and although generally in good condition some minor issues exist. They are not so badly defective that replacement is needed but some repairs are.</p> <p>Replacement in softwood would be more appropriate to preserve the character of the building although modern softwood is often poorly seasoned and has a limited life, so there is little advantage in replacement at the present time. Repair is both a more environmentally benign solution and probably more cost effective even in the long run.</p> | |

| | Repair needs | Intact glass could be left or a conservation repair carried out. The bowed item can probably be repaired insitu. | 2 |
| | | Repair flat windows, replace defective glazing and ironmongery. | 2 |

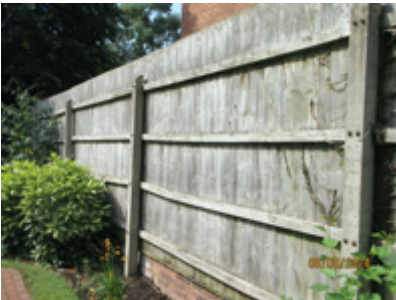
| | Condition<br> | Generally good condition, painted items ought to be redecorated every 4-5 years. Painting fences with a preservative stain will prolong their life.<br><br>Paint is flaking to the French doors in No. 1.<br><br>There is some corrosion to the metal handrails to the rear. | |

| | Repair needs | Touch up doors to No. 1. | 1 |
| | | Treat corrosion. | 2 |
| | | Stain fences. | 3 |

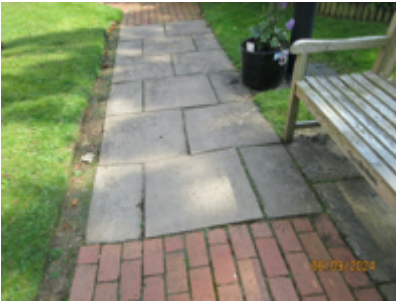
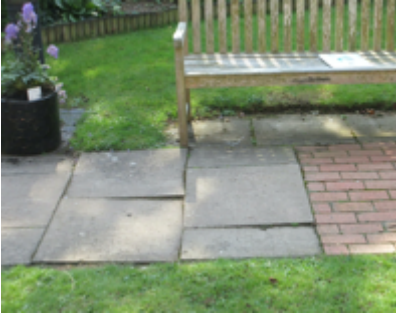
| | Condition<br> | Generally good although some areas of brick and concrete flag paving to the rear have sunk and are something of a trip hazard. | |

| | Repair needs | Take up and re-lay uneven flags and paved areas. | 1 |

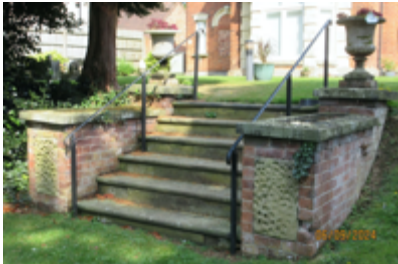
| | Condition<br> | <p>Fair; stone steps are original and show signs of wear.</p> <p>Handrails should not be 'cold to the touch', external metal handrails can become extremely cold. In these circumstances, some people may be reluctant to use the handrail (or involuntary let go of the handrail) if it is uncomfortably cold, representing a safety hazard.</p> <p>External decorations are considered in section 3.5.</p> | |

| | Repair needs | Consider replacing with nylon-coated or hardwood handrails. | 4 |

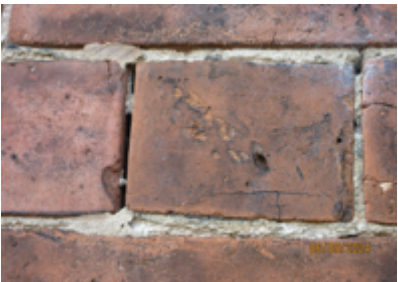
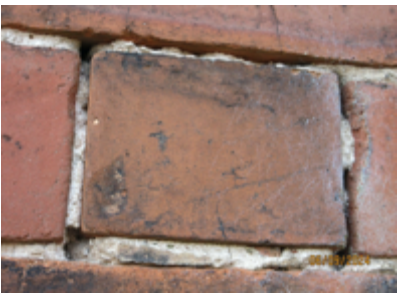
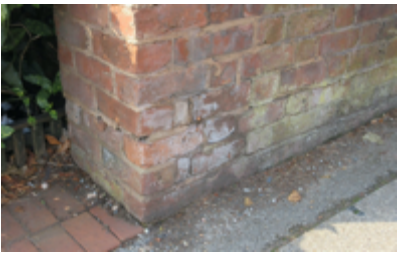
| | Condition<br><br><br> | Brickwork is variable; the majority is in good condition although there is some minor missing pointing and spalled bricks to the front. | |

| | Repair needs | Repoint isolated areas. | 1 |

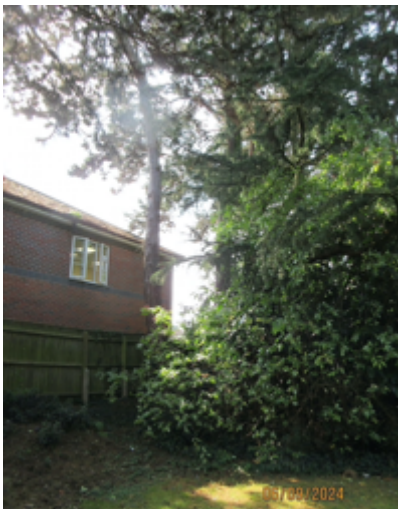
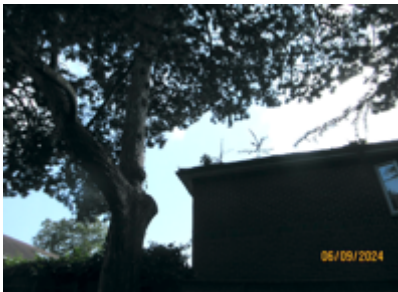
| | Condition<br><br> | Trees are distant enough to the building that any damage is unlikely.<br><br>However some of the trees, particularly to the left hand boundary are very large, some work has been carried out but some are still badly overhanging the neighbouring property. | |

| | Repair needs | Arrange for regular arborist inspections of the mature trees. | 2 |

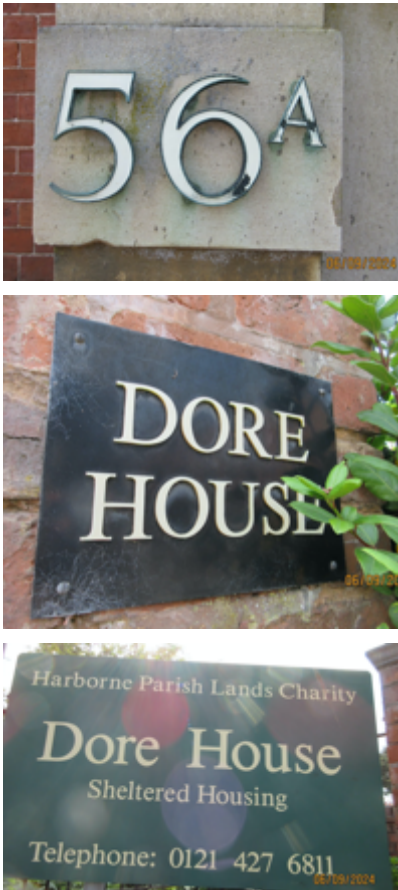
| 3.12.1 | Description | Name and numeral signage to the front. | |

| | <p>Condition</p> | <p>Fair, slight chipping or corrosion but nothing needing urgent work.</p> | |

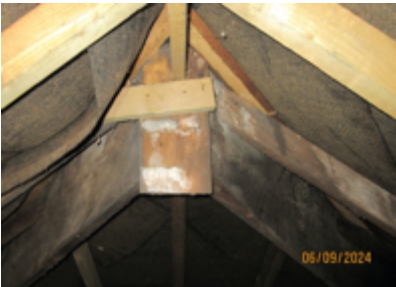
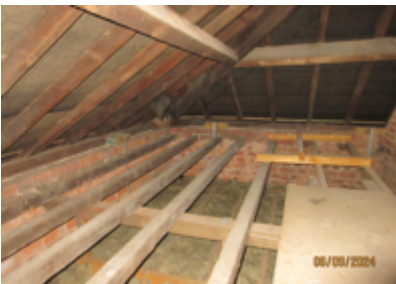
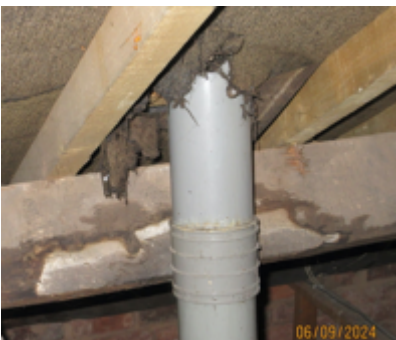
| | <p>Condition</p> | <p>Fire compartmentation between the units is compromised in several places and insulation is not present to some vertical elements, see also section 6.3.1.</p> <p>There is the remains of a birds nest to the rear right hand side of the roof. There is a large wasps' nest to the rear right hand side of the roof, see also section 6.5.2.</p> <p>A few areas of underfelt are torn and sagging.</p> | |

| | Repair needs | Repair underfelt. | 3 |

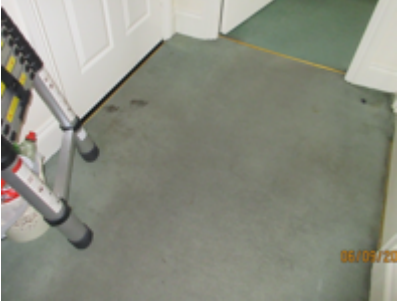
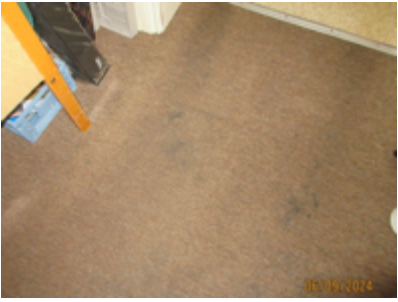
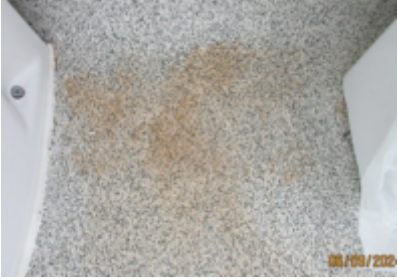
| <p>Condition</p> <p>No. 1</p> <p>No. 3</p> <p>No. 4</p> | | <p>The carpet is rucked and dirty in the hall in No. 1.</p> <p>The floorboards in the bedroom in No. 1 are creaking slightly.</p> <p>There is wear to the carpet floor tiles in the living room in No. 3.</p> <p>The vinyl bathroom floor in No. 4 is stained in two places.</p> |

| Repair needs | | <p>Replace carpets.</p> <p>Take up and relay floor boards.</p> <p>Replace vinyl.</p> |

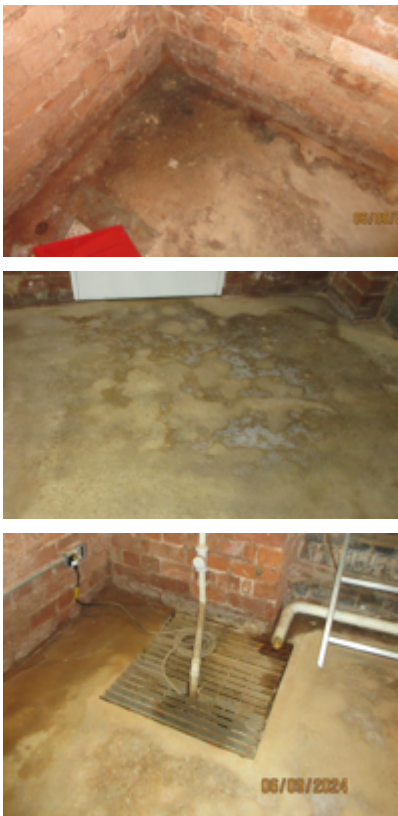
| 4.5.2 | Communal | Solid floors with vinyl or carpet finishes, there is a concrete floor to the cellar. | |

| | Condition<br> | Generally good, there is evidence of water penetration to the cellar but the sump pump appears to be working and most areas are relatively dry. | |

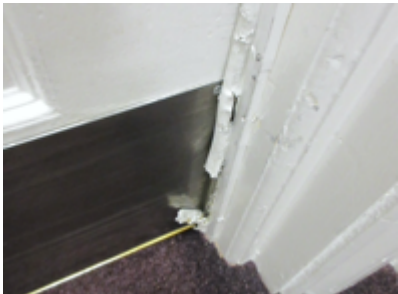
| 4.6.1 | Flats | Gloss painted woodwork, doors are flush or panelled items. | |

| | Condition<br><br>No. 3 | Fair, decorations to the insides of a few windows and French doors are worn.<br><br>There is damage to the draughtstrip to the front door in No. 3. | |

| | Repair needs | Decorate isolated areas. | 3 |
| | | Replace draughtstrip to front door. | 2 |

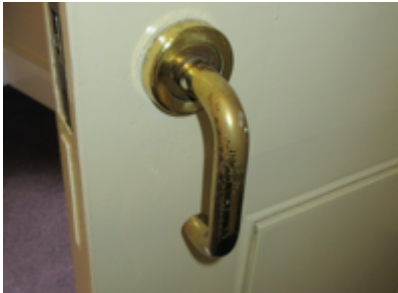
| | Condition<br> | A few door handles are showing signs of wear and one is broken. | |

| | Repair needs | Replace defective handles. | 2 |

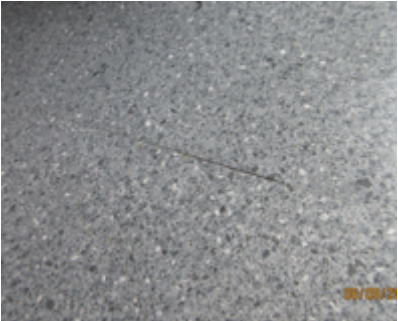
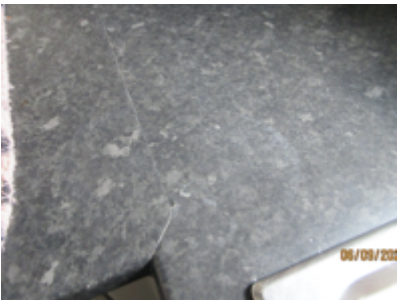
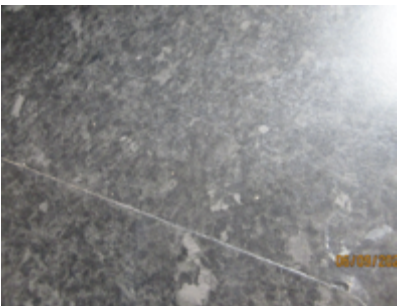
| | <p>Condition</p> <p>No. 1</p> <p>No. 4</p> | <p>There is very slight wear to the worktop joints in No.1 but no action is needed.</p> <p>The worktop in No. 4 is worn and scratched.</p> | |

| | Repair needs | Replace worktops. | 3 |

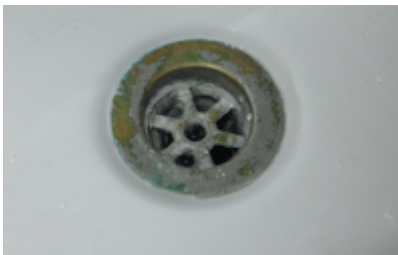
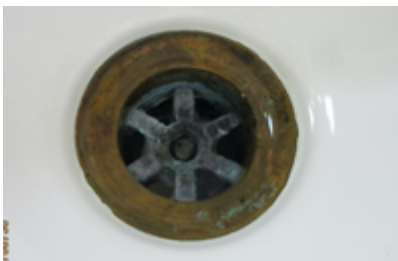
| | Condition<br><br>No. 3<br><br>No. 4 | The waste to the wash hand basin is tarnished in No. 3.<br><br>The waste to the wash hand basin is tarnished and corroded in No. 4. | |

| | Repair needs | Replace wastes. | 3 |

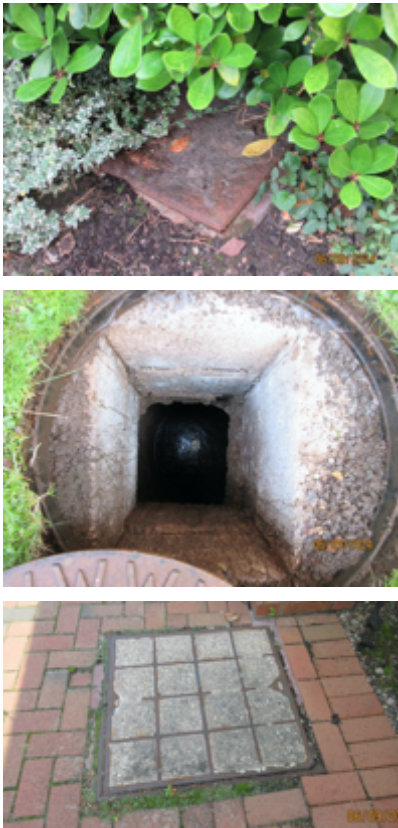
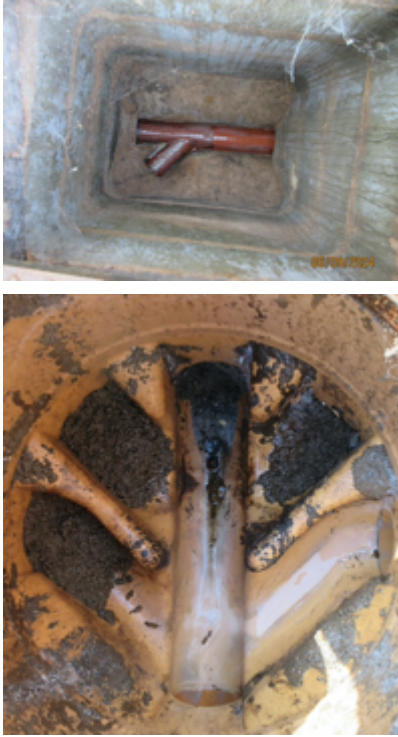
| | Condition | <p>A selection of accessible manhole covers were lifted.</p> <p>There is corrosion to some of the light duty items and they are slightly deformed, particularly the one to the right hand side under a bush.</p> <p>Note that from the 1<sup>st</sup> October 2011, most sewers (drains shared with two or more properties) are now the responsibility of Severn Trent Water, this includes responsibility for clearing blockages.</p> | |

| | Repair needs | Replace corroded light duty manhole cover. | 3 |

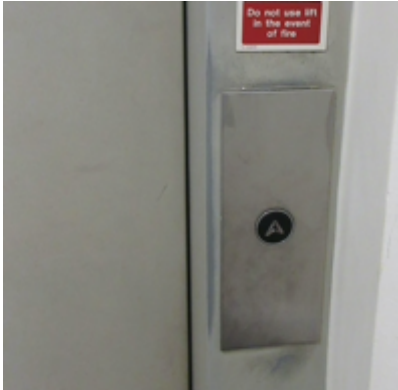
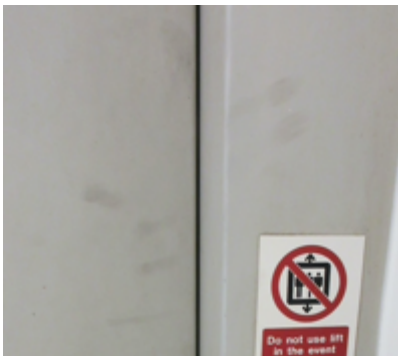
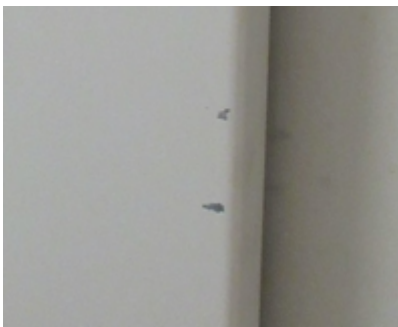
| | Condition <div data-bbox="293 418 692 806"> </div> <div data-bbox="293 817 692 1171"> </div> <div data-bbox="293 1182 692 1507"> </div> | <p>The lift is serviced every two months. The last inspection was carried out on 4<sup>th</sup> September 2024. The previous inspection was carried out on 26<sup>th</sup> June 2024.</p> <p>The finishes to the outside of the lift doors and surround are showing signs of age and the powder coated finish is worn.</p> <p>The lift does not have braille or audible indication of the floors.</p> | |

| | Repair needs | Touch up powder coating. | 3 |

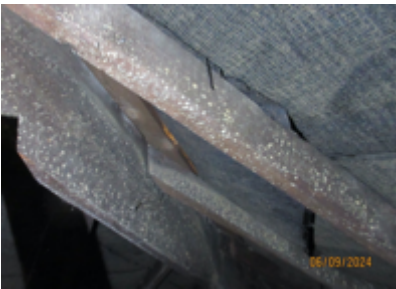
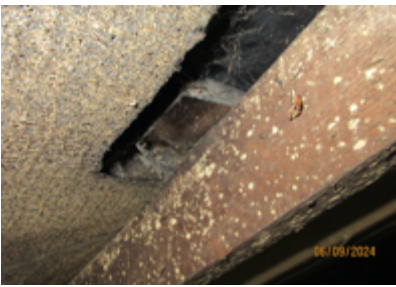
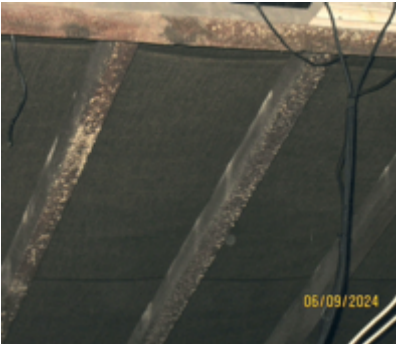
| | Condition<br><br><br> | <p>This type of roofing felt does hinder the ability of the roof to 'breathe', current practice is to provide ventilation to this type of roof to avoid condensation within the roofspace.</p> <p>The timbers in the roof void have an average moisture content of 12%, which is dry although there is some evidence of mould to many of the timbers, this may be historic or may just occur in winter. Without data logging monitoring or further surveys it is impossible to tell. The best solution is to increase ventilation anyway.</p> <p>Note that this type of felt was often made with asbestos.</p> | |

| | Repair needs | Consider increasing ventilation to roofspace. | 3 |

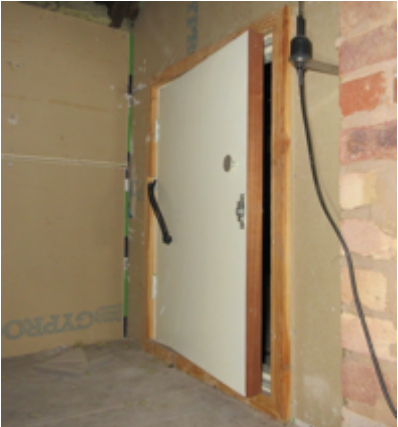
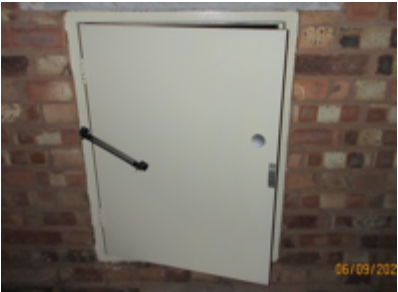
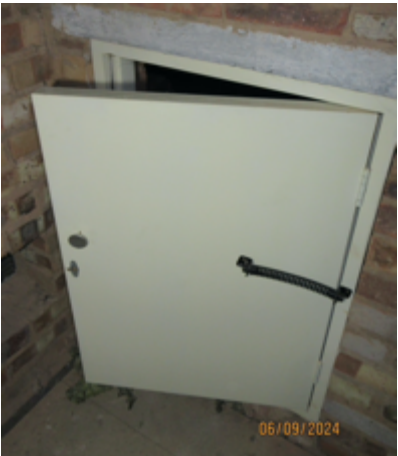
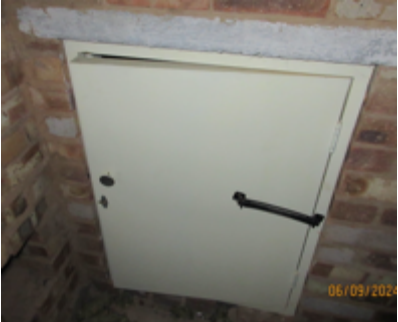
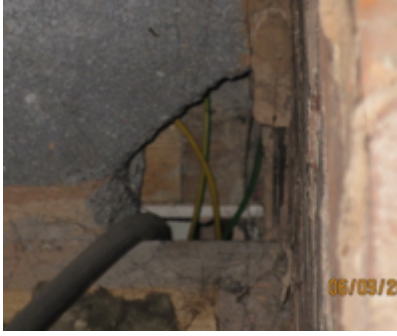
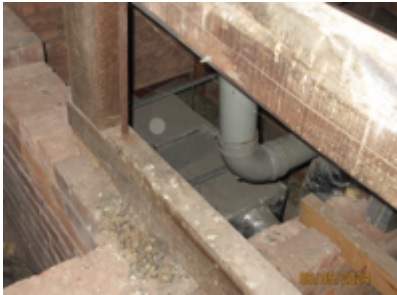
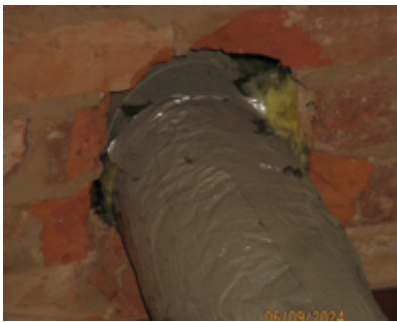
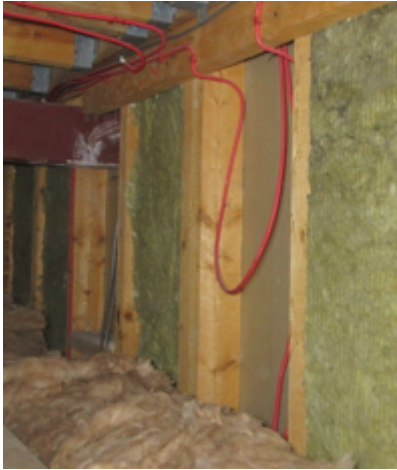
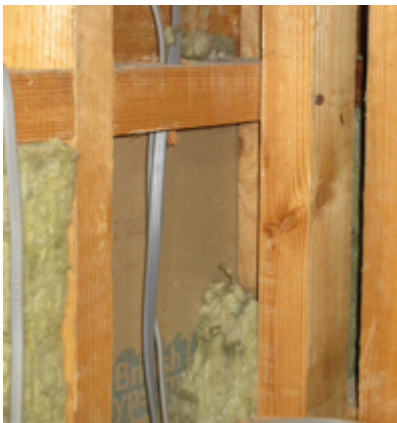
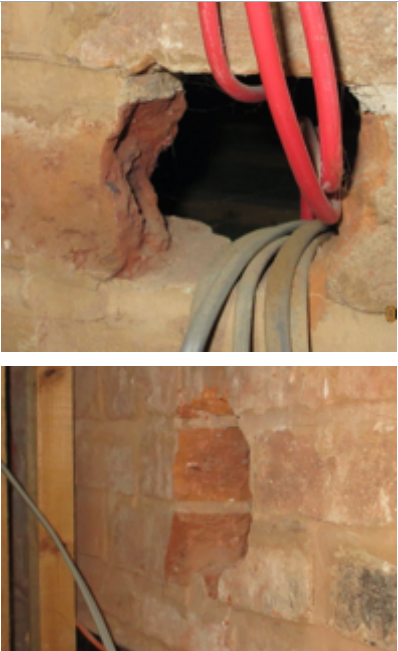
| | <p>Condition</p> | <p>The last fire alarm service was carried out on 19<sup>th</sup> July 2024 and the emergency lighting test was carried out on 22<sup>nd</sup> January 2024. Functional testing of the alarm system on site is carried out weekly. Emergency lighting is subject to a 20-minute test every month. The Automist system is serviced annually.</p> <p>Several flats have more than one smoke/heat detector, some are redundant but this could cause confusion for residents, staff and the emergency services in the event of a problem.</p> <p>Fire compartmentation is compromised in several places. There are fire rated hatches in the roofspace but most of these do not shut fully on the basic spring closers present, meaning that they are open.</p> <p>There are gaps to some of the door frames.</p> <p>There are unsealed holes for service penetrations.</p> <p>In places, rockwool is missing from vertical elements, this may only be a thermal insulation issue but equally may compromise the fire precautions as the fire resistance of such walls, designed in the 1990's often relied on a combination of materials which can only be ascertained by referring back to the original design documentation.</p> |

| | Repair needs | <p>Carry out a full compartmentation survey of all voids.</p> <p>Fill gaps.</p> <p>Replace door closers.</p> <p>Consider an alarm system so fire hatches cannot be left open.</p> | <p>1</p> <p>2</p> <p>2</p> <p>2</p> |

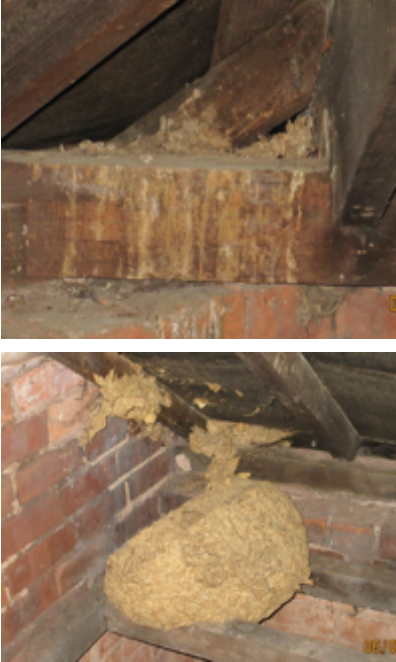
| 6.5.2 | Pests | There is the remains of a birds nest to the rear right hand side of the roof. There is a large wasps' nest to the rear right hand side of the roof. | |

| | Condition<br> | The age of these are not known.<br><br>They should be removed to prevent future confusion. | |

| | Repair needs | Remove nests. | 3 |
