# Management Asbestos Survey

Firs Close, Smethwick

274149-01(00)

31<sup>ST</sup> JANUARY 2012

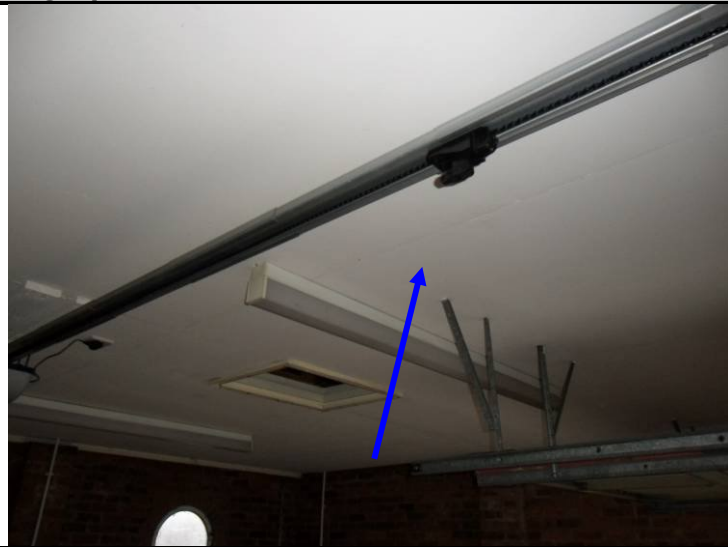
Photograph No. – P008

| This register <u>must</u> be read in conjunction with the full report and should not be extracted or used in isolation. | | | | | | | | | |
|---|---|---|---|---|---|---|---|---|---|
| ND 8 | Ext | Roof / Under cloaks to roof | | Cement | 35604 | P008 | R | - | No Action Required |
