# MANAGEMENT ASBESTOS SURVEY

| <b>Site</b> | Harbourne Cottages, Cooper Lane, Smethwick, B67 7DL. |
| <b>Date started</b> | 27/6/2013 |
| <b>Survey reference</b> | S073/HAR9/2 |

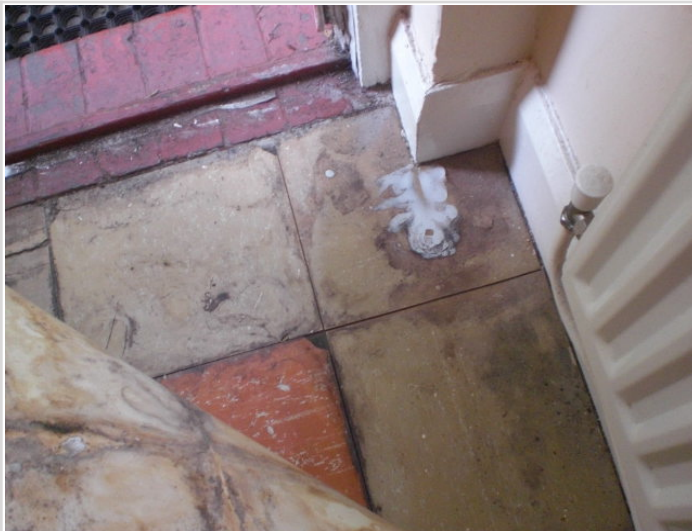
| Sample reference number | S073/HAR9/2/005 |

| ROOM | | KITCHEN | | ROOM DESCRIPTION | | | | | 'Plaster render towards Lathe and Plaster to ceiling Vinyl, Concrete and Floor tiles to floor No Bitumen pad to sink' | | | 4.1.2.3 | |
|---|---|---|---|---|---|---|---|---|---|---|---|---|--|
| S073 / HAR9 / 2 / 005 | Floor below vinyl | Beige floor tile | Asbestos flooring materials | Low Damage | Composite asbestos materials | 4m2 | Chrysotile | 3 | N/A | N/A | Risk code E | | |

| Condition / damage | Low Damage |
| Material assessment score | Very Low Risk (3) |
| Risk code | Risk code E |

| ROOM | | KITCHEN | | ROOM DESCRIPTION | | | | | 'Plaster render towards Lathe and Plaster to ceiling Vinyl, Concrete and Floor tiles to floor No Bitumen pad to sink' | | | 4.1.2.3 | |
|---|---|---|---|---|---|---|---|---|---|---|---|---|--|
| Low risk ACM Bound in matrix. Where appropriate label with warning signs. Undertake routine inspections for damage and deterioration. Where damaged, remove or repair In accordance with CAR2012 | | | | | | | | | | | | | |

Comments / recommendation: Low risk ACM (Bound in matrix). Where appropriate label with warning signs. Undertake routine inspections for damage and deterioration. Where damaged, remove or repair in accordance with CAR2012

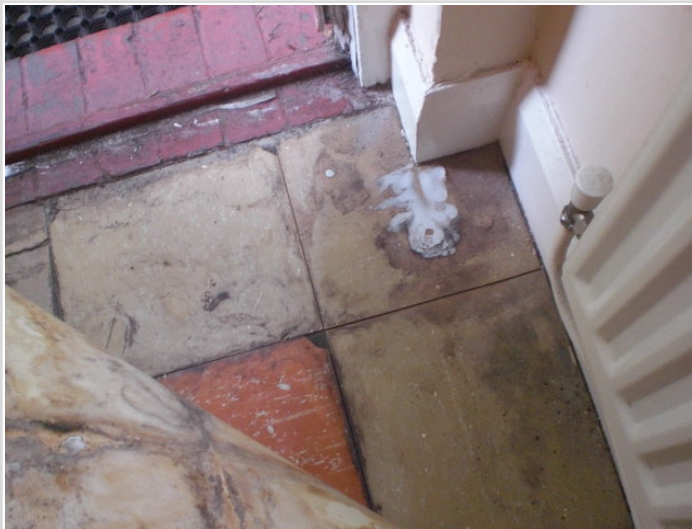
| Sample reference number | S073/HAR9/2/006 |

| Sample | Building | Floor | Room | Position | Item desc | Conclusion | Assessment scores | | | Risk code | |
|---|---|---|---|---|---|---|---|---|---|---|---|
| S073 / HAR9 / 2 / 006 | Bungalow 15 | Ground Floor | Kitchen | Floor below vinyl | Orange floor tile | Chrysotile | 3 | N/A | N/A | Risk code E | |

| ROOM | | KITCHEN | | ROOM DESCRIPTION | | | | | 'Plaster render towards Lathe and Plaster to ceiling Vinyl, Concrete and Floor tiles to floor No Bitumen pad to sink' | | | 4.1.2.3 | |
|---|---|---|---|---|---|---|---|---|---|---|---|---|--|
| S073 / HAR9 / 2 / 006 | Floor below vinyl | Orange floor tile | Asbestos flooring materials | Low Damage | Composite asbestos materials | 1m2 | Chrysotile | 3 | N/A | N/A | Risk code E | | |

| Condition / damage | Low Damage |
| Material assessment score | Very Low Risk (3) |
| Risk code | Risk code E |

| ROOM | | KITCHEN | | ROOM DESCRIPTION | | | | | 'Plaster render towards Lathe and Plaster to ceiling Vinyl, Concrete and Floor tiles to floor No Bitumen pad to sink' | | | 4.1.2.3 | |
|---|---|---|---|---|---|---|---|---|---|---|---|---|--|
| Low risk ACM Bound in matrix. Where appropriate label with warning signs. Undertake routine inspections for damage and deterioration. Where damaged, remove or repair In accordance with CAR2012 | | | | | | | | | | | | | |

Comments / recommendation: Low risk ACM (Bound in matrix). Where appropriate label with warning signs. Undertake routine inspections for damage and deterioration. Where damaged, remove or repair in accordance with CAR2012

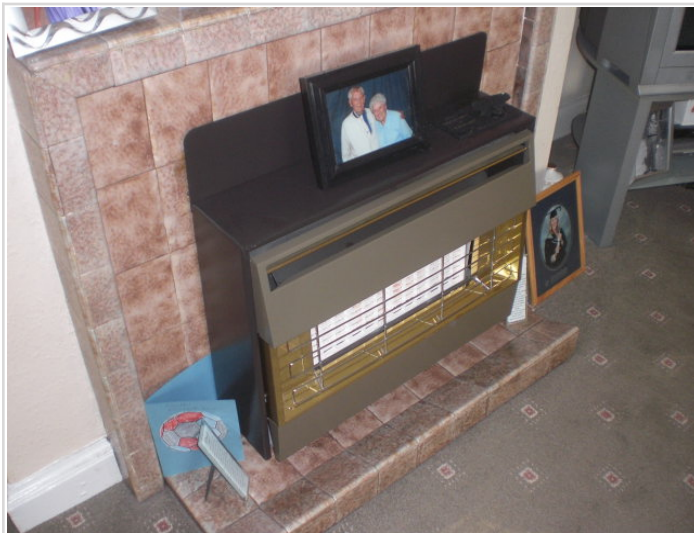
| Sample reference number | Item Ref 1 - Presumed |

| Sample ref no | Building | Floor level | Room | Position | Item | Access level |
|---|---|---|---|---|---|---|
| Item Ref 1 - Presumed | Bungalow 15 | Ground Floor | Lounge | Behind gas fire into chimney | | No Access |

Comments / recommendation: No access in or behind fire Presume Asbestos until proven otherwise

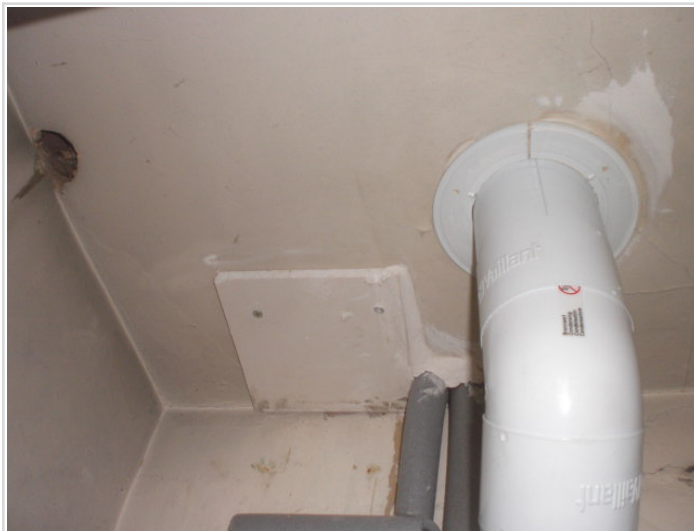
| Sample reference number | S073/HAR9/2/004 |

Comments / recommendation: Sample analysed no asbestos detected no further action required

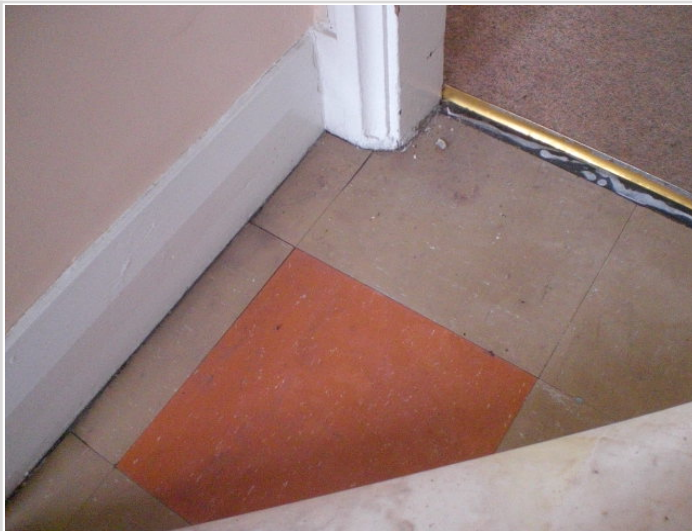
| Sample reference number | S073/HAR9/2/001 |

| ROOM | | KITCHEN | | ROOM DESCRIPTION | | | | 'Plaster render to walls Lathe and Plaster to ceiling Vinyl Concrete and Floor tiles to floor Modern electrics to wall' | | | | 4.2.2.2 | |
|---|---|---|---|---|---|---|---|---|---|---|---|---|--|
| S073 / HAR9 / 2 / 001 | Floor below vinyl | Beige floor tile | Asbestos flooring materials | Low Damage | Composite asbestos materials | 4m2 | Chrysotile | 3 | N/A | N/A | Risk code E | | |

| Condition / damage | Low Damage |
| Material assessment score | Very Low Risk (3) |
| Risk code | Risk code E |

Low risk ACM Bound in matrix. Where appropriate label with warning signs. Undertake routine inspections for damage and deterioration. Where damaged, remove or repair In accordance with CAR2012

Comments / recommendation: Low risk ACM (Bound in matrix). Where appropriate label with warning signs. Undertake routine inspections for damage and deterioration. Where damaged, remove or repair in accordance with CAR2012

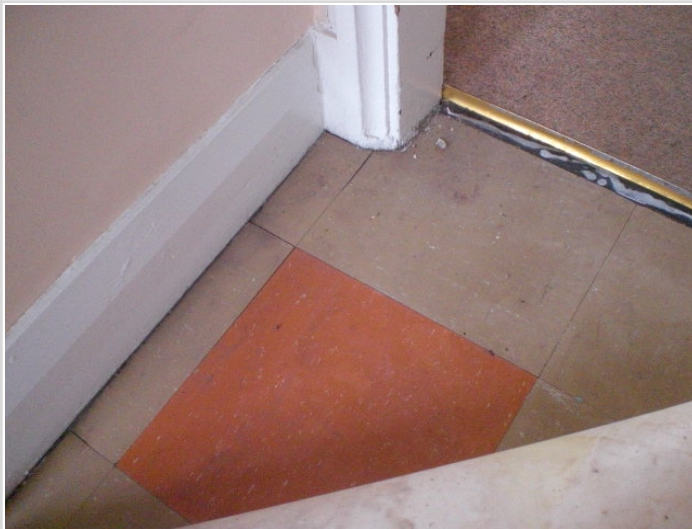
| Sample reference number | S073/HAR9/2/002 |

| Condition / damage | Low Damage |
| Material assessment score | Very Low Risk (3) |
| Risk code | Risk code E |

Comments / recommendation: Low risk ACM (Bound in matrix). Where appropriate label with warning signs. Undertake routine inspections for damage and deterioration. Where damaged, remove or repair in accordance with CAR2012

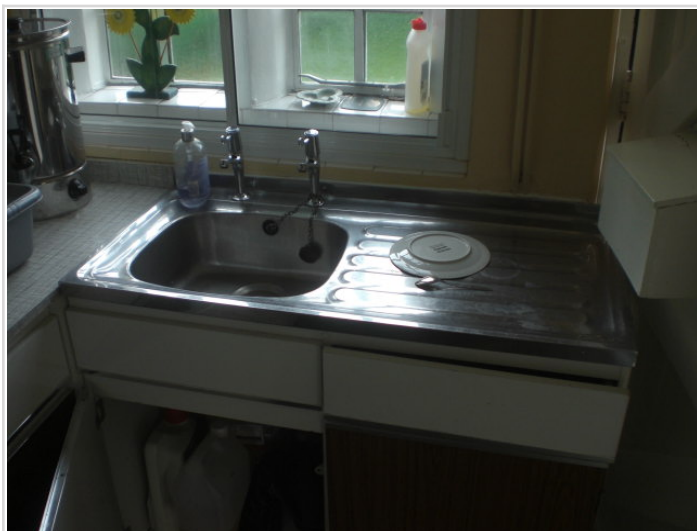
| Sample reference number | S073/HAR9/2/003 |

Comments / recommendation: Sample analysed no asbestos detected no further action required
