## Quinquennial Inspection Report

Harborne Cottages,  
Coopers Lane,  
Smethwick B67 7DL

20<sup>th</sup> August 2024

Project number: 1253C-04

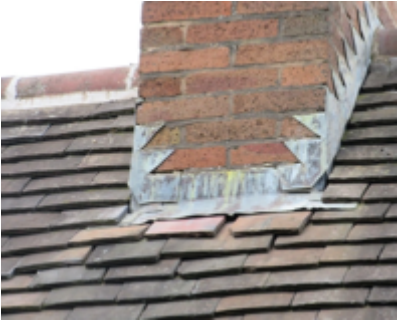
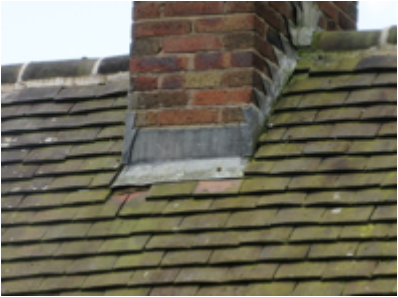
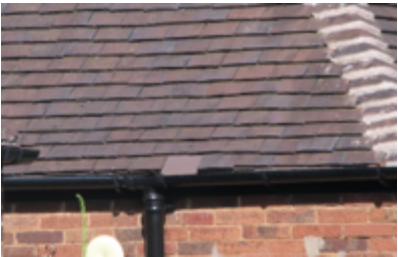
| | Condition<br><br><br> | <p>Roof coverings are original and now some 97 years old. Recent work has prolonged the life of the covering but it should be reviewed every quinquennium and replacement should be budgeted for in the long term</p> <p>A few isolated tiles have slipped.</p> | |

| | Repair needs | Replace slipped tiles.<br><br>Eventually replace covering. | 2<br><br>4 |

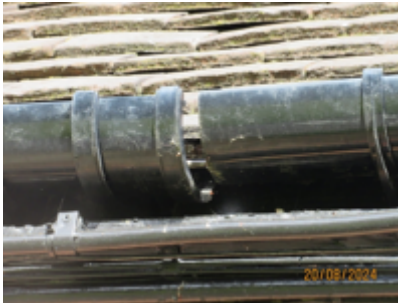
| | Condition<br> | There is a gap to the gutter to the front of No. 5. | |

| | Repair needs | Repair gap to gutter. | 1 |

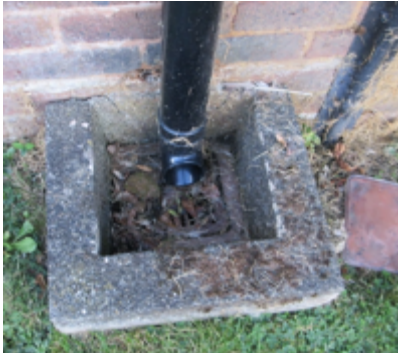
| | Condition<br> | Fair, a few are slightly blocked with vegetation and leaves. See also section 5.8.1. | |

| | Repair needs | Clean out gulleys. | 2 |

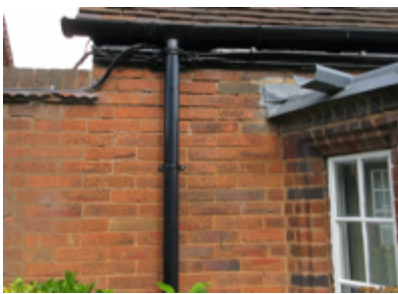
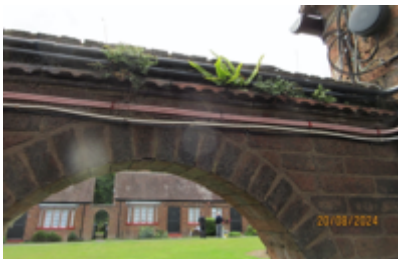
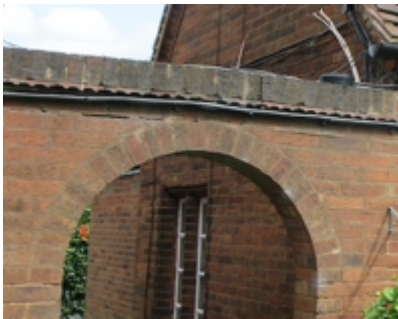
| | <div>Condition</div> <div> </div> | <p>Generally good.</p> <p>There are minor areas of isolated eroded and cracked pointing, in particular:</p> <p>Front of No. 9<br/>Front of No. 5<br/>Bay of No. 4<br/>Door head of No. 3</p> <p>Several of the arches to the walls between terraces have cracked and slipped slightly and there is some vegetation growth to the tops of the walls, in particular:</p> <p>Arch to No. 6/7</p> <p>Although many are affected to an extent.</p> |

| | Repair needs | Repoint isolated areas. |
| | | Repoint and repair arches. |

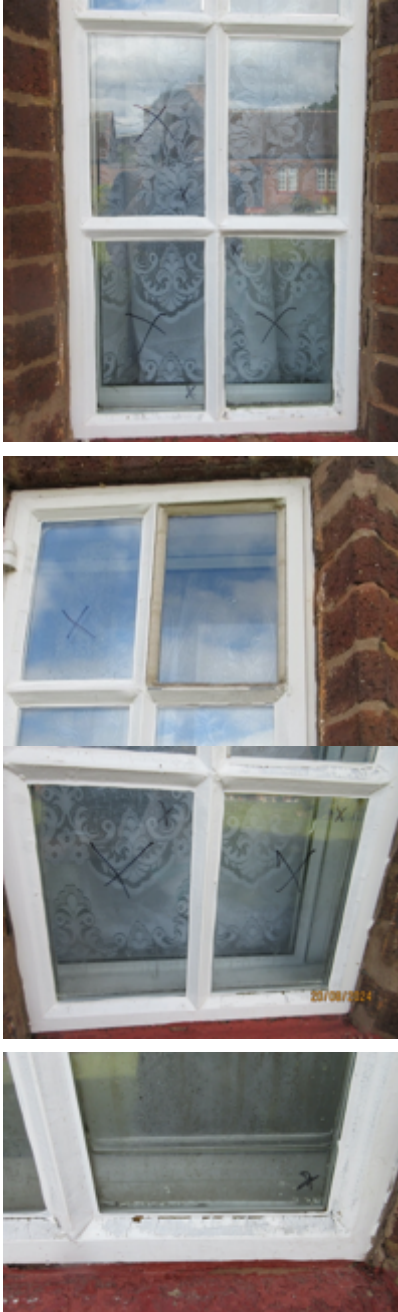
| | <p>Condition</p> | <p>A number of the sealed double glazed units have failed leading to condensation between the panes. This affects a large number of the courtyard side windows.</p> <p>Work was in progress at the time of the survey to repair these and the remaining failed units are No's. 15, 16 and 17.</p> <p>UPVC windows would not really be appropriate to this development and due to the unusually narrow openings would look very poor as well.</p> | |

| | Repair needs | Re-glaze affected windows. | 1 |

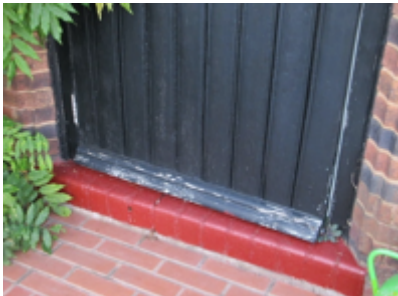
| | Condition<br> | <p>Fascias are largely obscured by cables and whilst most appear to be redundant some may not be.</p> <p>Decorations to a few doors are peeling.</p> <p>External woodwork and metalwork should be redecorated on a 5-7 year cycle.</p> <p>Decorative finishes to the bench around the monument are flaking.</p> | |

| | Repair needs | <p>Touch up decorations.</p> <p>Redecorate paintwork.</p> | <p>2</p> <p>4</p> |

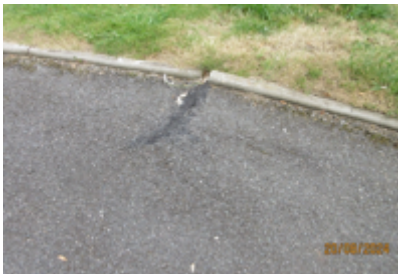
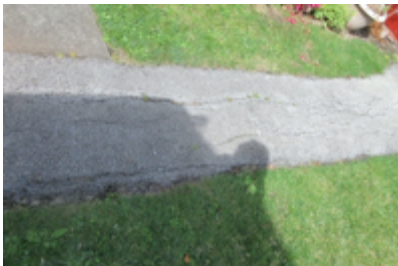
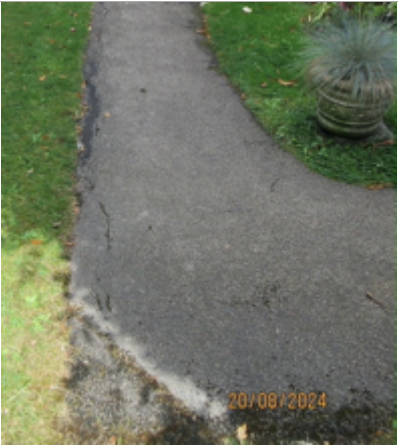
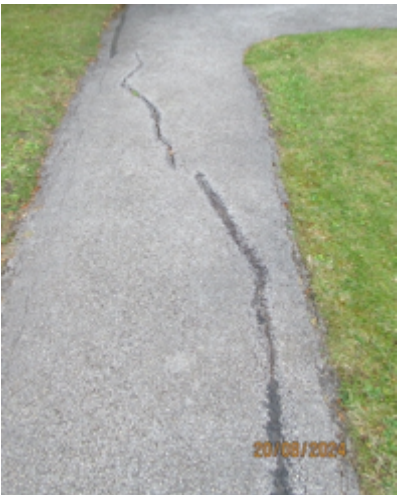
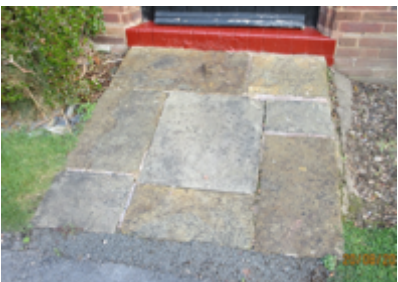
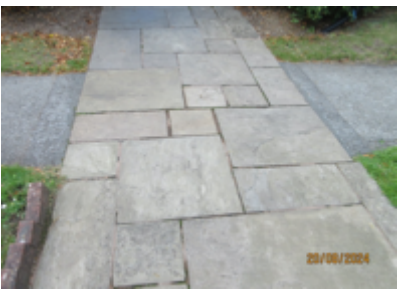
| | Condition<br><br> | <p>Tarmac paths are showing signs of wear, there are no proper edgings to most of the paths and as a result the tarmac is loose and crumbling at the edges.</p> <p>The situation has deteriorated slightly since the previous Quinquennial Inspection.</p> | |

| | Repair needs | Re-surface tarmac paths. | 3 |

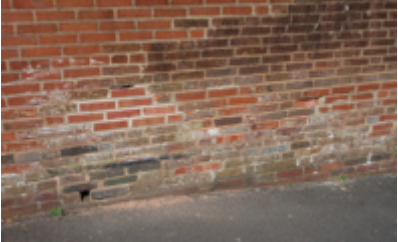
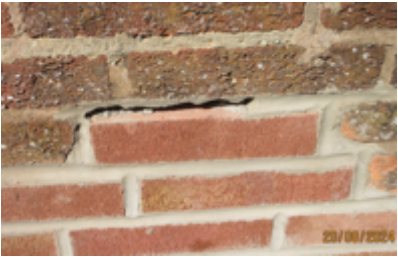
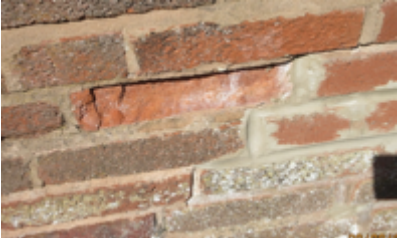
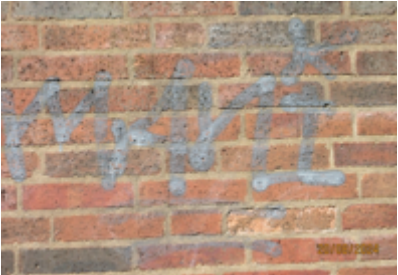
| | Condition<br> | There are a few isolated areas of missing pointing to the rear wall and some graffiti. | |

| | Repair needs | Repoint isolated areas.<br><br>Clean off graffiti. | 3<br><br>2 |

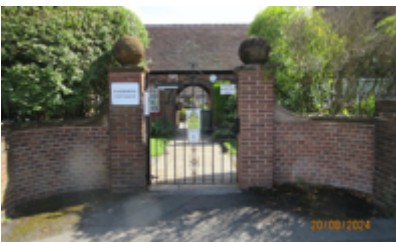
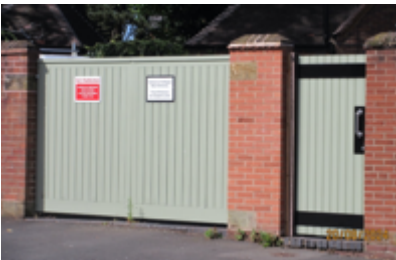
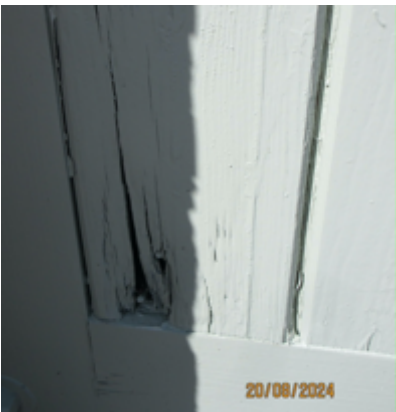
| | <p>Condition</p> | <p>Fences and gates are generally in good condition although there is some rot to the bottom of the rear gate.</p> <p>External decorations are considered in section 3.5.</p> | |

| | Repair needs | Repair rot to gate. | 2 |

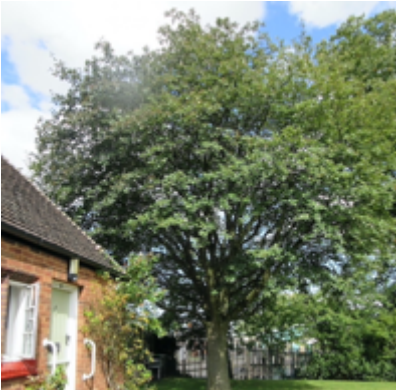
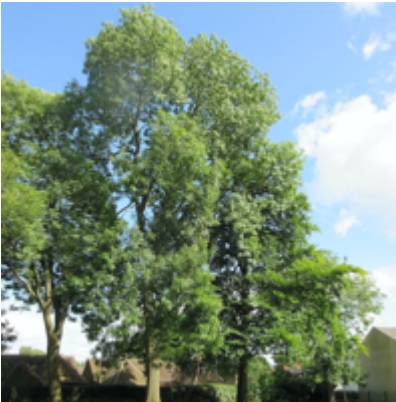
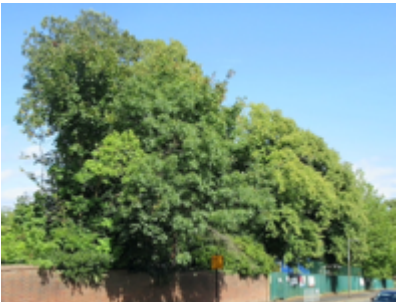
| | Condition<br><br><br> | <p>Many are closer than the "safe" distance to cause any damage but there are no obvious signs of damage at the present time. Some tree work will be needed.</p> <p>Whilst there is no current evidence of any structural problems caused by tree roots they do overhang some of the roofs, leaves will be problematic to clear and falling branches are a potential hazard and could cause damage to the roofs.</p> | |

| | Repair needs | Carry out tree work. | 3 |
| | | Arrange for regular arborist inspections of the mature trees. | 4 |

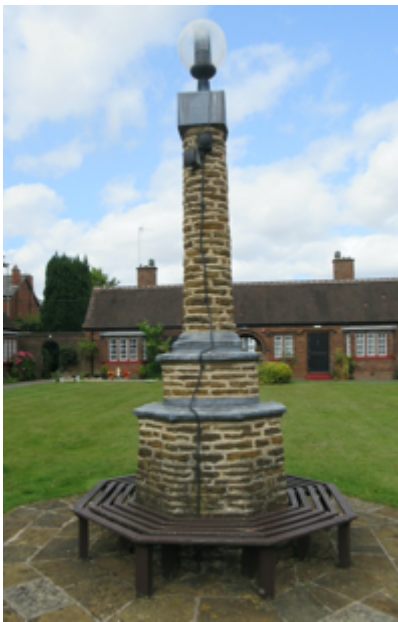
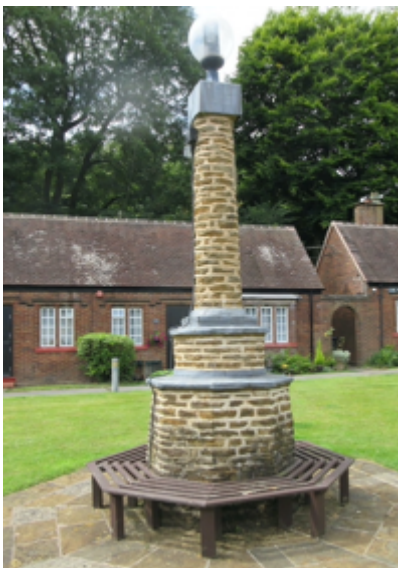
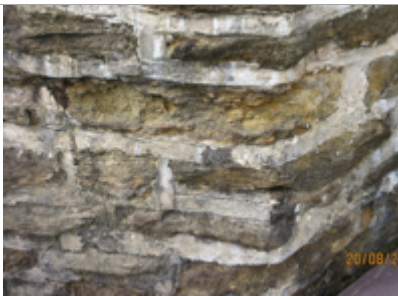
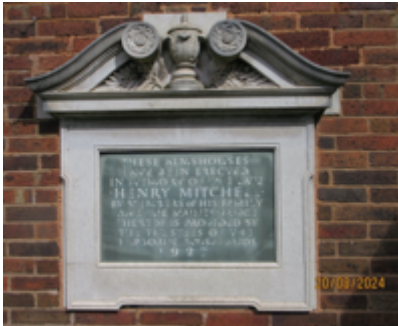
| | <p>Condition</p> | <p>Repairs to the monument including consolidation of the stone were carried out in 2014 have been successful with only very minor deterioration having occurred since.</p> <p>Consolidation of this type is not a one-off solution and further treatment is likely to be needed to maintain the condition of the stone.</p> <p>There is some very minor loose pointing present.</p> <p>The tablet is in fair condition, some of the lettering is showing signs of wear but no immediate action is needed.</p> | |

| | Repair needs | Repoint isolated areas.<br><br>Carry out further limewater treatment.<br><br>Restore tablet. | 2<br><br>4<br><br>4 |

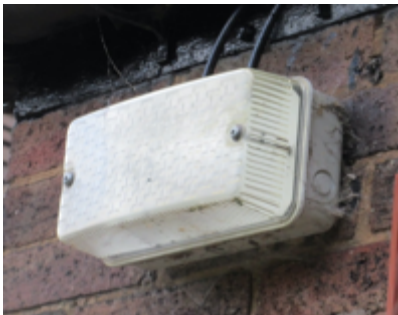
| | Condition | Reasonable, older fittings are showing signs of age. Some diffusers are yellowed and dirty.<br><br>As the inspection was carried out during daylight it was not possible to check the efficacy of the lighting. | |

| | Repair needs | Consider replacing the older lights with newer and more efficient LED lighting. | 3 |

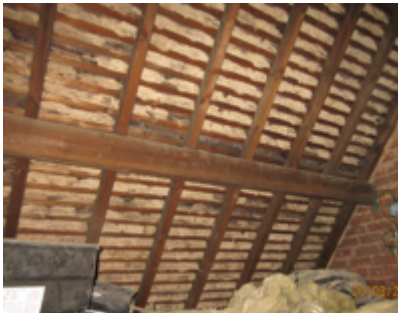
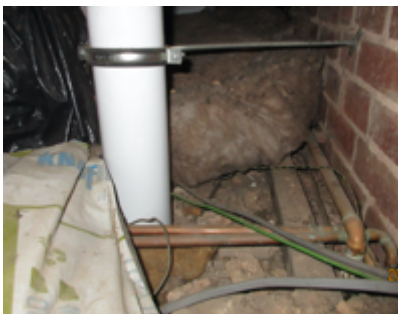
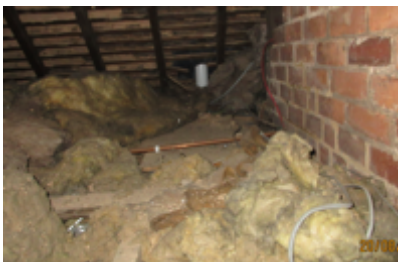
| | <p>Condition</p> <p>No. 2</p> <p>No. 5</p> <p>No.10</p> | <p>Roofspaces are insulated with around 200mm fibreglass insulation.</p> <p>The insulation in the loft in No. 5, 6, 9, 10 is disturbed. This is a cold bridge and will lead to condensation.</p> <p>The roofs still have the original sand and lime torching present to the underside of the tiles. This used to be fitted as a secondary line of defence instead of roofing felt. Torching has become dry and brittle. Once considered an archaic skill there are now more tradespeople able to reapply torching.</p> | |

| | Repair needs | <p>Relay insulation.</p> <p>Re-torch areas as necessary.</p> | <p>1</p> <p>3</p> |

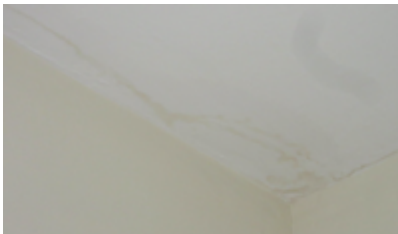
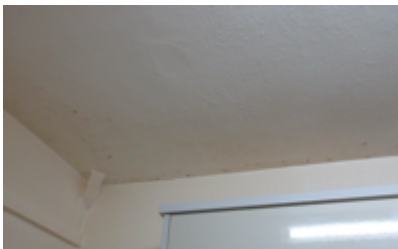
| | <p>Condition</p> <p>No. 2</p> <p>No.6</p> <p>No.14</p> | <p>Staining was noted to No. 2 (bathroom), all is now dry. There is staining to the kitchen ceiling in No. 14.</p> <p>Cracking was noted to No. 6 (living room), No. 9 (hall, kitchen, living room, bedroom 1), No. 12 (living room, kitchen), No.13 (bedroom), No. 14 (living room, kitchen, bedroom).</p> | |

| | Repair needs | <p>Fill cracks and redecorate ceilings.</p> <p>Apply stain block and redecorate.</p> <p>Maintain an asbestos register.</p> | <p>3</p> <p>3</p> <p>1</p> |

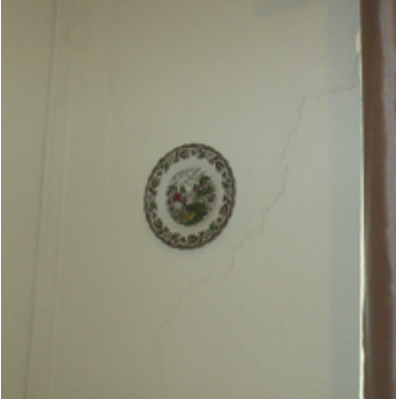
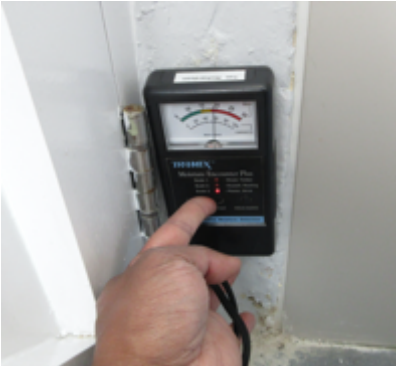
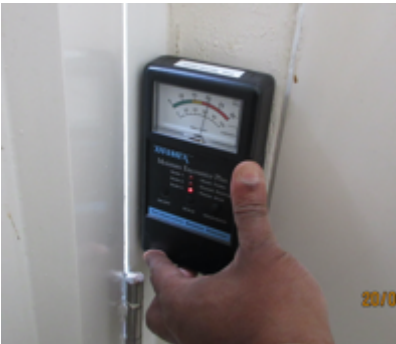
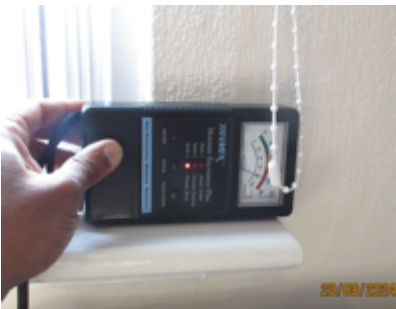
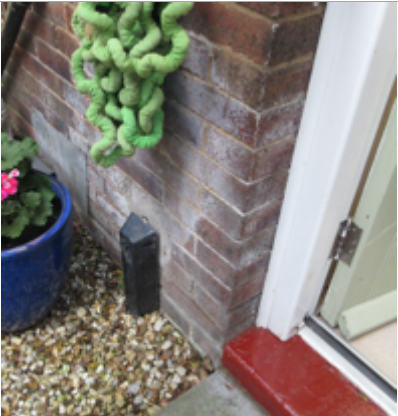
| | Condition<br><br>No.6<br><br>No.10<br><br><br>No.12 | <p>Cracking was noted to No. 5 (bedroom), No. 6 (living room).</p> <p>Damp was noted to the kitchen walls in No. 10 and No. 12, this is located next to the external door and needs further investigation. Staining was also noted to the external wall. There is a water main that enters the property. Further investigation required to ascertain if there is a likely leak from the water main.</p> <p>Damp staining was noted in the bedroom of No. 12, just above the window sill. No obvious signs of water ingress. It could be a result of condensation and needs further investigation.</p> <p>The original plaster in this age of property is composed of sand and lime with animal hair reinforcement. The bond between the wall surface and plaster breaks down and in many properties the plaster is partly held in place by the wallpaper. It is likely that areas of original plaster will become detached when stripping wallpaper and the extent of this can be greater than first thought. Minor cracks should be filled when decorating.</p> |

| | Repair needs | Fill cracks and redecorate. | 3 |
| | | Damp patches require further investigation. | 3 |

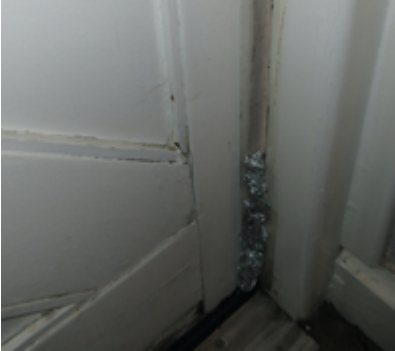
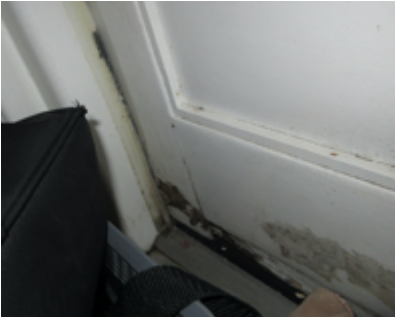
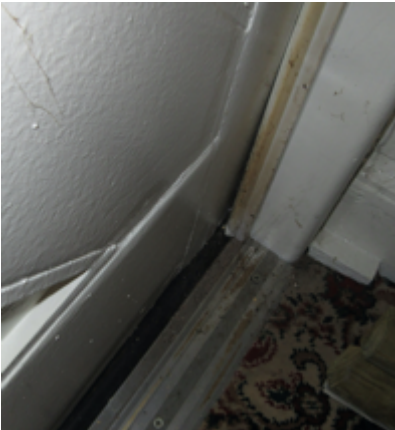
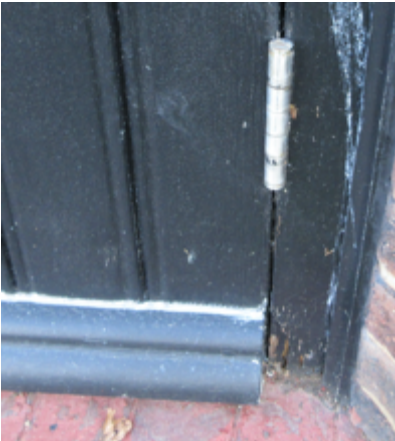
| | <p>Condition</p> <p>No.13</p> <p>No.14</p> | <p>Generally fair.</p> <p>There are gaps to the external door in the bedroom of No. 13 &amp; No.14, rot was also noted.</p> | |

| | Repair needs | Replace or repair external doors. | 1 |
| | | Splice repair to rotten door frame. | 1 |

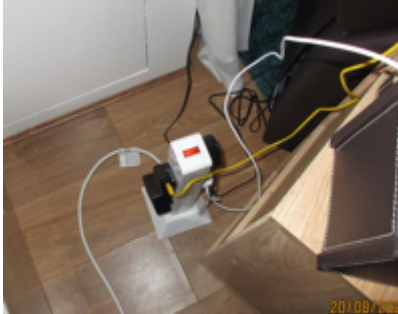
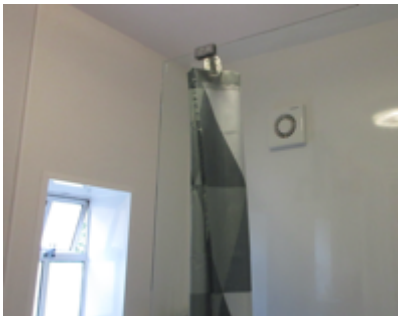
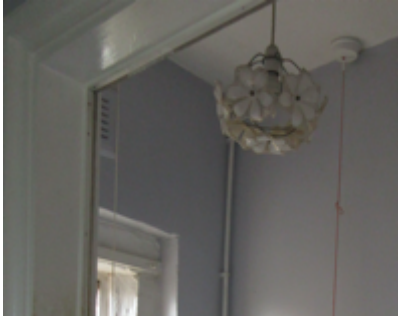
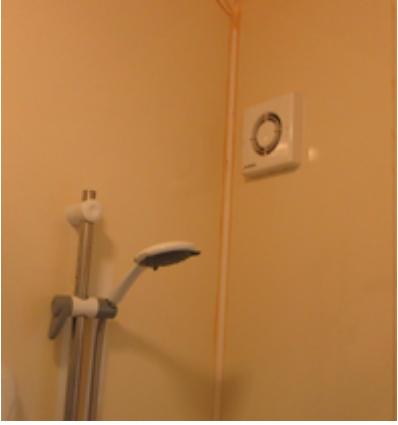
| | Condition | <p>Some of the units are plastic, which is not in accordance with the latest regulations, although this is not a defect.</p> <p>The date of the last Electrical Installation Condition Report is September 2020.</p> <p>The electrical installations are regularly inspected and tested.</p> <p>Electrical Safety First and the Almshouse Association recommend that periodic inspection and testing is carried out at least every 5 years or on the change of occupancy.</p> <p>The numbers of sockets are below current recommendations and multiple adaptors are in use in places. Insufficient sockets to cottage No. 13.</p> <p>There was limited access to the consumer unit in No. 6 due to personal belongings and furniture situated in front of the cupboard.</p> <p>The extractor fan is located in wet area shower of cottage No. 9, No.10 &amp; No.14. Check to</p> | |

| | <p>No.14</p> | <p>ensure the fan is SELV (Safety Extra Low Voltage)</p> <p>Light fitting in toilet of No. 10 is not a sealed light fitting.</p> <p>The number of sockets could be increased at the same time as any other electrical work.</p> | |

| | Repair needs | <p>Rewire flats to remove aluminium cable, replace fuses and increase number of socket outlets.</p> <p>Replace ceiling pendant with sealed light fitting to No.10</p> <p>Check extractor fan zoning and ensure correct type of extractor is installed, i.e SELV.</p> | <p>2</p> <p>1</p> <p>4</p> |

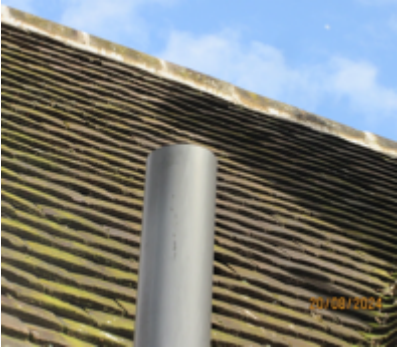
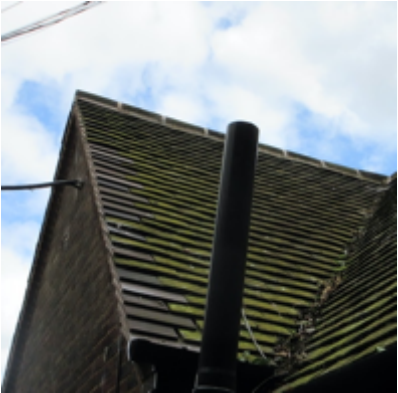
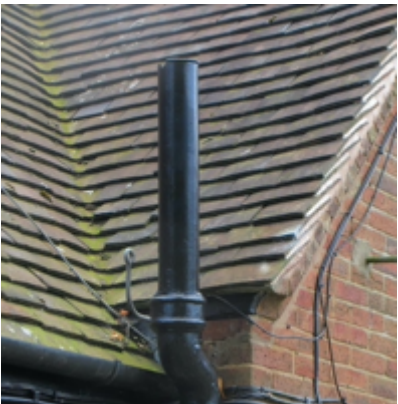
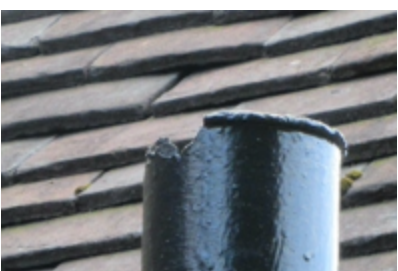
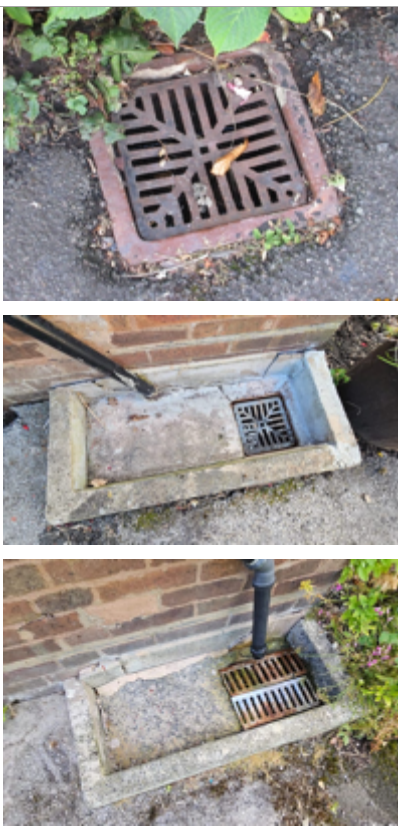
| | Condition<br><br><br><br> | <p>There are no wire balloons to the top of most of the external soil stacks, these stop birds dropping debris down the pipes.</p> <p>Some gulley surrounds are cracked as are a few gullies.</p> <p>Many of the gullies no longer operate as by law gullies as pipework has been adapted over time so water loss from the open part is less of a problem although there are more general concerns about the below ground drainage installation.</p> | |

| <p>Repair needs</p> | <p>Provide wire balloon to the top of the soil stacks.</p> <p>Repair gulley surrounds.</p> | <p>2</p> <p>3</p> |

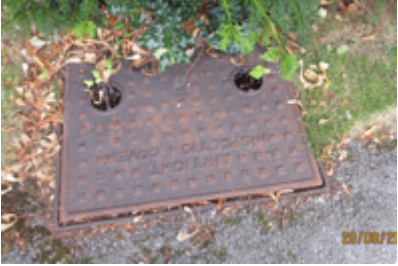
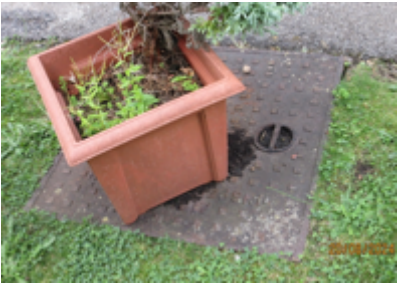
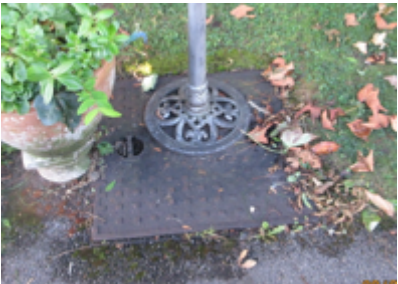
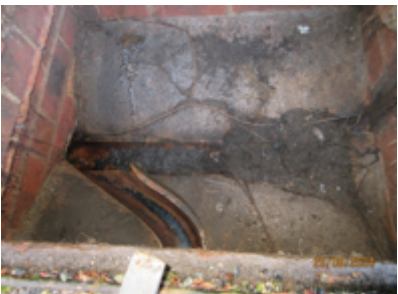
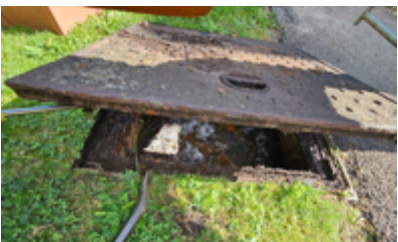
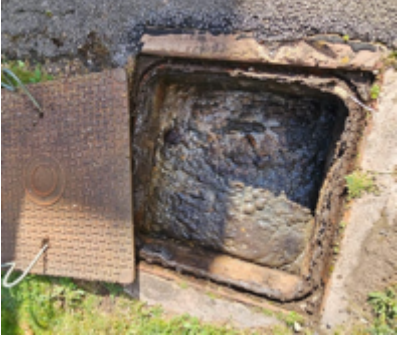
| | <p>Condition</p> | <p>There are two blocked manholes to the east of the site.</p> <p>The drainage appears to be original and, at 97 years, it is likely to need increasing maintenance in time. A CCTV survey of the drainage should be carried out along with water testing of the gulley to determine the condition of the drainage. It is likely that some repairs or replacement will be needed.</p> <p>The large trees and recent hot summers may have hastened any problems.</p> <p>Note that from the 1<sup>st</sup> October 2011, most sewers (drains shared with two or more properties) are now the responsibility of Severn Trent Water, this includes responsibility for clearing blockages. Whilst none of the individual residents pay's their own water bills currently this could be considered if major work is needed to the below ground drainage.</p> <p>Several covers are corroded.</p> |

| | Repair needs | <p>Clear blockage.</p> <p>Carry out a CCTV survey of the drainage and water testing of the gulleys.</p> <p>Consider painting corroded medium duty covers with a suitable paint.</p> | <p>1</p> <p>2</p> <p>3</p> |

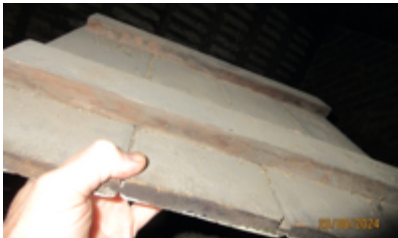
| | Condition<br><br>No. 2 | Good, some loft hatches are uninsulated. | |

| | Repair needs | Insulate loft hatches. | 3 |
