# MANAGEMENT ASBESTOS SURVEY

| <b>Client</b> | Harborne Parish Lands Charity |
| <b>Site</b> | Harbourne House, Tibbets Lane, Harborne, B17 0SX. |
| <b>Survey reference</b> | S073/HAR9/5 |

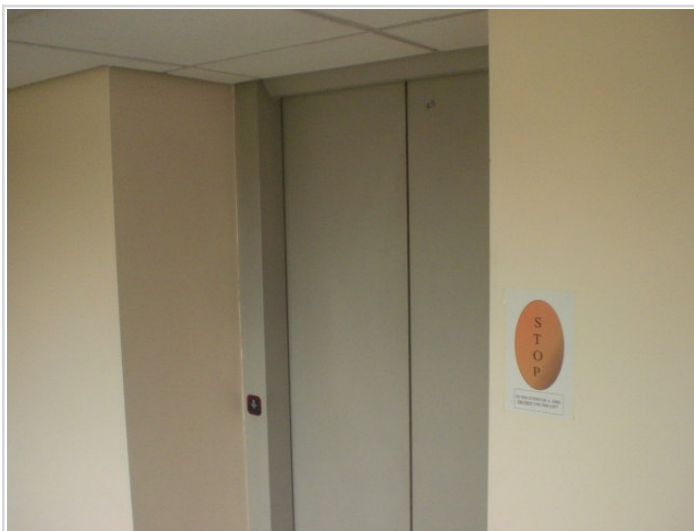
| Sample reference number | Item Ref 18 - Presumed |

Comments / recommendation: No access Live lifts no engineer on site Presume asbestos until proven otherwise(All Lifts)

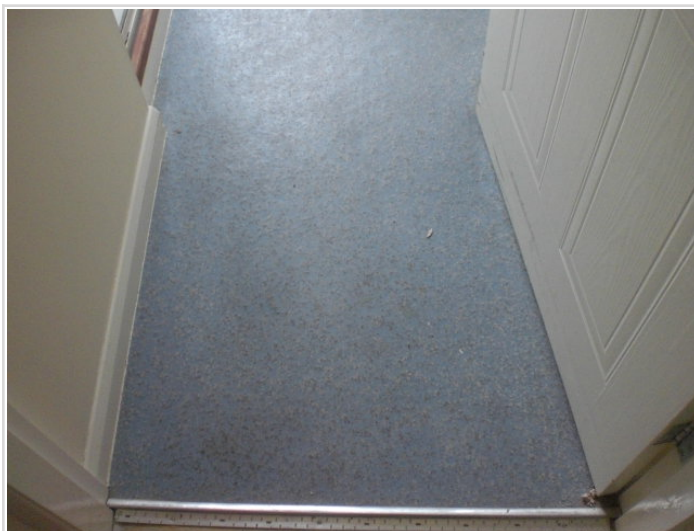
| Sample reference number | Item Ref 7 - Strongly Presumed |

Comments / recommendation: Visually similar to sample 002Low risk ACM (Bound in matrix). Where appropriate label with warning signs. Undertake routine inspections for damage and deterioration. Where damaged, remove or repair In accordance with CAR2012

| Risk code | Risk code E |

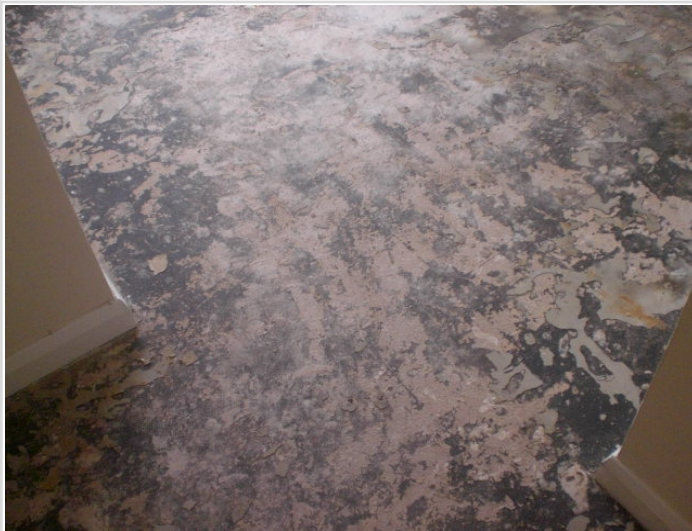
| Sample reference number | Item Ref 4 - Strongly Presumed |

Comments / recommendation: Visually similar to sample 002Low risk ACM (Bound in matrix). Where appropriate label with warning signs. Undertake routine inspections for damage and deterioration. Where damaged, remove or repair in accordance with CAR2012

| Risk code | Risk code E |

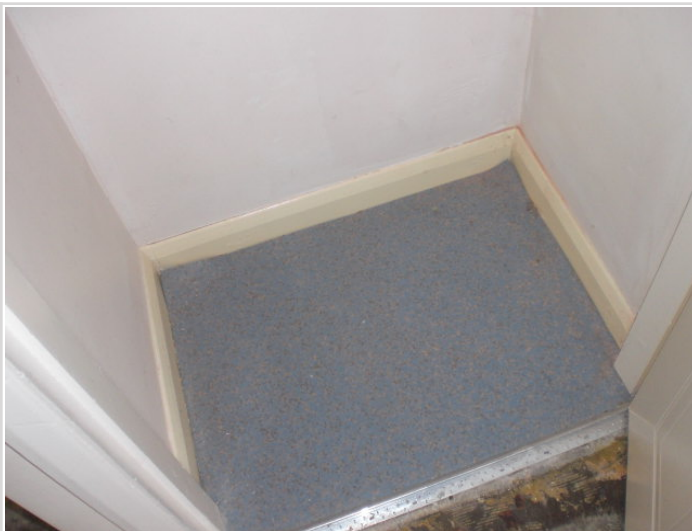
| Sample reference number | Item Ref 2 - Strongly Presumed |

Comments / recommendation: Visually similar to sample 002Low risk ACM (Bound in matrix). Where appropriate label with warning signs. Undertake routine inspections for damage and deterioration. Where damaged, remove or repair in accordance with CAR2012

| Risk code | Risk code E |

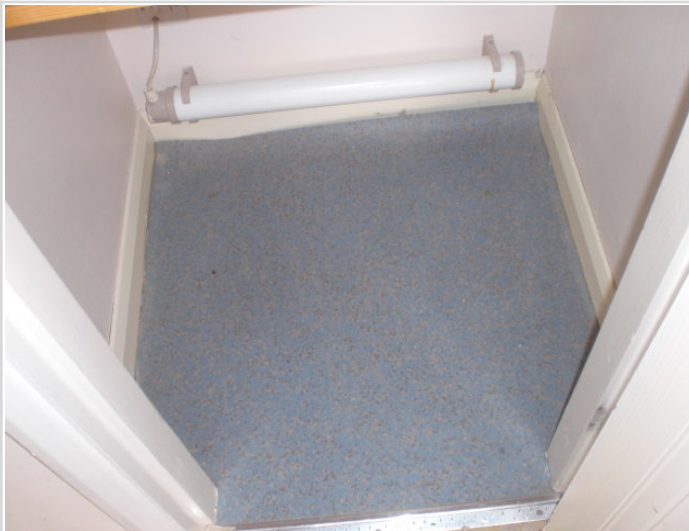
| Sample reference number | Item Ref 5 - Strongly Presumed |

Comments / recommendation: Visually similar to sample 002 Low risk ACM (Bound in matrix). Where appropriate label with warning signs. Undertake routine inspections for damage and deterioration. Where damaged, remove or repair in accordance with CAR2012

| Risk code | Risk code E |

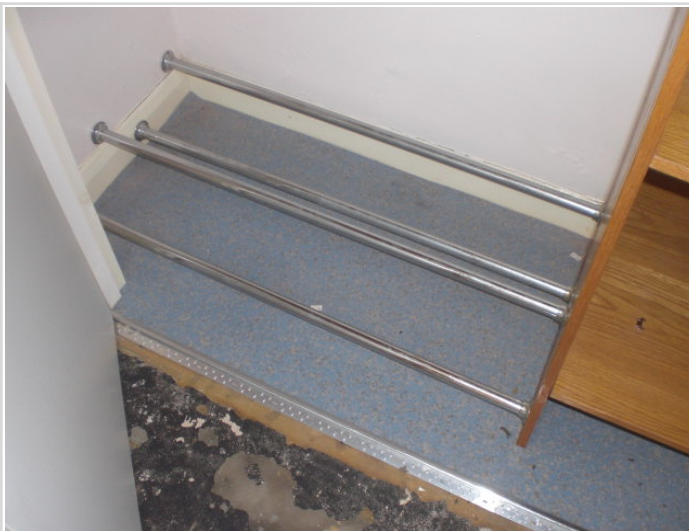
| Sample reference number | Item Ref 6 - Strongly Presumed |

Comments / recommendation: Visually similar to sample 002 Low risk ACM (Bound in matrix). Where appropriate label with warning signs. Undertake routine inspections for damage and deterioration. Where damaged, remove or repair in accordance with CAR2012

| Risk code | Risk code E |

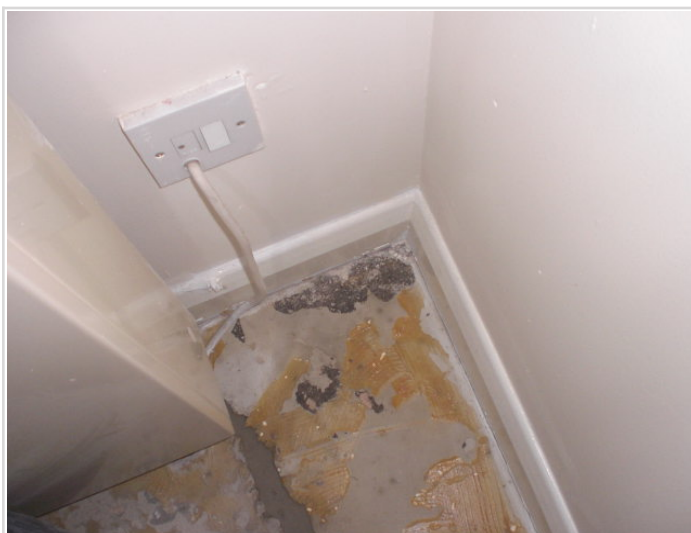
| Sample reference number | Item Ref 3 - Strongly Presumed |

Comments / recommendation: Visually similar to sample 002 Low risk ACM (Bound in matrix). Where appropriate label with warning signs. Undertake routine inspections for damage and deterioration. Where damaged, remove or repair in accordance with CAR2012

| Risk code | Risk code E |

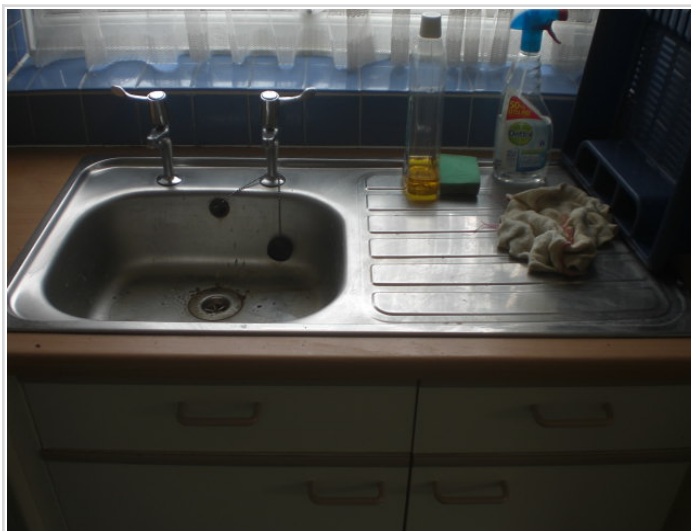
| Sample reference number | S073/HAR9/5/001 |

Comments / recommendation: Sample analysed no asbestos detected no further action required

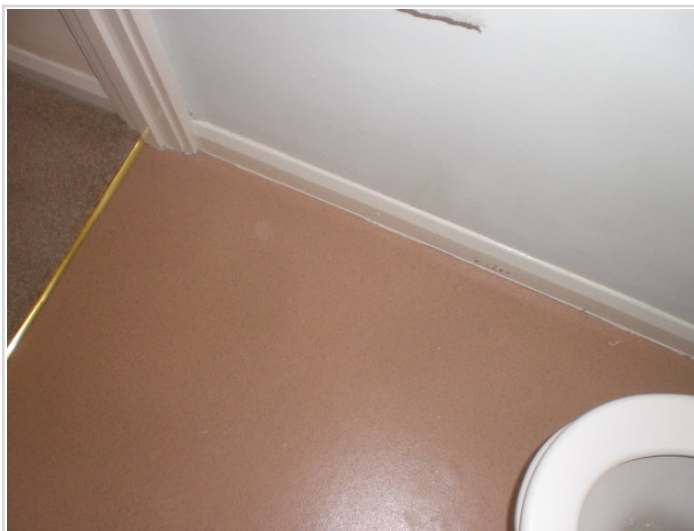
| Sample reference number | Item Ref 12 - Presumed |

Comments / recommendation: No access below fitted vinyl Presume asbestos until proven otherwise

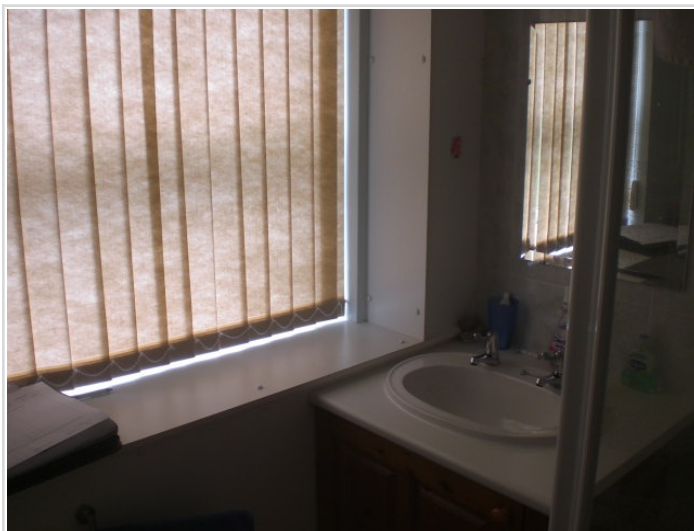
| Sample reference number | Item Ref 13 - Presumed |

Comments / recommendation: No access Presume asbestos until proven otherwise

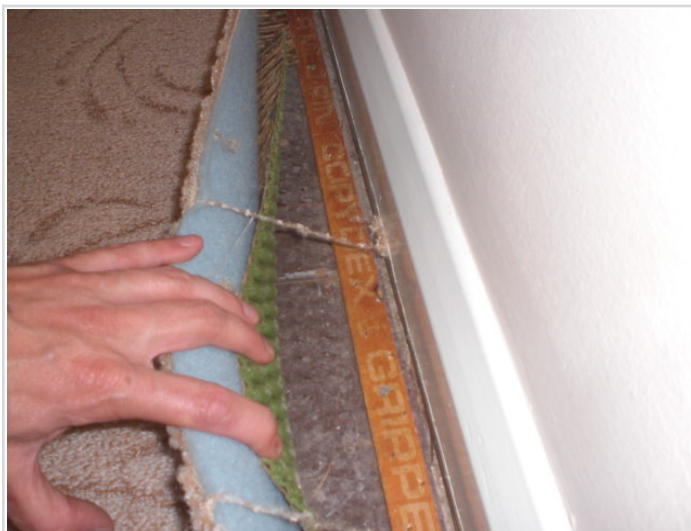
| Sample reference number | Item Ref 14 - No Asbestos Presumed |

Comments / recommendation: Sample visually similar to sample 003 No further action required

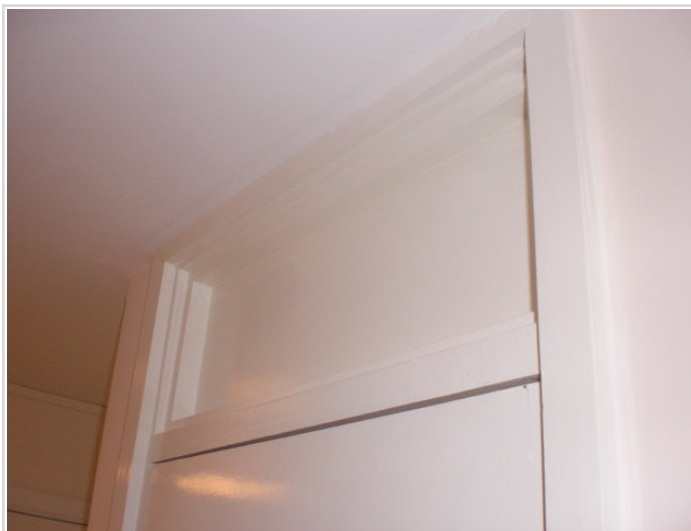
| Sample reference number | S073/HAR9/5/004 |

Comments / recommendation: Sample analysed no asbestos detected no further action required

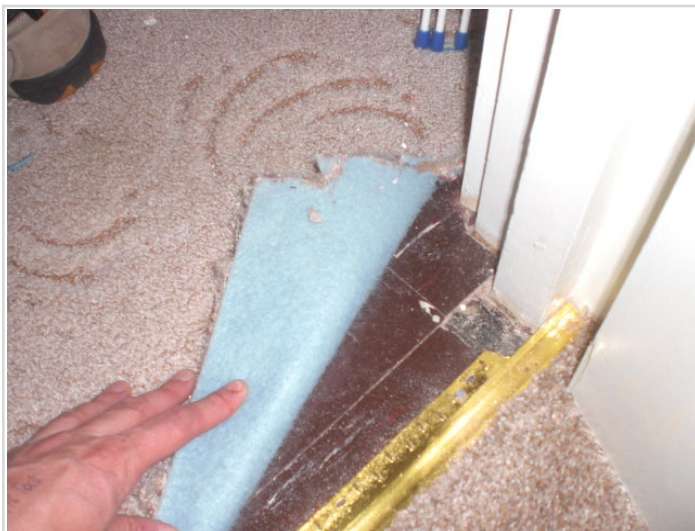
| Sample reference number | Item Ref 10 - No Asbestos Presumed |

Comments / recommendation: Sample visually similar to sample 003 No further action required

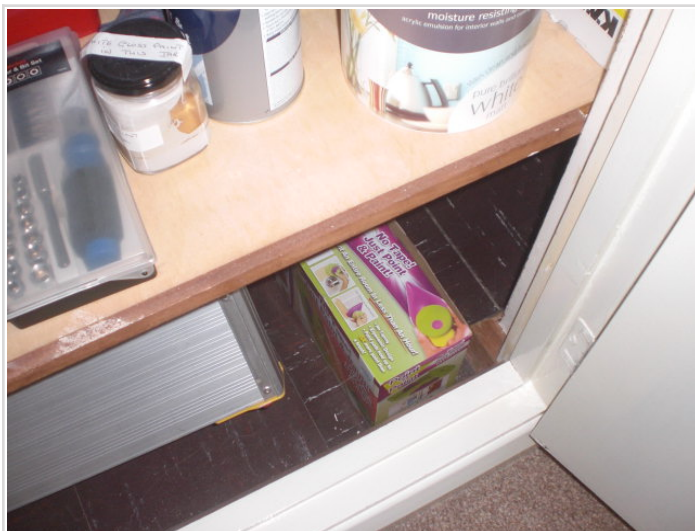
| Sample reference number | Item Ref 11 - No Asbestos Presumed |

Comments / recommendation: Sample visually similar to sample 003 No further action required

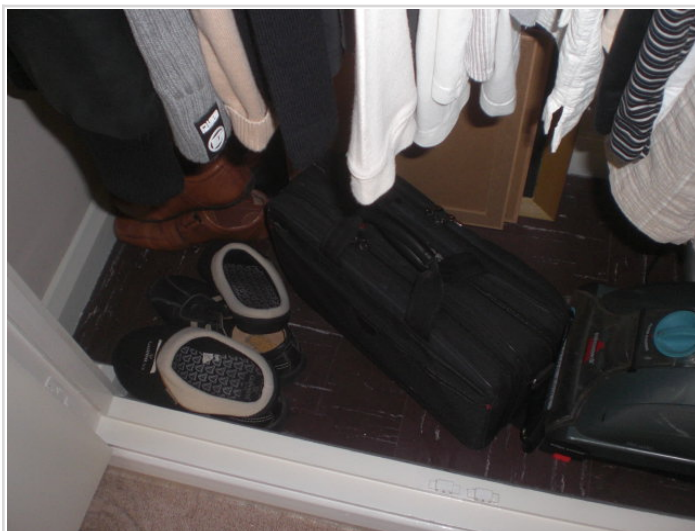
| Sample reference number | Item Ref 15 - No Asbestos Presumed |

Comments / recommendation: Sample visually similar to sample 003 No further action required

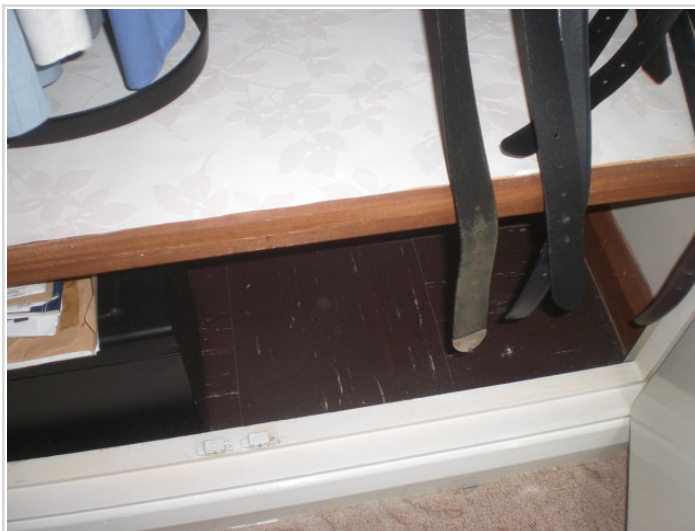
| Sample reference number | Item Ref 16 - No Asbestos Presumed |

Comments / recommendation: Sample visually similar to sample 003 No further action required

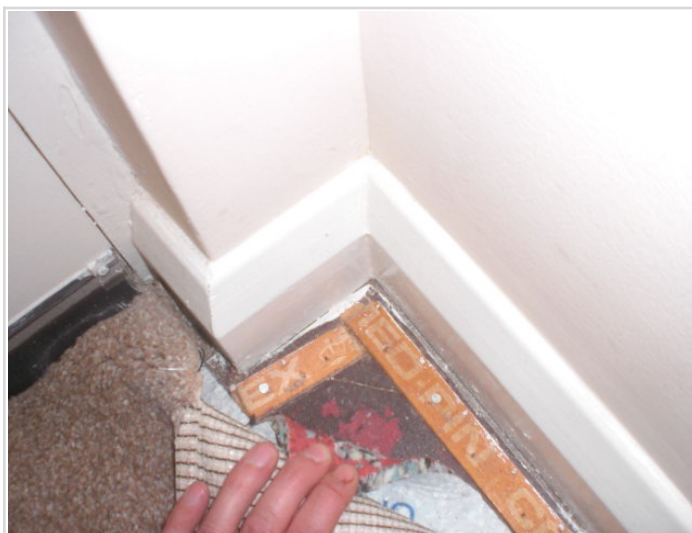
| Sample reference number | Item Ref 9 - No Asbestos Presumed |

Comments / recommendation: Sample visually similar to sample 003 No further action required

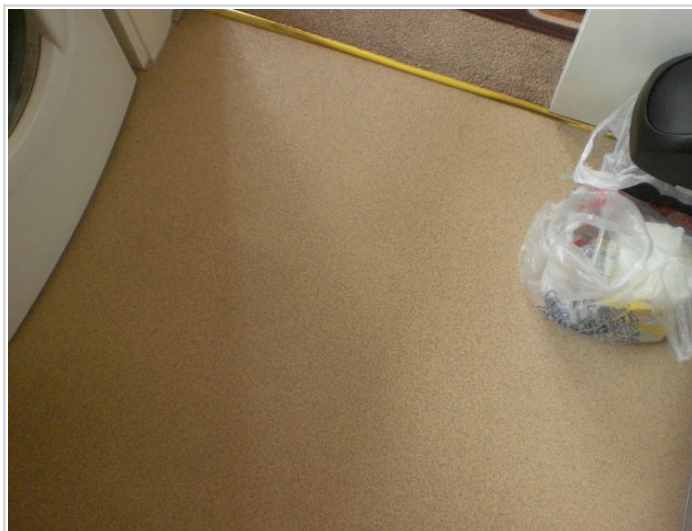
| Sample reference number | Item Ref 8 - Presumed |

Comments / recommendation: No access Presume asbestos until proven otherwise

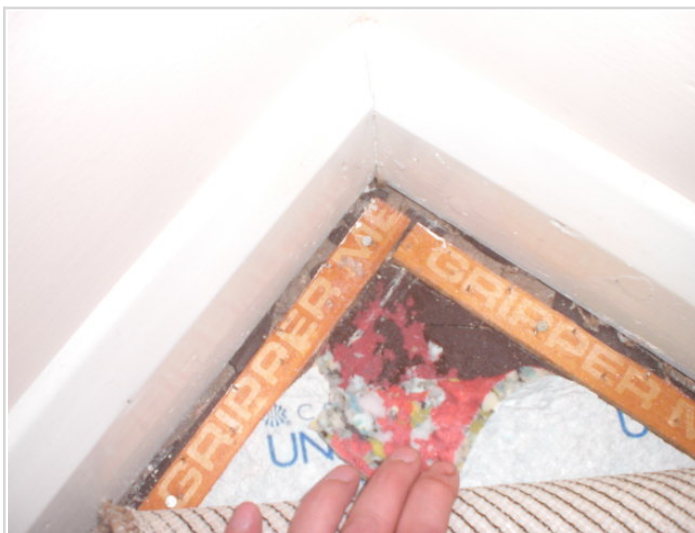
| Sample reference number | S073/HAR9/5/003 |

Comments / recommendation: Sample analysed no asbestos detected no further action required

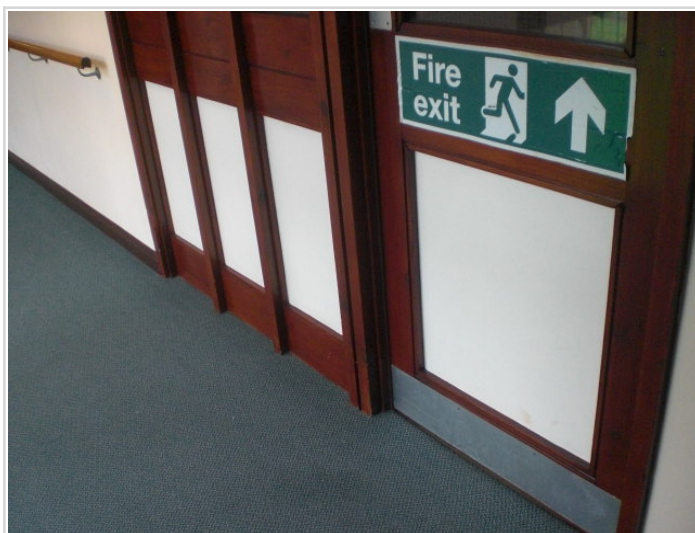
| Sample reference number | S073/HAR9/5/007 |

Comments / recommendation: Sample analysed no asbestos detected no further action required Both sides

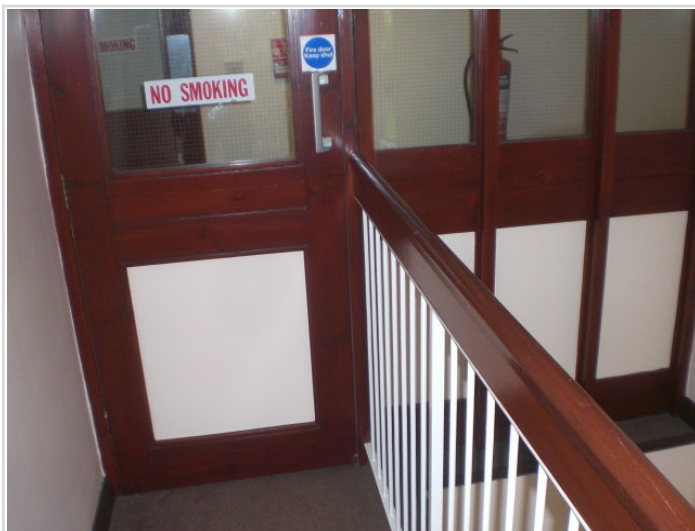
| Sample reference number | Item Ref 19 - No Asbestos Presumed |

Comments / recommendation: Sample visually similar to sample 007 No further action required Both sides

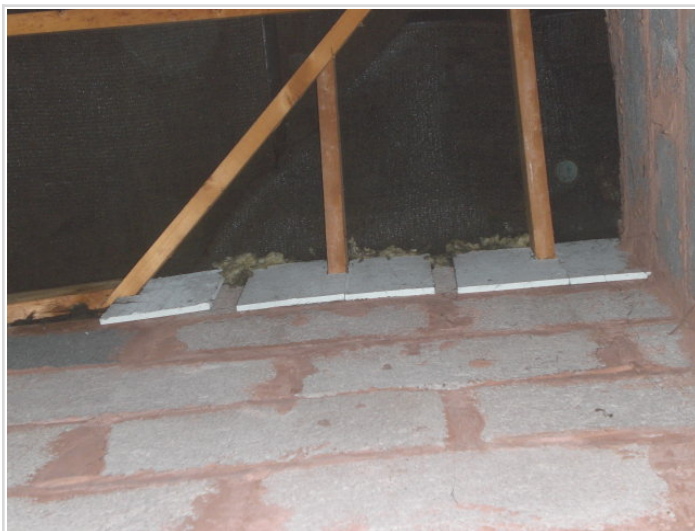
| Sample reference number | Item Ref 20 - Presumed |

Comments / recommendation: No access due to height Presume asbestos until proven otherwise

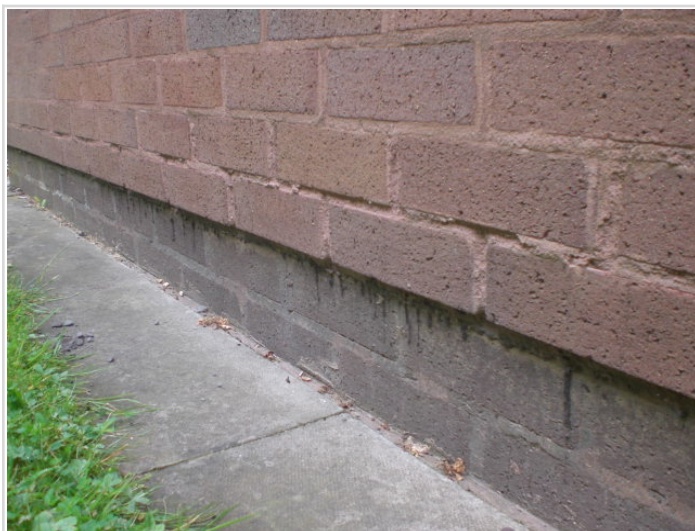
| Sample reference number | S073/HAR9/5/016 |

Comments / recommendation: Sample analysed no asbestos detected no further action required

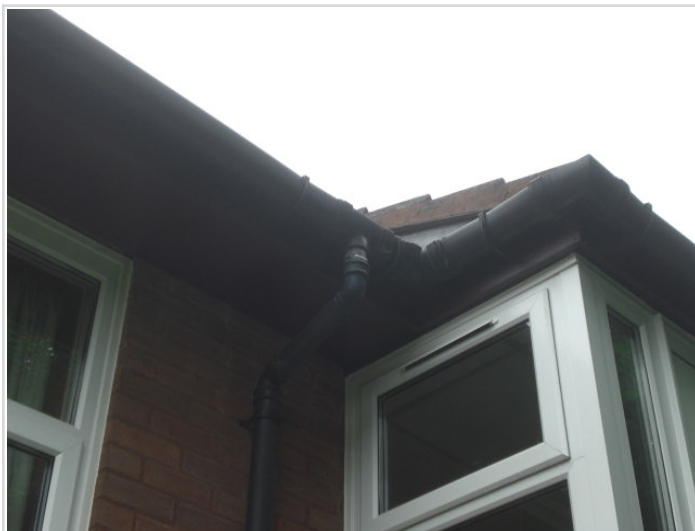
| Sample reference number | Item Ref 38 - Presumed |

Comments / recommendation: No access due to height Presume asbestos until proven otherwise

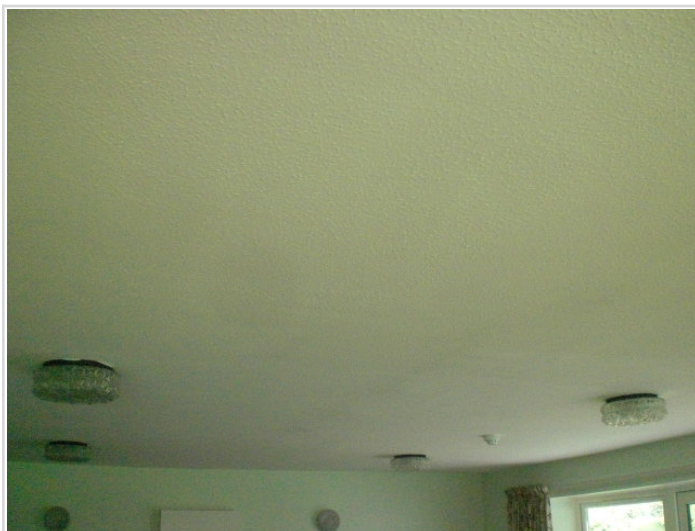
| Sample reference number | S073/HAR9/5/010 |

Comments / recommendation: Sample analysed no asbestos detected no further action required

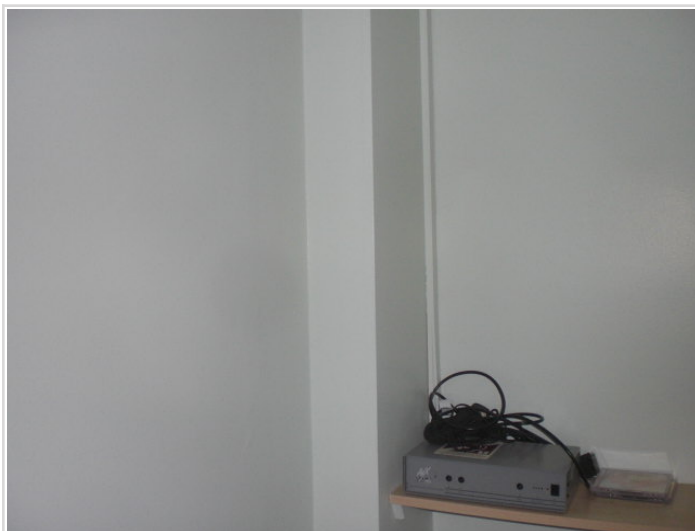
| Sample reference number | Item Ref 22 - Presumed |

Comments / recommendation: No access Presume asbestos until proven otherwise

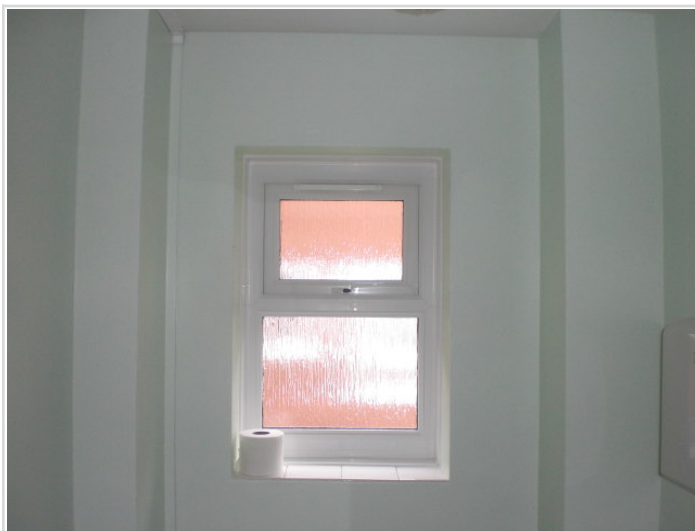
| Sample reference number | Item Ref 23 - Presumed |

Comments / recommendation: No access Presume asbestos until proven otherwise

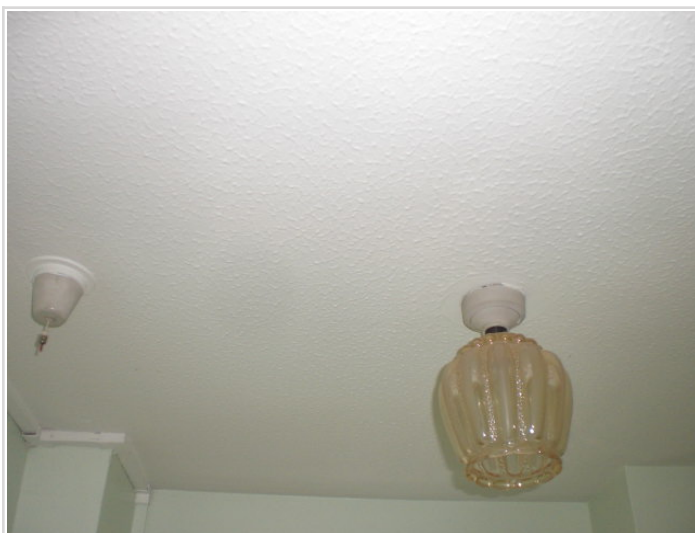
| Sample reference number | Item Ref 27 - No Asbestos Presumed |

Comments / recommendation: Sample visually similar to sample 010 No further action required

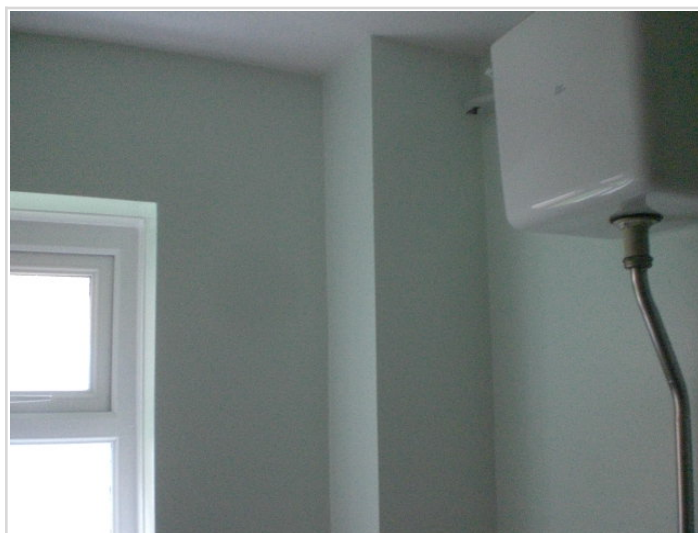
| Sample reference number | Item Ref 24 - Presumed |

Comments / recommendation: No access Presume asbestos until proven otherwise

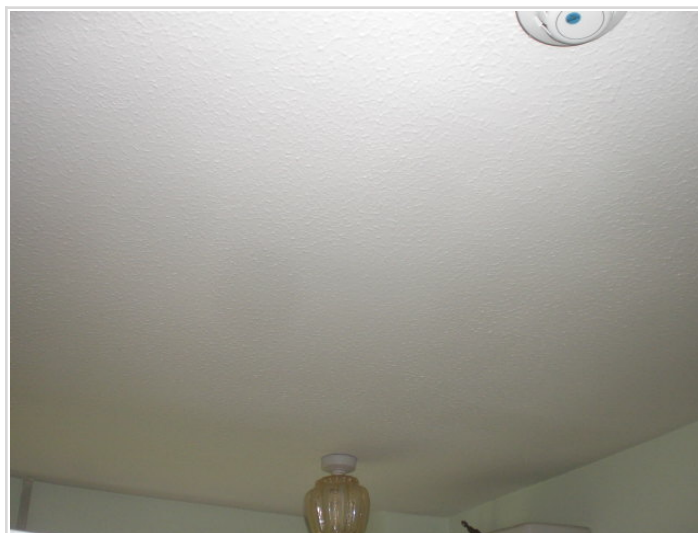
| Sample reference number | Item Ref 26 - No Asbestos Presumed |

Comments / recommendation: Sample visually similar to sample 010 No further action required

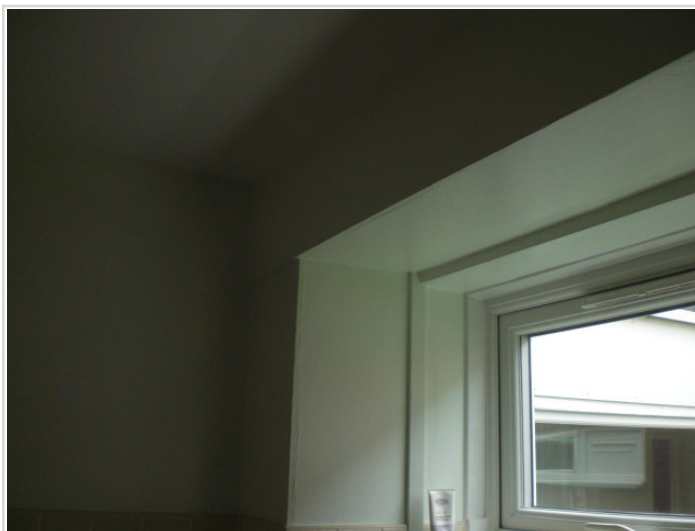
| Sample reference number | Item Ref 29 - Presumed |

Comments / recommendation: No access Presume asbestos until proven otherwise

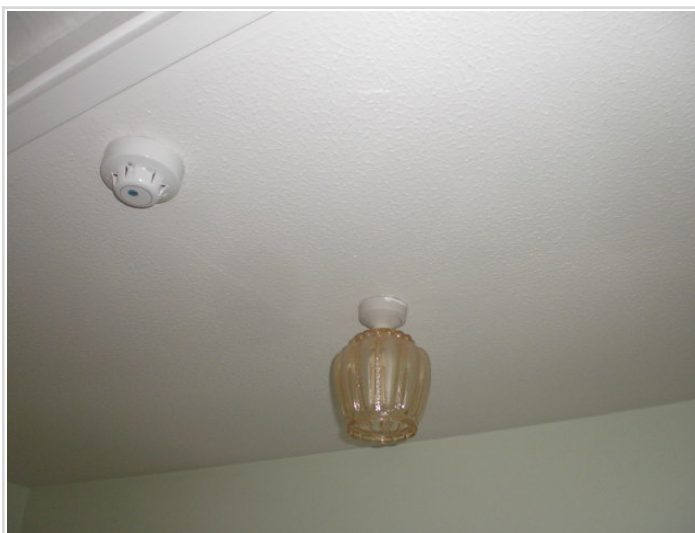
| Sample reference number | Item Ref 25 - No Asbestos Presumed |

Comments / recommendation: Sample visually similar to sample 010 No further action required

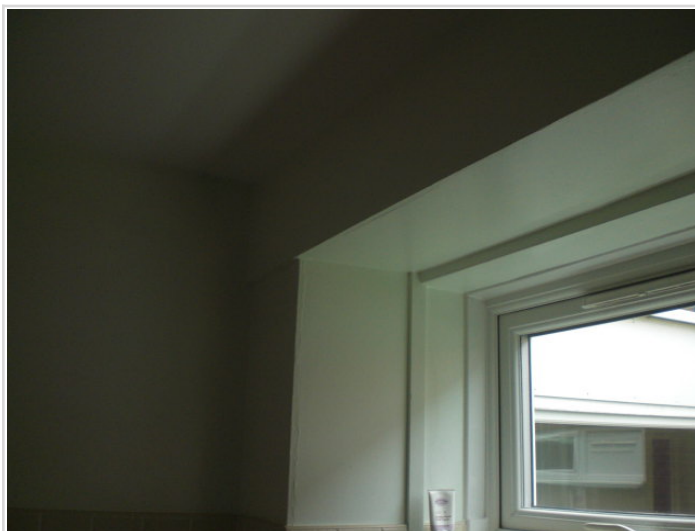
| Sample reference number | Item Ref 30 - Presumed |

Comments / recommendation: No access Presume asbestos until proven otherwise

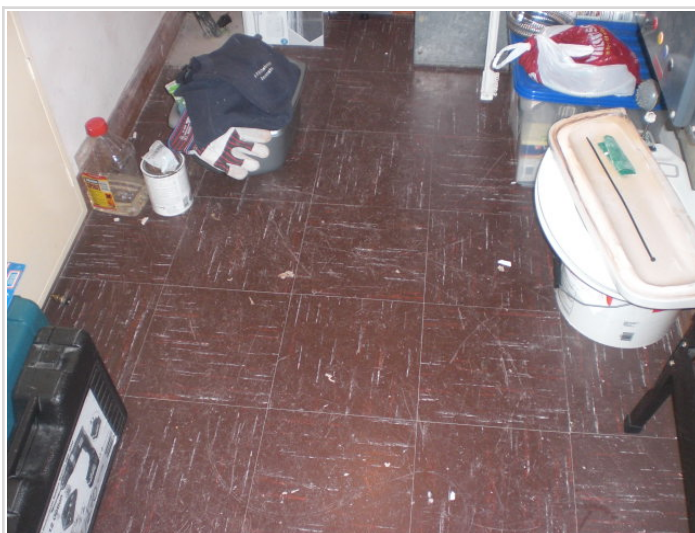
| Sample reference number | S073/HAR9/5/009 |

Comments / recommendation: Sample analysed no asbestos detected no further action required

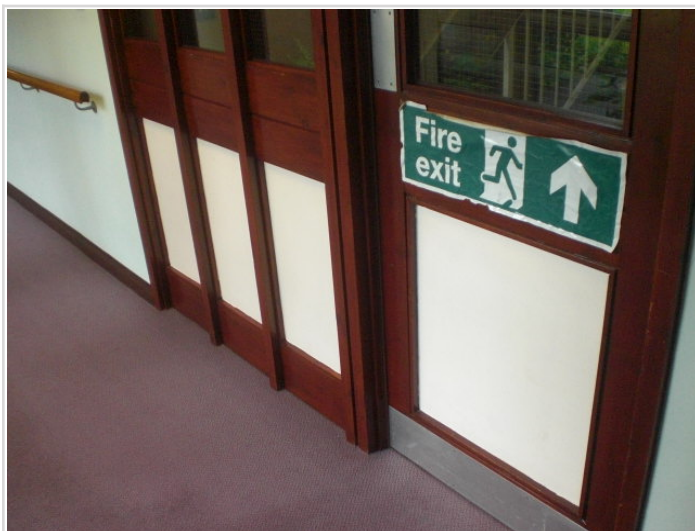
| Sample reference number | S073/HAR9/5/008 |

Comments / recommendation: Sample analysed no asbestos detected no further action required

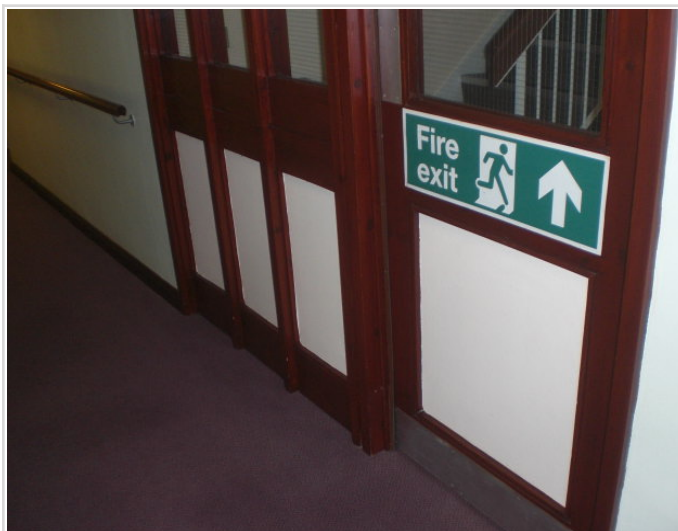
| Sample reference number | Item Ref 21 - No Asbestos Presumed |

Comments / recommendation: Sample visually similar to sample 008 No further action required

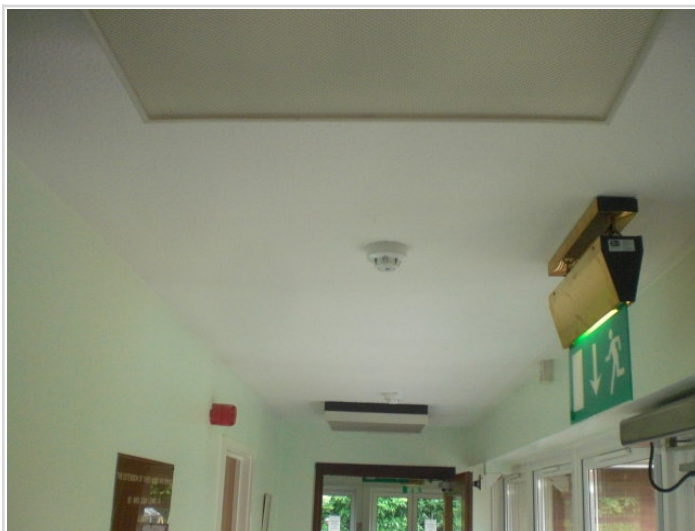
| Sample reference number | Item Ref 28 - No Asbestos Presumed |

Comments / recommendation: Sample visually similar to sample 010 No further action required

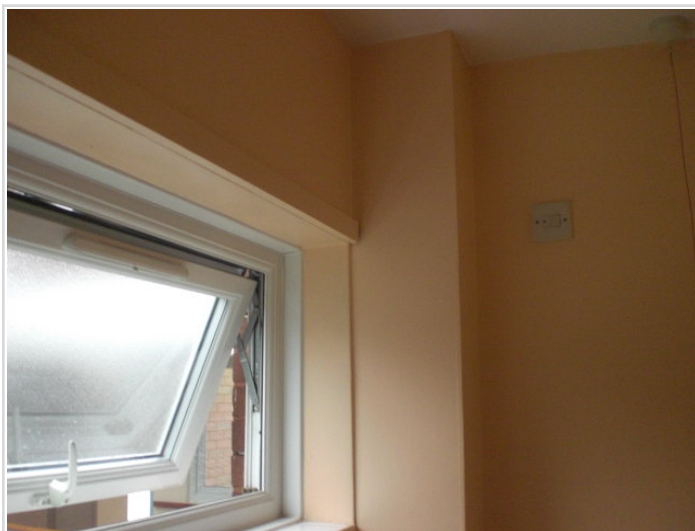
| Sample reference number | Item Ref 17 - Presumed |

Comments / recommendation: No access Presume asbestos until proven otherwise

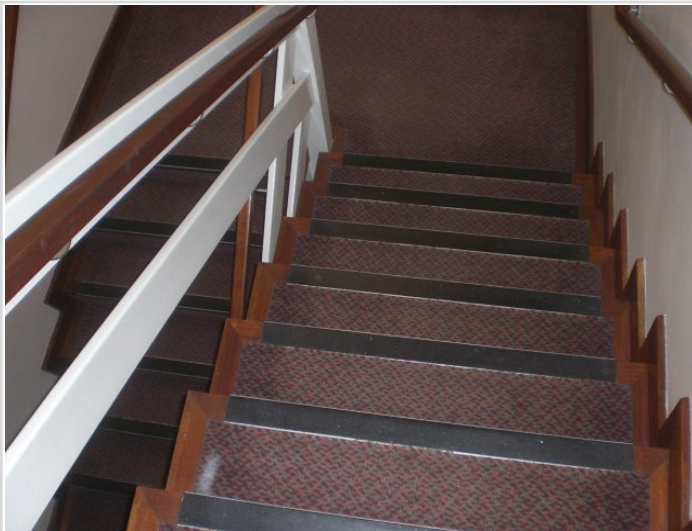
| Sample reference number | S073/HAR9/5/006 |

Comments / recommendation: Sample analysed no asbestos detected no further action required

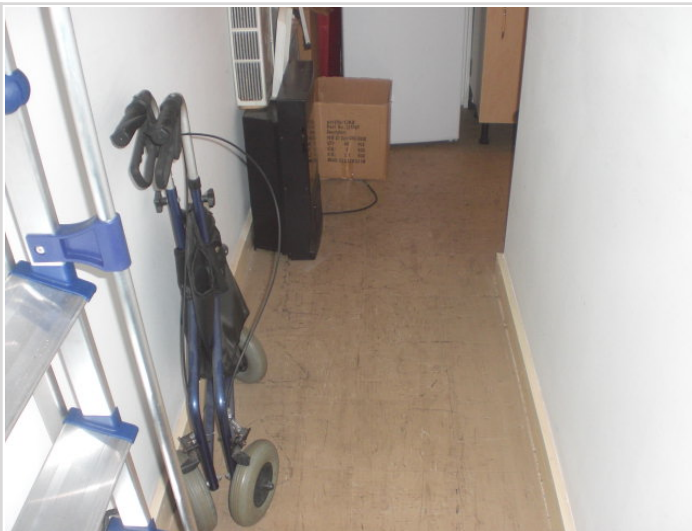
| Sample reference number | S073/HAR9/5/005 |

Comments / recommendation: Low risk ACM (Bound in matrix). Where appropriate label with warning signs. Undertake routine inspections for damage and deterioration. Where damaged, remove or repair in accordance with CAR2012

| Risk code | Risk code E |

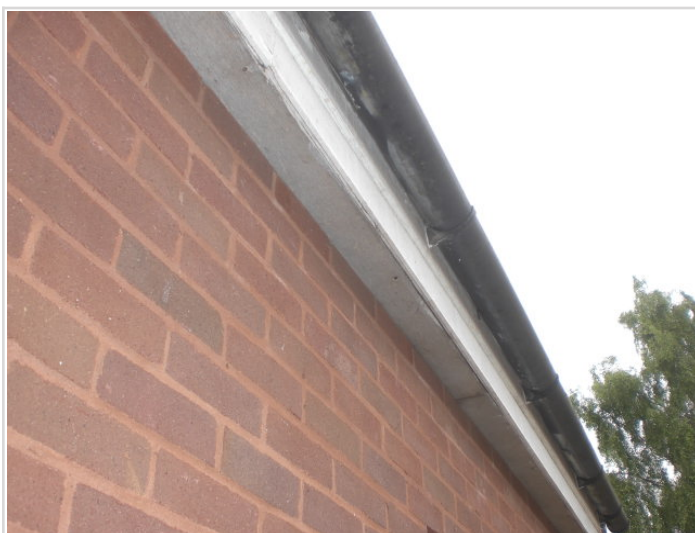
| Sample reference number | S073/HAR9/5/014 |

Comments / recommendation: Low risk ACM (Bound in matrix). Where appropriate label with warning signs. Undertake routine inspections for damage and deterioration. Where damaged, remove or repair in accordance with CAR2012

| Risk code | Risk code E |

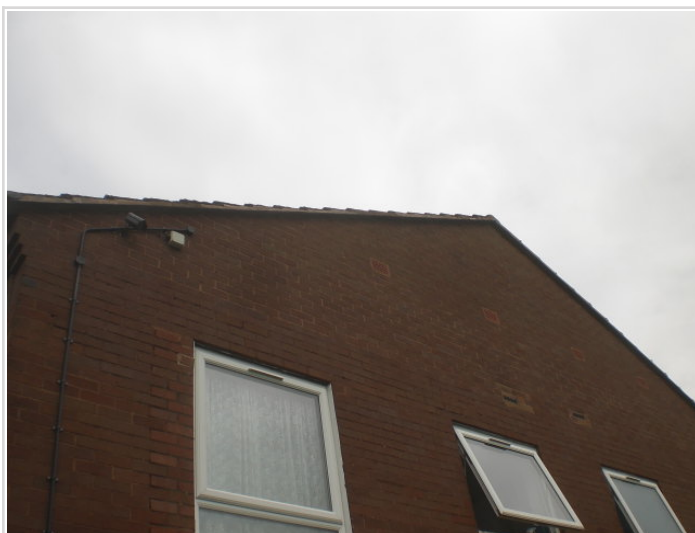
| Sample reference number | S073/HAR9/5/015 |

Comments / recommendation: Low risk ACM (Bound in matrix). Where appropriate label with warning signs. Undertake routine inspections for damage and deterioration. Where damaged, remove or repair in accordance with CAR2012

| Risk code | Risk code E |

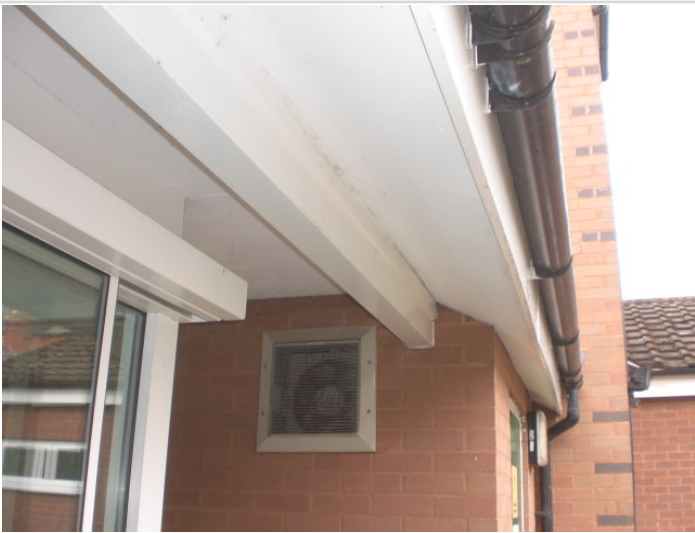
| | Sample reference number | Item Ref 37 - No Asbestos Presumed |

Comments / recommendation: Sample visually similar to sample 013 No further action required By main entrance and Lift motor room 2

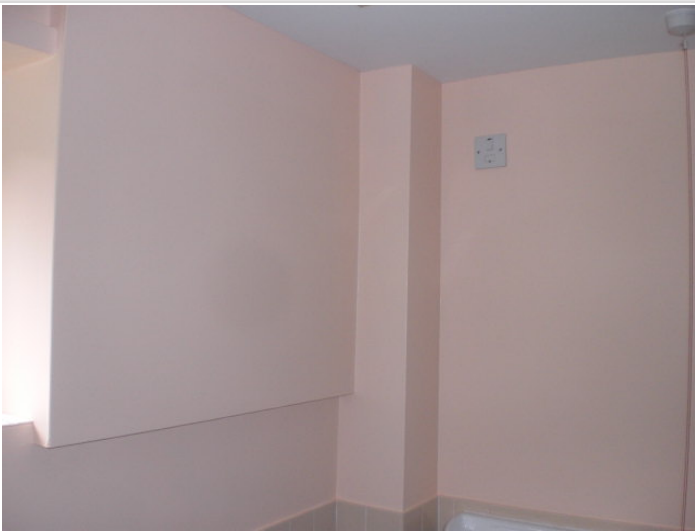
| | Sample reference number | Item Ref 32 - Presumed |

Comments / recommendation: No access Presume asbestos until proven otherwise

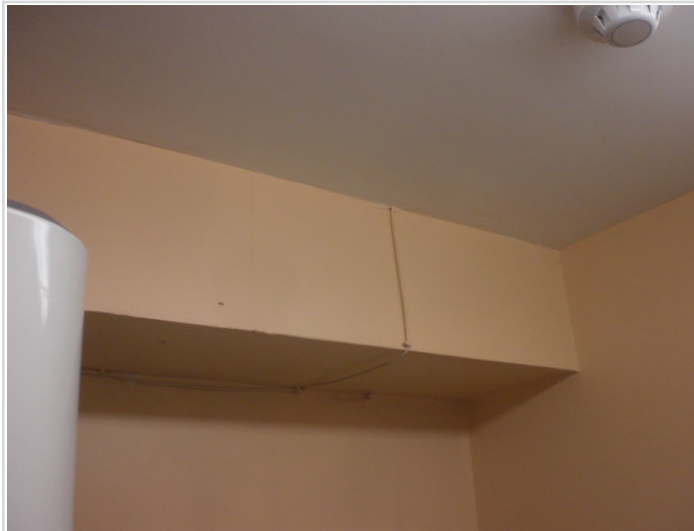
| Sample reference number | Item Ref 31 - Presumed |

Comments / recommendation: No access Presume asbestos until proven otherwise

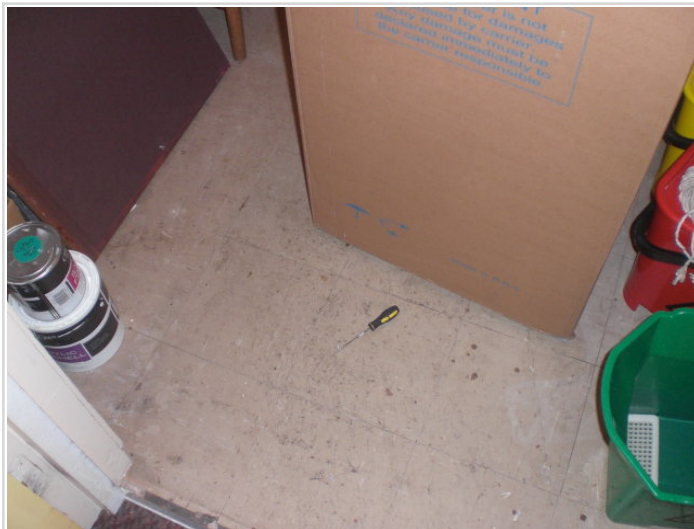
| Sample reference number | S073/HAR9/5/011 |

Comments / recommendation: Low risk ACM (Bound in matrix). Where appropriate label with warning signs. Undertake routine inspections for damage and deterioration. Where damaged, remove or repair in accordance with CAR2012

| Risk code | Risk code E |

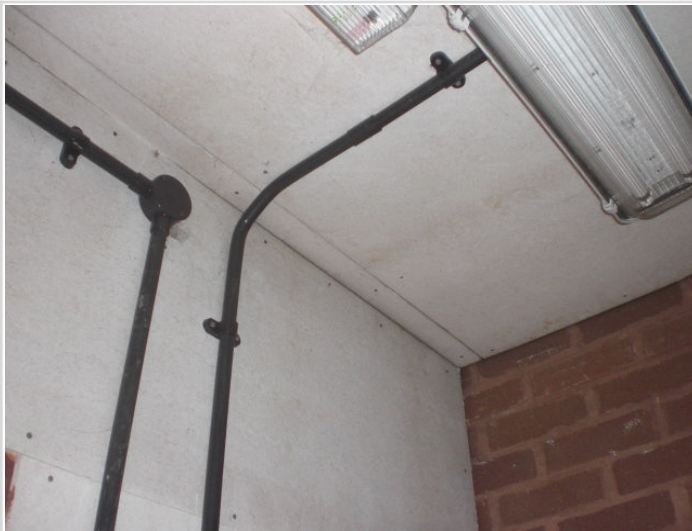
| Sample reference number | S073/HAR9/5/013 |

Comments / recommendation: Sample analysed no asbestos detected no further action required

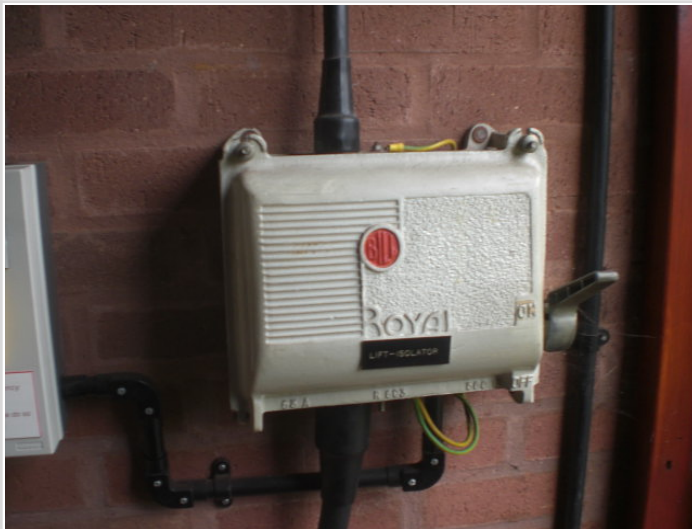
| Sample reference number | Item Ref 35 - Presumed |

Comments / recommendation: No access Live Presume asbestos until proven otherwise

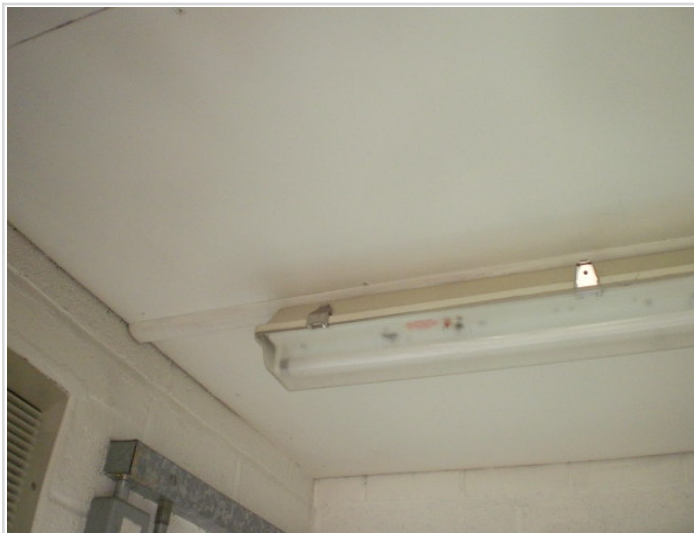
| Sample reference number | Item Ref 36 - No Asbestos Presumed |

Comments / recommendation: Sample visually similar to sample 013 No further action required

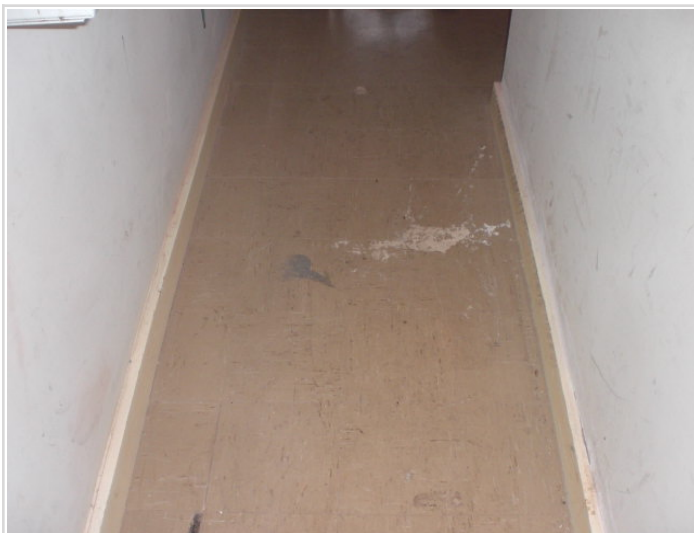
| Sample reference number | Item Ref 34 - Strongly Presumed |

Comments / recommendation: Visually similar to sample 011 Low risk ACM (Bound in matrix). Where appropriate label with warning signs. Undertake routine inspections for damage and deterioration. Where damaged, remove or repair in accordance with CAR2012

| Risk code | Risk code E |

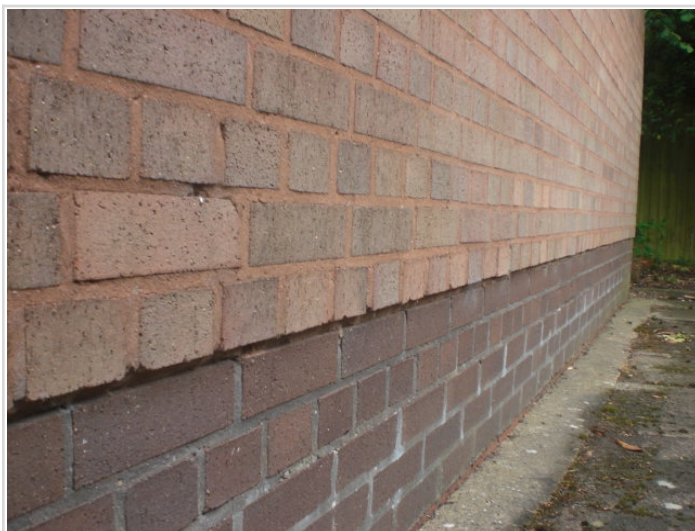
| Sample reference number | S073/HAR9/5/012 |

Comments / recommendation: Sample analysed no asbestos detected no further action required

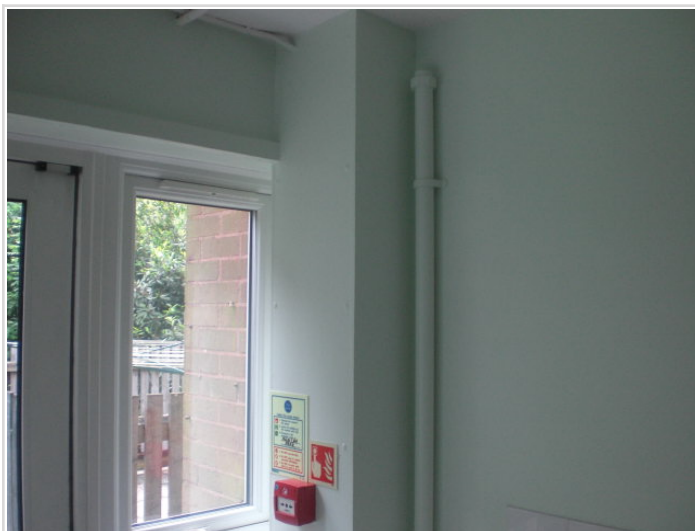
| Sample reference number | Item Ref 33 - Presumed |

Comments / recommendation: No access Presume asbestos until proven otherwise
