## Quinquennial Inspection Report

Harborne House,  
Tibbets Lane, Harborne,  
Birmingham B17 0SX

6<sup>th</sup> September 2024

Project number: 1253C-01

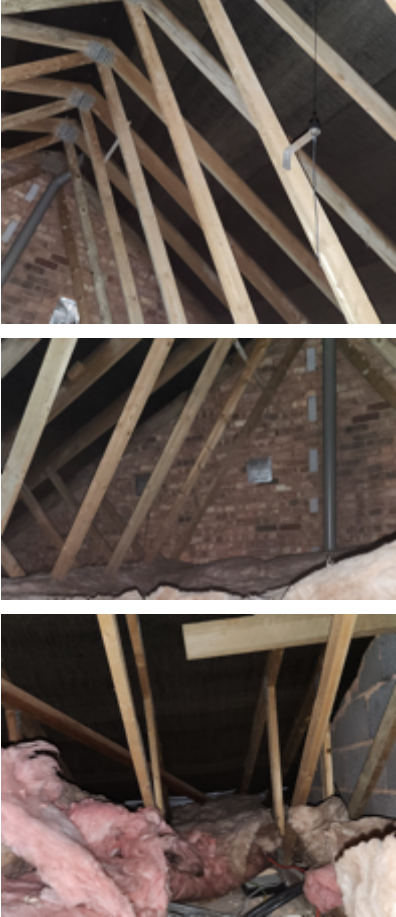
| | <p>Condition</p> | <p>There is no diagonal cross bracing to some of the roof trusses although it is in place to others, some of the end trusses are not strapped to the gable walls. There is insufficient cross bracing in No. 14.</p> <p>This is a relatively common defect and was not required by Building Regulations until 1976. Cross bracing serves to stop the trusses falling sideways during heavy wind or snow loading. There is, however, no evidence of any undue movement of the roof structure.</p> <p>Only carrying out a detailed survey of every roofspace and consequent analysis would reveal whether this is actually a problem warranting further action.</p> <p>The timbers in the roof void have an average moisture content of 12%, which is dry.</p> |

| | Repair needs | Further investigation needed. |

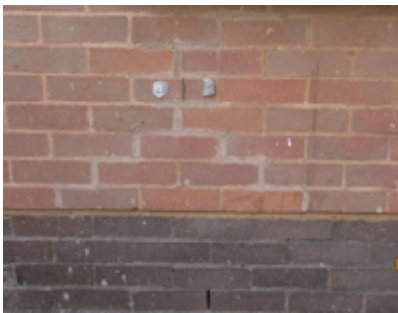
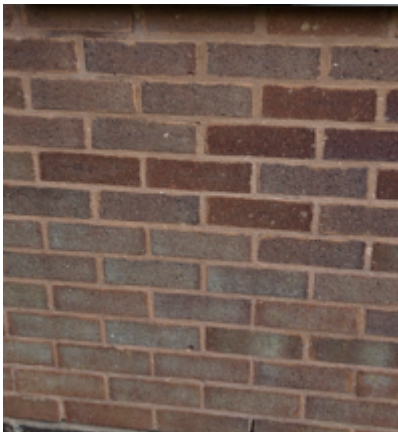
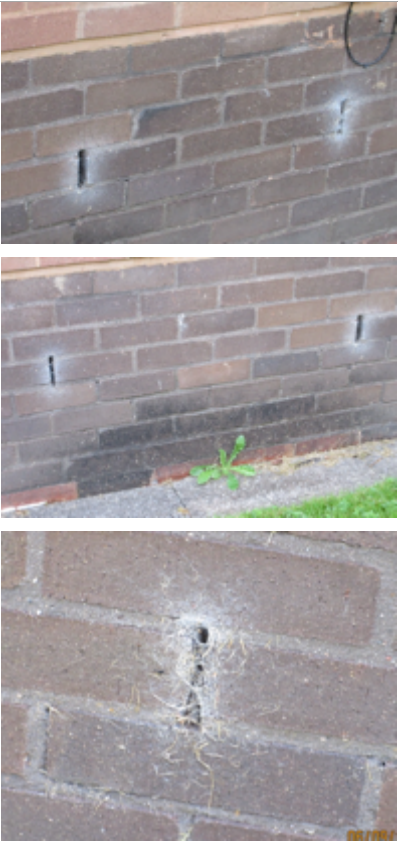
| | Condition<br><br><br> | <p>Monitoring put in place at the time of the previous Stock Condition Survey in 2012 indicated no further movement and these areas have been repointed. The remains of one tell-tale and a cracked brick are still present.</p> <p>There are also two minor areas of diagonal cracking remaining.</p> <p>There are quite a large number of isolated damaged bricks from careless installation of cables, although other cables have been neatly fitted with grommets (see section . . ).</p> <p>To the older part of the building the weep holes in the brickwork have been left open, there is evidence that insects are colonising these openings – cobwebs around the openings, they should be filled using proprietary plastic weep hole inserts to prevent future problems.</p> |

| | <p>Repair needs</p> | <p>Remove remains of tell-tale and repoint isolated areas.</p> <p>Replace cracked bricks.</p> <p>Fit proprietary plastic weep hole inserts.</p> | <p>2</p> <p>2</p> <p>2</p> |

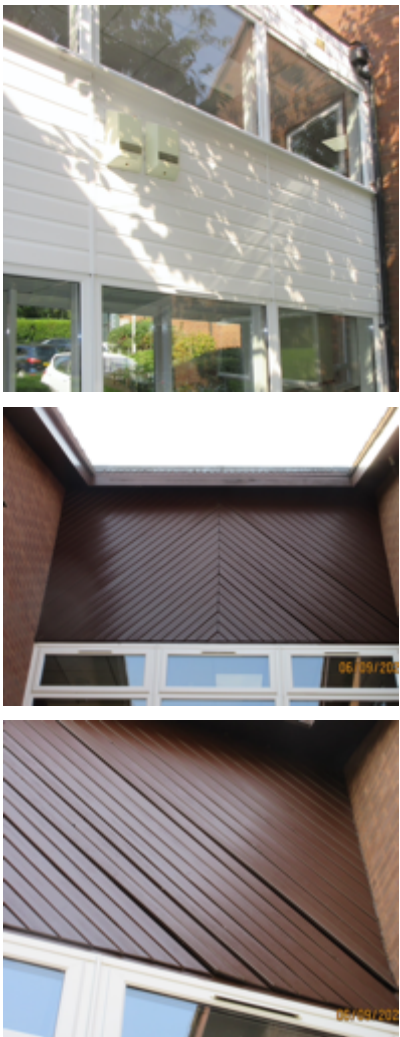
| | <p>Condition</p> | <p>UPVC items are in good condition.</p> <p>Some of the diagonal boarding above the entrance between No. 28 and No. 29 is twisted and cupped slightly. There is no visible sign of rot but water will be able to penetrate between the gaps in the boards. The boards may be capable of being screwed back into position.</p> <p>External decorations are considered in section 3.5.</p> | |

| | Repair needs | Refix loose boards. | 2 |

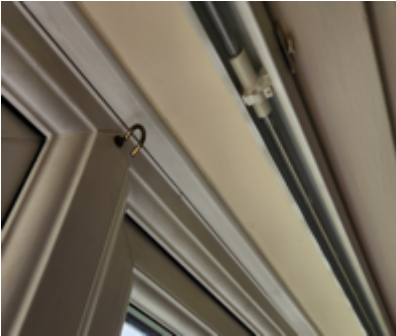
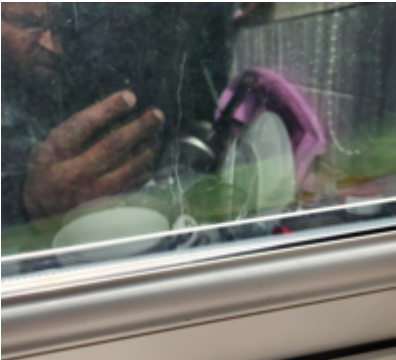
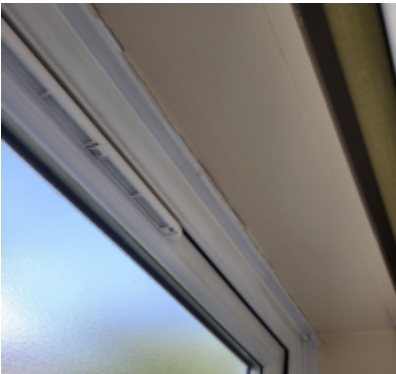
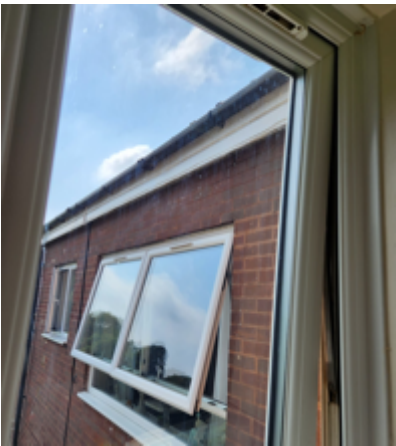
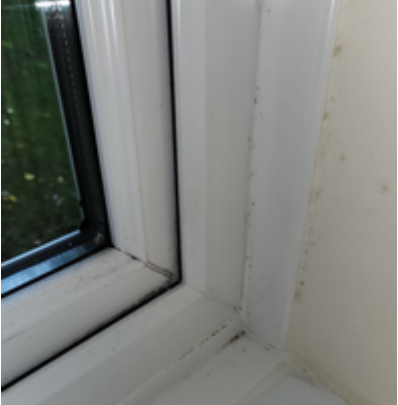
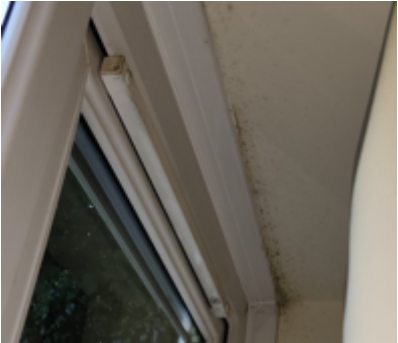
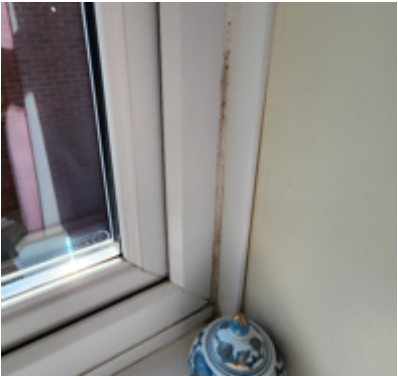
| | <p>Condition</p> <p>No. 3</p> <p>No. 8</p> <p>No. 11</p> <p>No. 14</p> | <p>Windows are UPVC and have been replaced in phases since 2000, the design of the windows is understood to be the same as those that were replaced.</p> <p>The previous quinquennial inspection report noted that the windows were bowing in places, with quite large gaps to the tops of some of the windows. Remedial works have apparently been carried out and no further problems have been noted apart from minor issues as seen below:</p> <p>There is a hairline crack in the silicone in No. 3 (living room).</p> <p>The window has failed in No. 8 (kitchen).</p> <p>There is a slight crack to the top of the window head and wall joint in the bathroom of No.11, there is some movement when closing the window.</p> <p>The seal to the kitchen window in No. 14 has failed.</p> <p>Minor mould was noted to the bathroom and bedroom windows in No. 22 and to the living room window in No. 28.</p> | |

| <p>Repair needs</p> <p>No. 22</p> <p>No. 28</p> | <p>Further investigation is required to ascertain if there is sufficient fixings to window frame.</p> <p>Repoint silicone to No. 3 (living room) &amp; No. 11 (bathroom).</p> <p>Replace double glazed unit to No. 8 (kitchen) and No.14 (kitchen).</p> <p>Clean mould, remove loose and defective silicone and reapply.</p> <p>Check for any gaps to closing light and adjust hinge if necessary to the bathroom and bedroom windows in No. 22 and to the living room window in No. 28.</p> | <p>2</p> <p>2</p> <p>2</p> <p>2</p> <p>2</p> |

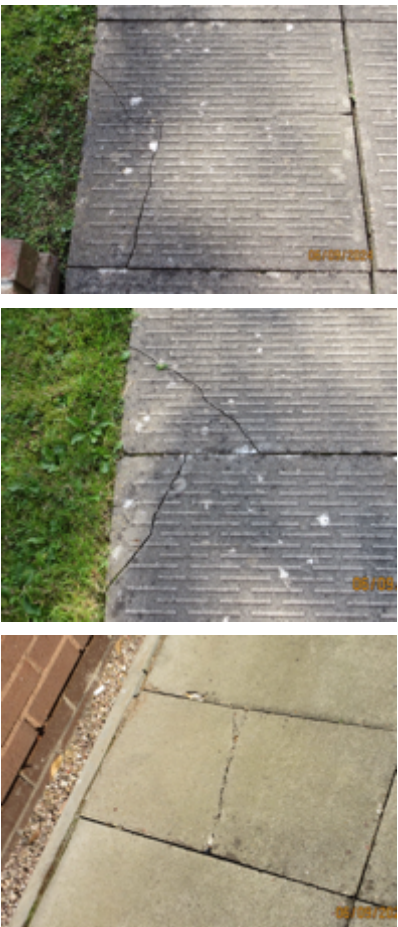
| 3.6.1 | General | Tarmac drive and paths with precast concrete kerbs and edgings. | |

| | Condition<br> | A few isolated concrete flagstones are cracked. | |

| | Repair needs | Take up and replace cracked flags. | 2 |

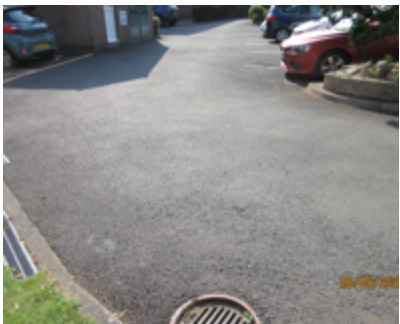
| | Condition<br><br> | <p>The front tarmac has been renewed recently.</p> <p>There are two small holes to the tarmac to the rear drive, the situation is likely to deteriorate.</p> | |

| | Repair needs | Patch repair holes in tarmac. | 2 |

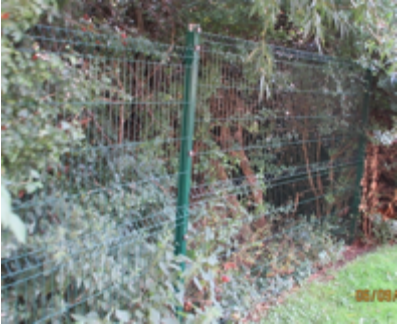
| | <p>Condition</p> | <p>Fences are in variable condition; some of the close boarded fences are bare of any decorative finish and are starting to rot at the bottom.</p> <p>Chain-link and security fences are in good condition.</p> | |

| | Repair needs | Replace minor areas of rotten boards. | 3 |

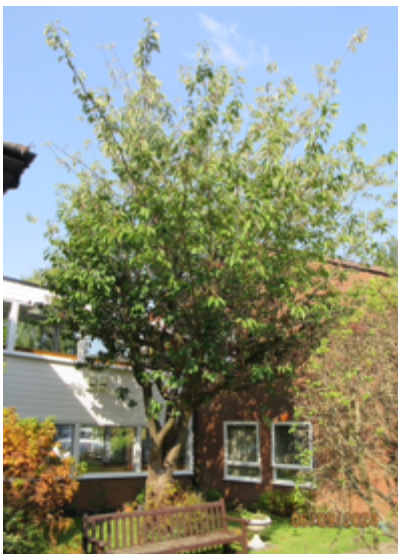
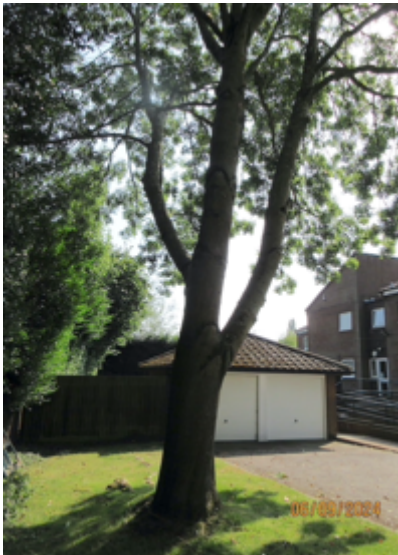
| | Condition<br> | <p>Some of these are closer than the recommended 'safe' distances. There is currently little evidence that they may be causing any damage.</p> <p>The cherry tree to the rear of the link building is still rather large and the roots are close to the surface, leaves and branches are overshadowing the roofs and windows and some reduction in size is desirable. There is no current evidence of any cracking which could be due to these roots, however.</p> <p>Other large trees on the site will also require ongoing work and it would be prudent to arrange for regular arborist inspections.</p> | |

| | Repair needs | Arrange for regular arborist inspections of the mature trees. | 2 |

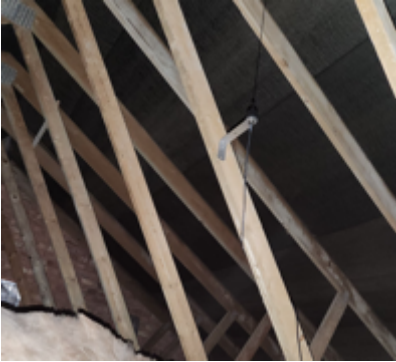
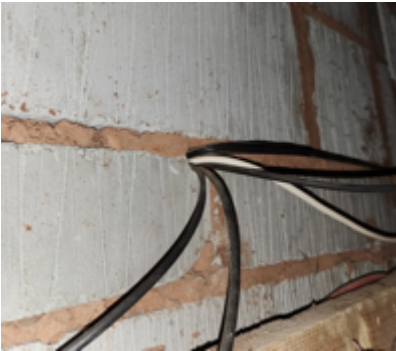
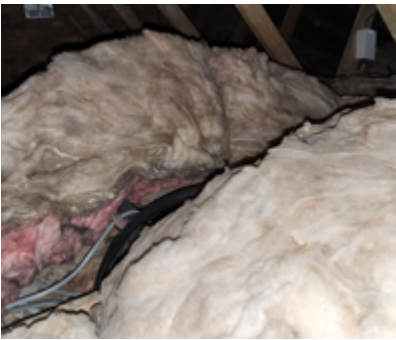
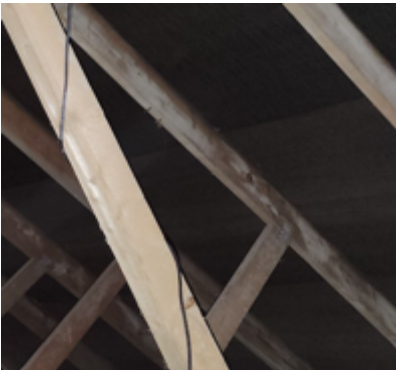
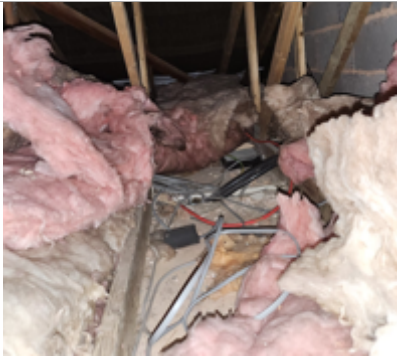
| | <p>Condition</p> <p>No. 11</p> | <p>Roofspaces are insulated with a variety of materials and thicknesses. The best of these is around 250mm fibreglass insulation.</p> <p>There is no diagonal bracing to trussed rafters in flat No. 11 (see section 3.1.1).</p> <p>Service penetrations in party wall (Compartment wall) without appropriate fire sleeving in flat No. 11.</p> <p>There is disturbed loft insulation to flat No. 11.</p> <p>Water stain marks to some timbers. Stain marks to ceiling below. Further investigation required as the stain marks may be historic. Check for adequate cross flow roof ventilation.</p> <p>Disturbed loft insulation to Flat No.14. Could give rise to condensation and mildew.</p> <p>In No. 14, there is no fire rated vent cover to the party wall, this is a fire risk. and there is insufficient cross bracing.</p> <p>In No. 14, there is a gap to party wall. Investigate if this is a compartment wall.</p> <p>The loft hatch has been painted shut in No. 15.</p> <p>Insufficient cross bracing to flat No. 28 (see section 3.1.1). No fire rated vent cover to party wall.</p> | |

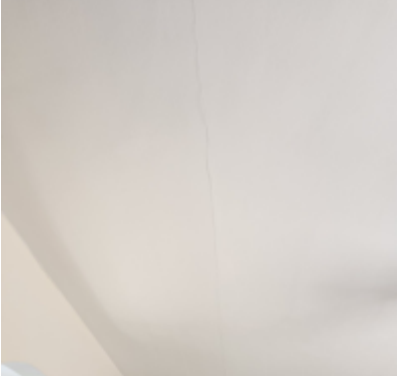
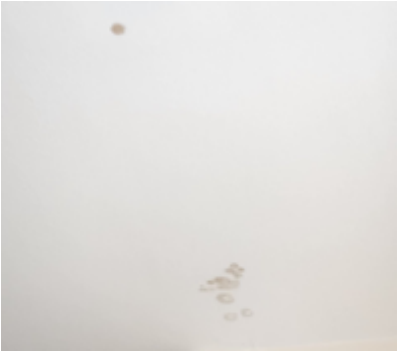
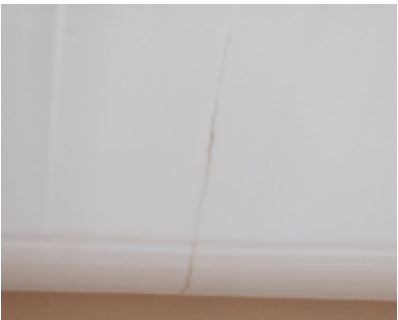
| | <p>Condition</p> <p>No. 11</p> <p>No. 15</p> <p>No. 19</p> | <p>Cracking was noted to No. 11 (hall, living room, kitchen, bedroom), No. 15 (living room, No. 19 (living room), No. 22 (bedroom).</p> <p>The most severe of this is Category 1 cracking and appears to be normal shrinkage to board joints.</p> <p>There is staining to the ceiling in No. 11 (living room), No. 19 (kitchen) and No. 28 (bedroom).</p> <p>Roof voids were inspected, but no obvious signs of water ingress were identified. Some rafters had staining on them. This need to be investigated further as it could be a result of inadequate ventilation or a roof leak.</p> | |

| | Repair needs | Fill cracks when redecorating.<br><br>Stainblock and redecorate. | 3<br><br>2 |

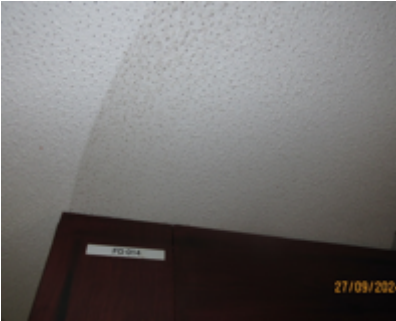
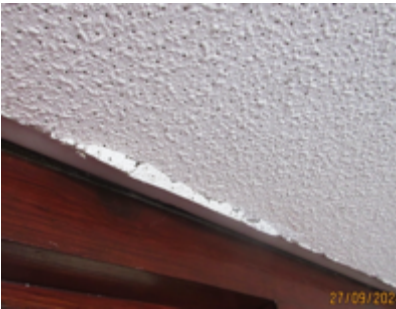
| | <p>Condition</p> | <p>Generally good, there are a few isolated damaged tiles. In one place the ceiling is too low and the top of the fire door is catching the ceiling tile and leading to wear.</p> | |

| | Repair needs | <p>Replace damaged tiles.</p> <p>Adjust ceiling grid to avoid it catching on the door.</p> | <p>3</p> <p>2</p> |

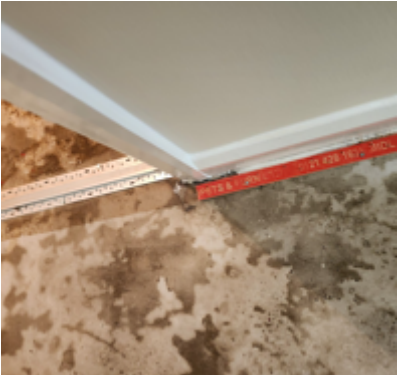
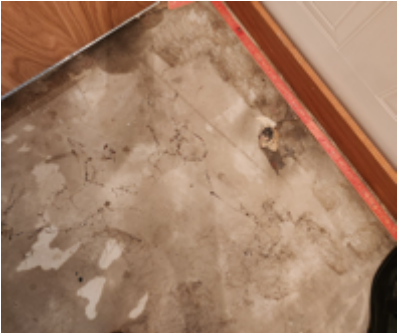
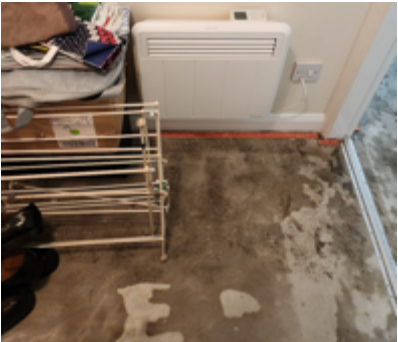
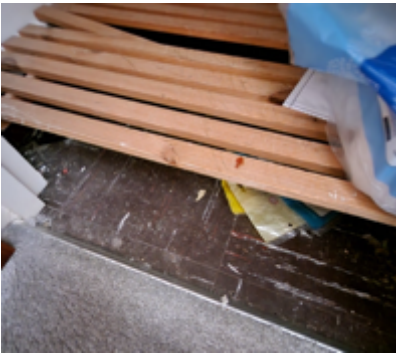
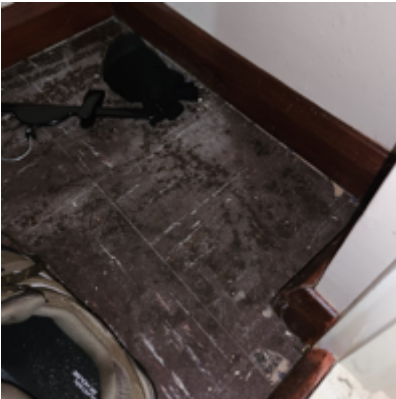
| | Condition<br><br><br><br>No. 3 | There is no floor finish flat No. 3, the grippers and nails are exposed and have been since February 2024. This is a hazard and a risk which could lead to harm. | |

| <p>No. 15</p> <p>No.19</p> <p>No.22</p> | | <p>Possible asbestos floor finish to store of Flat No. 22. Stained vinyl floor finish to kitchen and no silicone seal to perimeter of vinyl floor in kitchen and bathroom.</p> <p>No. 15 &amp; 19 some staining to vinyl sheet floor covering. This isn't a defect but more of an aesthetic appeal. Silicone sealant to perimeter should be checked for deterioration.</p> | |

| | <p>Repair needs</p> | <p>Fit carpet throughout flat No.3 or remove carpet grippers and lay suitable floor finish.</p> <p>Vinyl sheet flooring cleaned.</p> <p>Apply silicone seal to perimeter of vinyl sheet floor in kitchen and bathrooms.</p> <p>Check asbestos record, if none available then commission asbestos survey of floor tiles.</p> | <p>1</p> <p>3</p> <p>2</p> <p>1</p> |

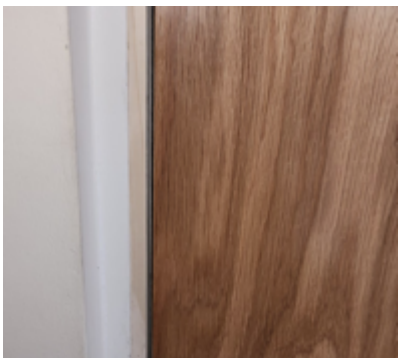
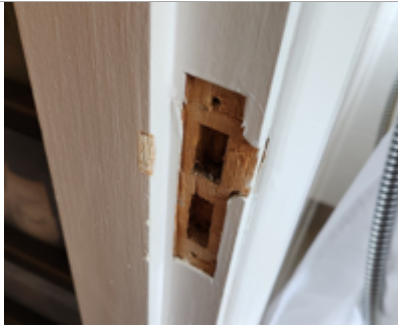
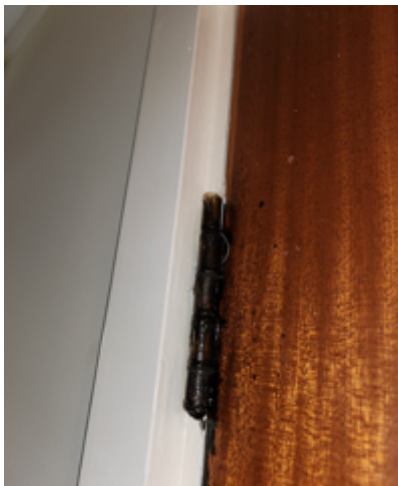
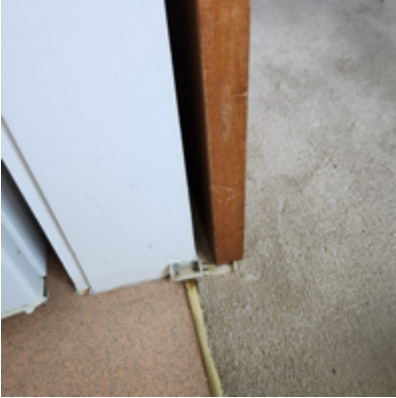
| | Condition<br><br>No. 8<br><br><br>No.11 | <p>There is no door stop to the front door of No. 3.</p> <p>There is no strike plate to the shower room door in flat No. 14.</p> <p>The door catch plate to the bedroom in No. 19 is incorrect.</p> <p>The viewer to the front door of No. 22 was missing at time of survey, however construction work was in progress and may have been fitted in the following days.</p> <p>Grease dripping from door hinge to flat No.22.</p> <p>Sliding door guide to flat No.22 is loose and is no longer performing as intended. The door will pull away from the wall.</p> <p>No door stop to flat No.8 the door handle could cause damage to wall if door was swung open quickly.</p> | |

Door to bathroom to flat No. 11 is misaligned and catching on the door frame. Front door was recently replaced. This is a fire door and the gap between the door and frame appears to be greater than the allowable tolerance for fire doors, which would render the fire door ineffective in the event of a fire.

| | <p>Repair needs</p> | <p>Fit door stops generally to all flats.</p> <p>Fit missing strike plate to shower room door of flat No.14.</p> <p>Remove redundant stay and fit correct strike plate to bedroom door of flat No.19.</p> <p>Install door viewer to flat No.22.</p> <p>Replace old and worn-out door hinges to flat No.22.</p> <p>Replace sliding door guide.</p> <p>Adjust hinge and re-align bathroom door to flat No.11.</p> <p>Adjust hinge and re-align door to provide correct gap (less than 4mm to top and sides of door) for fire door.</p> | <p>2</p> <p>2</p> <p>2</p> <p>1</p> <p>2</p> <p>1</p> <p>1</p> <p>1</p> |

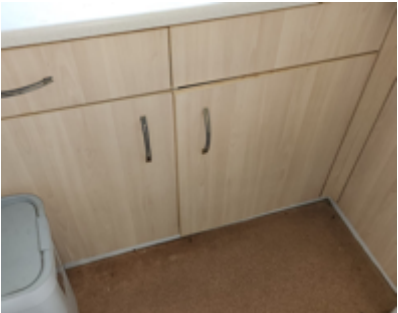
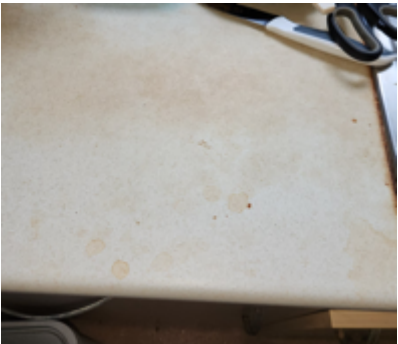
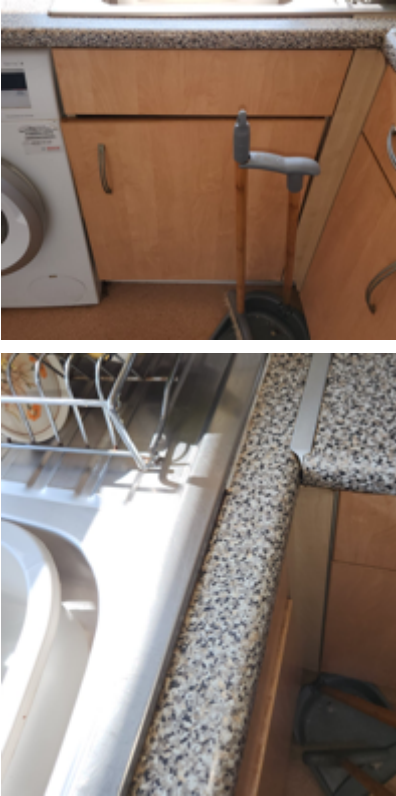
| <p>Condition</p> <p>No. 8</p> <p>No. 22</p> | | <p>The worktop in No. 8 is pitted and worn.</p> <p>The kitchen doors in No. 22 are loose and the worktop is worn.</p> <p>The unit doors are loose in No. 28. Silicone seal to sink is partly missing.</p> | |

| | Repair needs | <p>Replace worktop to flat No. 8.</p> <p>Replace kitchens to No. 22 &amp; 28.</p> | <p>2</p> <p>3</p> |

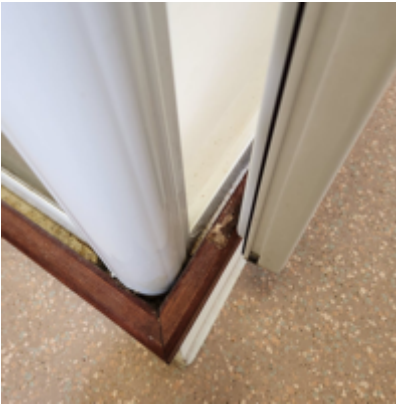
| | <p>Condition</p> | The shower door in No. 3 is catching. | |

| | Repair needs | Adjust shower door. | 1 |

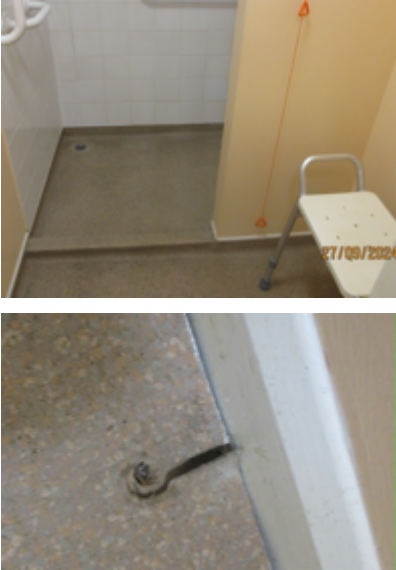
| 4.10.5 | Communal Shower | Shower cubicle with vinyl sheet floor.<br><br>The communal bathroom has an assisted bath. | |

| | Condition<br> | There is some damage to the vinyl flooring. | |

| | Repair needs | Replace vinyl. | 3 |

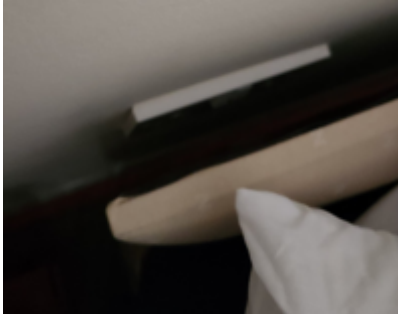
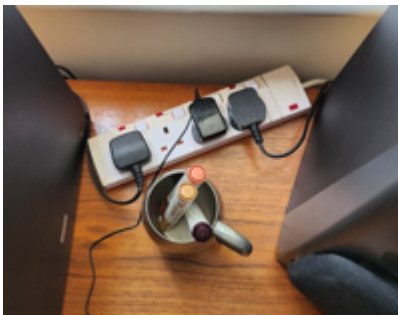
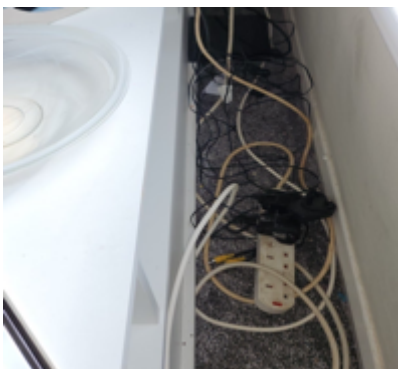
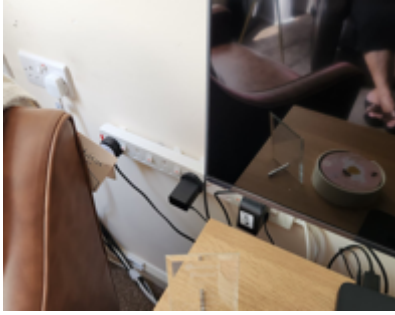
| | Condition | <p>Some of the units are plastic, which is not in accordance with the latest regulations, although this is not specifically a defect.</p> <p>The electrical installations are regularly inspected and tested. We were informed that the date of the last Electrical Installation Condition Report was September 2020, and it is assumed that all of the installations were "Satisfactory" at the time of testing.</p> <p>Electrical Safety First and the Almshouse Association recommend that periodic inspection and testing is carried out at least every 5 years or on the change of occupancy.</p> <p>The numbers of sockets are below current recommendations and multiple adaptors are in use in places.</p> <p>The double socket in the bedroom in No. 3 is insufficient – there is only 1 double socket, which is located behind the headboard.</p> <p>Two double sockets to lounge to flat No. 3<br/>Additional electric power points required.</p> | |

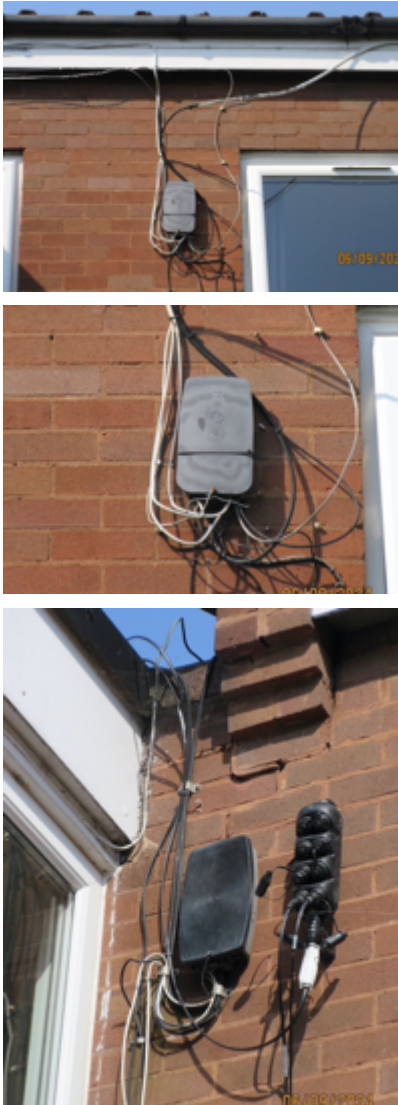
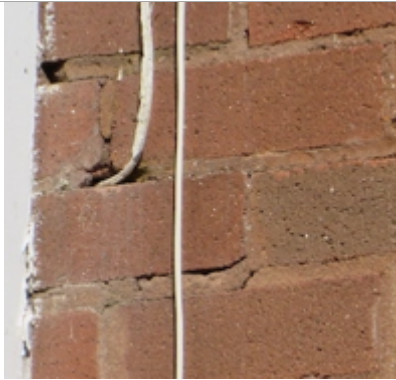
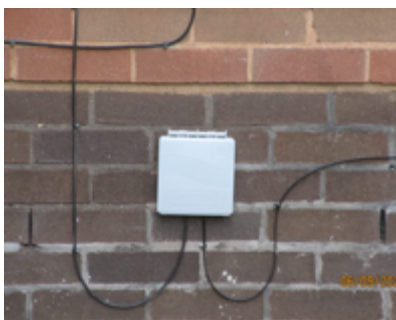
| | Condition<br> | Installation of external telephone cables is extremely messy and has been done very poorly in places with loose and redundant cables, damaged bricks and pointing and badly repaired bricks. In a few places the installation has been done neatly with holes drilled through joints rather than the middle of the bricks and grommets fitted but this is in the minority. | |

| | Repair needs | Remove redundant cables, repair bricks and pointing, fit grommets where possible. | 2 |

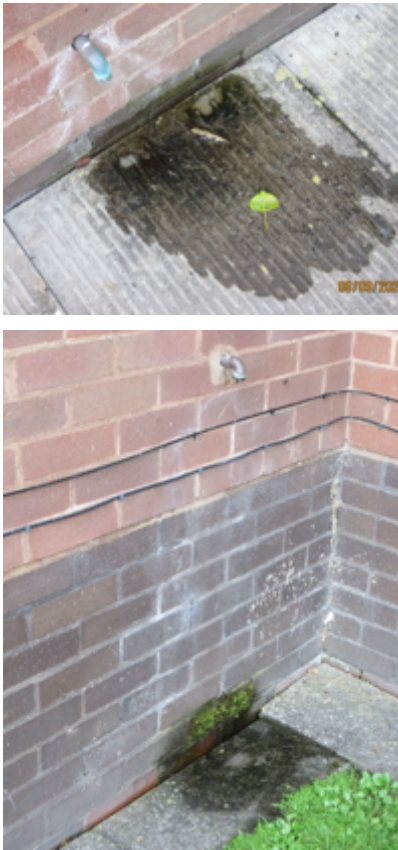
| | <p>Condition</p> | <p>These types of cylinder can be something of a legionella risk as the water is often stored at above 20°C. This should be addressed as part of the Legionella Risk Assessments.</p> <p>Several of the hot water cylinders are dripping from the external overflows.</p> <p>The cylinders are a standard size, approximately 115 litres. In the absence of baths, this is rather a large amount of water to heat to just serve a washbasin and kitchen sink for a single person to use. As well as being a legionella risk, if all of the water is not used, it is also wasteful of fuel to heat up large quantities of water only to leave them to cool down again.</p> <p>Latest guidance from the HSE has confirmed that Legionella Risk Assessments are now needed for all non-residential premises whether or not they have stored water. See also Appendix 2.</p> | |

| | Repair needs | <p>Carry out Legionella Risk Assessments for all flats.</p> <p>Review arrangements for hot water heating.</p> | <p>1</p> <p>3</p> |

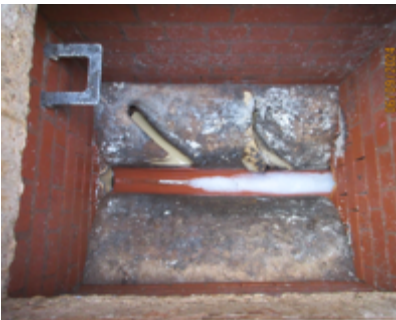
| | <p>Condition</p> | <p>A selection of accessible manhole covers were lifted.</p> <p>There is surface corrosion to a number of the covers; one of the drain access covers is loose. The surface corrosion has worsened since the last quinquennial inspection.</p> <p>Note that from the 1<sup>st</sup> October 2011, most sewers (drains shared with two or more properties) are now the responsibility of Severn Trent Water, this includes responsibility for clearing blockages.</p> |

| | Repair needs | Manhole covers should be lifted, the channels cleaned out and covers set in grease. | 2 |

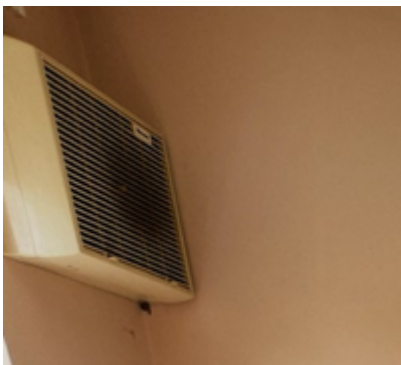
| | Condition<br><br>No.19 | <p>There are no particular or widespread problems with condensation or mould growth apparent. Where individual properties are affected this is noted elsewhere in this report.</p> <p>Mould to ceilings and walls in section 4.2.1 and 4.3.1, floors in section 4.5.1, shower rooms in 4.10.2,</p> <p>The ventilation fan in No. 3 (bathroom) is switched off.</p> <p>The ventilation fan in No. 19 (kitchen) is dirty.</p> <p>There is what appears to be a humidity fan in the bathroom in No. 19, it is unclear if this is working.</p> <p>The bedroom in No. 22 smells of damp. There is a humidity fan in the bathroom, we were unable to check if this was working.</p> | |

| | Repair needs | Repair or replace defective fans. | 2 |

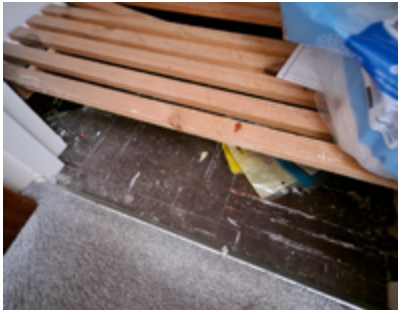
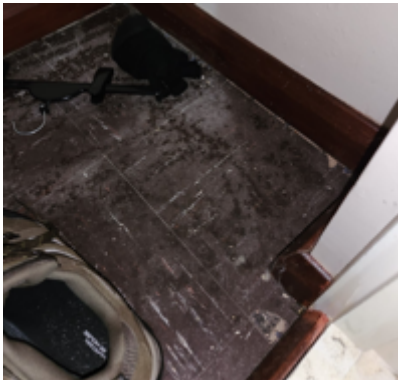
| | Condition<br><br>No.19<br><br>No.22 | <p>There are possibly asbestos floor tiles in the cupboard in No. 19 &amp; 22.</p> <p>Current legislation (The Control of Asbestos Regulations 2012) requires that any asbestos in common areas of properties is recorded and managed.</p> <p>Asbestos fibres were included in many different types of building materials, and may be released when these materials are damaged, disturbed or otherwise exposed. These fibres can cause a hazard to health when inhaled. There is a risk that any work activity that intrudes beyond the surface finish of this building may expose or disturb asbestos fibres and thereby create a potential health hazard.</p> <p>An asbestos register is in place and is reviewed annually by the Building Manager.</p> | |

| | Repair needs | Continue to review asbestos register. | 3 |

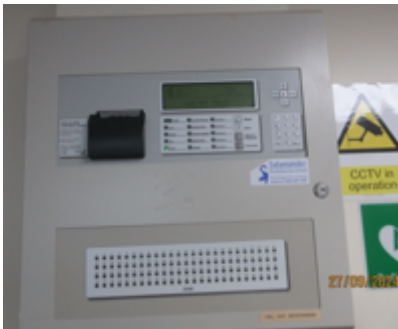
| | Condition<br> | <p>The last fire alarm test was carried out on 19<sup>th</sup> July 2024 and the emergency lighting test was carried out on 22<sup>nd</sup> January 2024. Functional testing of the alarm system on site is carried out weekly. Emergency lighting is subject to a 20-minute test every month.</p> <p>Portable firefighting equipment in common areas is becoming less common as some authorities recommend its removal unless residents are trained in its use.</p> <p>There is a non-fire rated vent to the party walls as noted in section 4.1.1/2 this is a fire risk. The lack of fire breaks in the roof space is a Category 2 Hazard under the Housing Health and Safety Rating System.</p> | |

| | Repair needs | <p>Fill gaps in the party walls/build up party walls.</p> <p>Consider fitting all flats with mains interlinked smoke detectors in living rooms and heat detectors in kitchens.</p> | <p>1</p> <p>3</p> |
