## Quinquennial Inspection Report

Larksfield,  
Windmill Lane,  
Smethwick B66 3ET

28<sup>th</sup> August 2024

Project number: 1253C-07

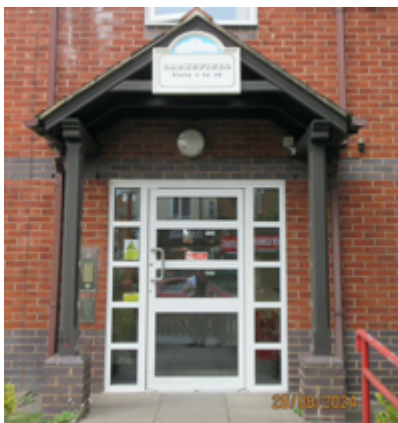
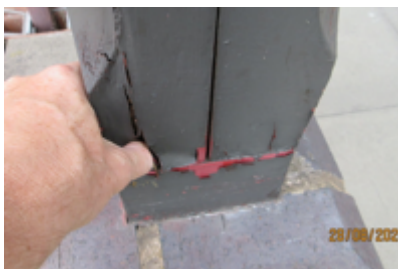
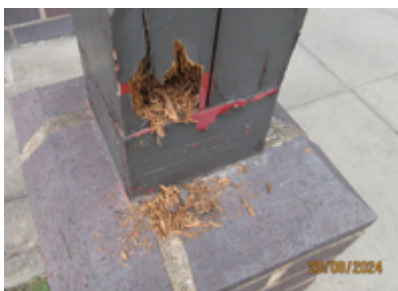
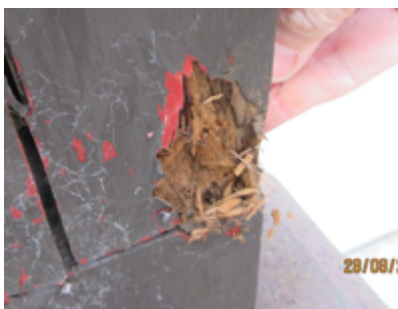
| | Condition | <p>Main roofs are in good condition with diagonal bracing present to the surveyed flat.</p> <p>The bottom of the post supporting the front canopy is rotten. It is capable of a splice repair however.</p> <div></div> | |

| | Repair needs | Splice repair canopy post. | 2 |

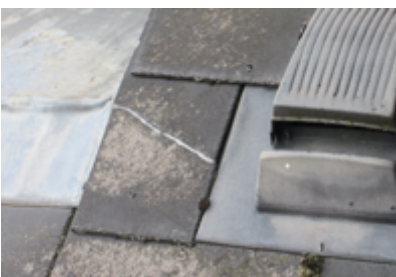
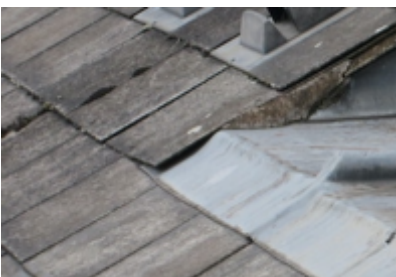
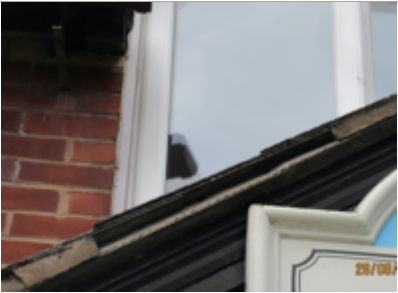
| | <p>Condition</p> | <p>Most slates have faded in colour, a very common phenomenon with this type and age of slate.</p> <p>There is some minor moss growth still present, mostly beneath the trees on the Suffrage Street elevation.</p> <p>The covering is deteriorating but will probably not need to be replaced for 5-10 years.</p> <p>A slate has slipped above No. 4, several slates to the Windmill Lane elevation have curled or slipped.</p> <p>There is evidence of birds nesting in the eaves above No. 10 rear elevation (see section 6.5.2).</p> <p>The cement mortar pointing to the front canopy verge is missing in places.</p> | |

| | Repair needs | <p>Clean moss growth.</p> <p>Attend to slipped slates.</p> <p>Repoint verges.</p> <p>Re-cover roof.</p> | <p>3</p> <p>3</p> <p>2</p> <p>4</p> |

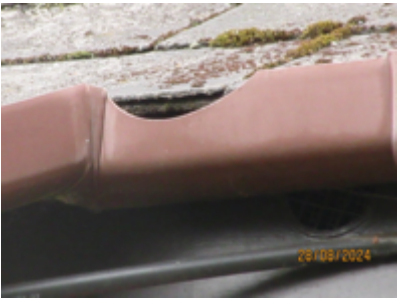
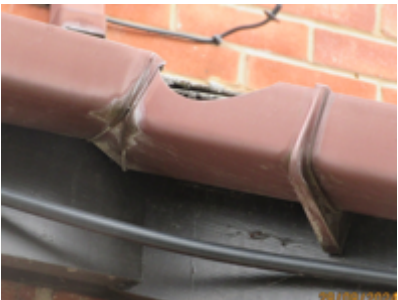
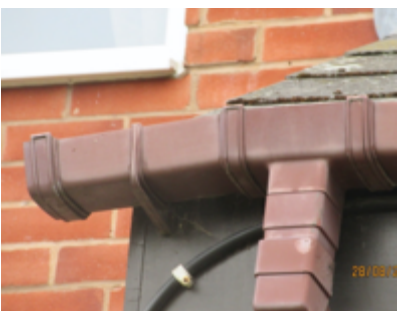
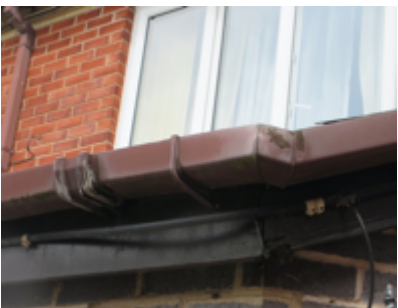
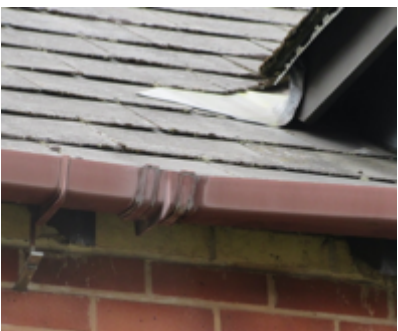
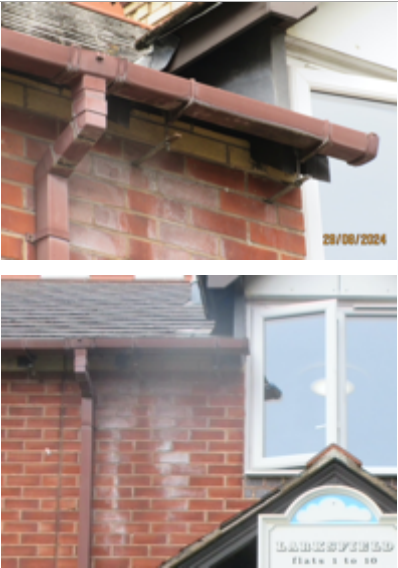
| | <p>Condition</p> | <p>There is some leaf blockage to the binstore roof gutters.</p> <p>As with the slates, the gutters are nearing the end of their lives.</p> <p>Two sections of gutters above No.'s. 2, 4 and 5 are cracked, others are misaligned above No. 2 and 3.</p> <p>Some show evidence of overflowing (although this could be historic) – above the first floor corridor rear elevation.</p> <p>As it was not raining at the time of the inspection it is not possible to confirm if the rainwater goods are effective.</p> <p>Similar issues were noted in the previous quinquennial inspection.</p> <p>Gutters will probably need replacing before the roof covering but it would make economic sense to do both together as gutters (if replaced in UPVC) will inevitably break if the covering is subsequently replaced.</p> |

| | <p>Repair needs</p> | <p>Replace cracked section of gutter.</p> <p>Observe gutters during heavy rain.</p> <p>Clear gutters.</p> <p>Replace gutters.</p> | <p>2</p> <p>2</p> <p>2</p> <p>4</p> |

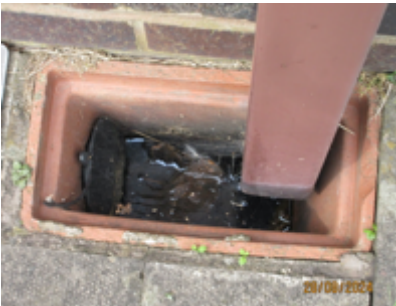
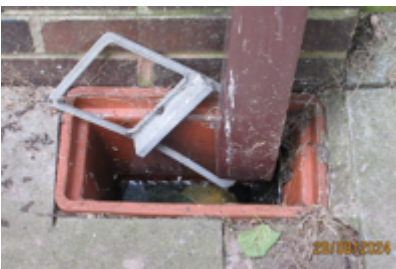
| | <p>Condition</p> | <p>Fair, a number of the grids are light plastic items and do not fit into the openings or are broken or missing, this allows debris into the below ground drainage installation.</p> | |

| | Repair needs | Replace missing / damaged grids. | 2 |

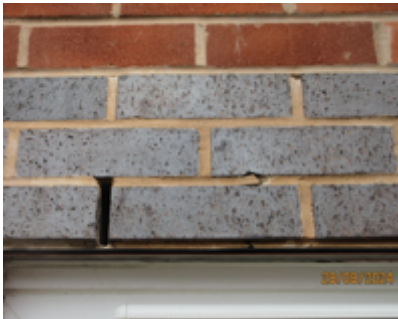
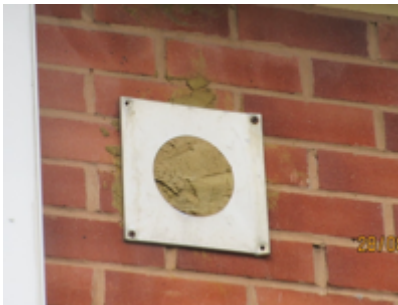
| | <p>Condition</p> | <p>There is cracking to the brickwork in places, particularly above lintels to the south elevation to Suffrage Lane and the north elevation to the garden. None of this is visible internally and it appears to be minor seasonal movement, although the excessively tall trees close to the building may be implicated as during hot, dry summers like in 2022 they will take large quantities of water out of the ground.</p> <p>One old boiler flue has been poorly filled with a plate and thick mortar, it looks unsightly and will crack and fall out.</p> | |

| | Repair needs | <p>Fill cracks.</p> <p>Build up old flue opening correctly using bricks and mortar.</p> | <p>3</p> <p>3</p> |

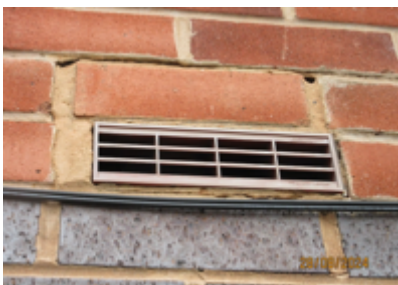
| | Condition | Good, although one appears to have been reduced in size with a poorly positioned brick. | |

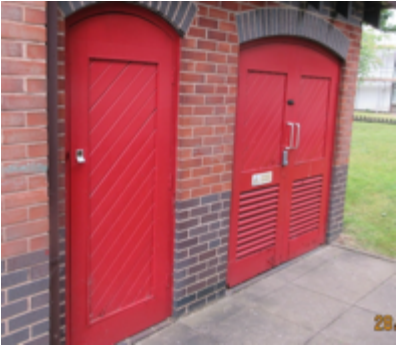
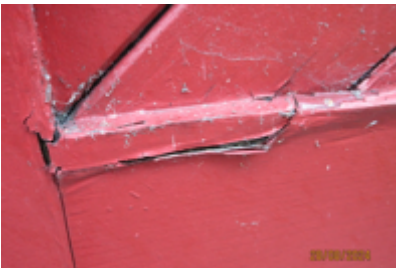
| | <p>Condition</p> | <p>Poor, there is rot to the bottom of the meter cupboard door and to a lesser extent above the mid-rail of the binstore door.</p> | |

| | Repair needs | Repair rot or replace doors. | 2 |

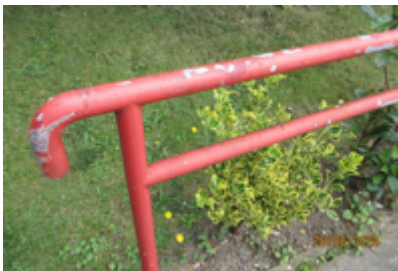
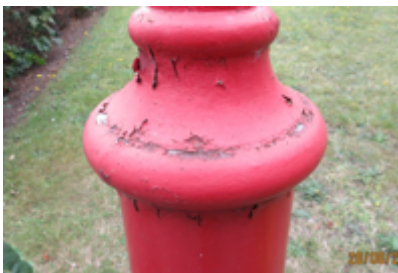
| | Condition | <p>Generally good, a few areas are peeling.</p> <p>The paint finish to the handrail is chipped and missing.</p> <p>Fences are bare of decoration.</p> | |

| | Repair needs | Decorate paintwork. | 3 |

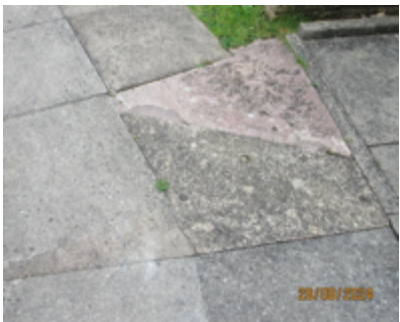
| | Condition<br> | There are a few uneven areas of concrete flag paving, particularly to No. 1 but none is yet a particular trip hazard, paving should be regularly checked. A couple of flags are loose. | |

| | Repair needs | Take up and re-lay uneven flags. | 3 |

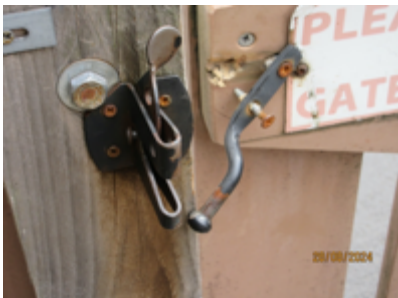
| | Condition<br> | The gate latch is loose and not well fixed.<br><br>External decorations are considered in section 3.5. | |

| | Repair needs | Repair gate and re-fix latch. | 2 |

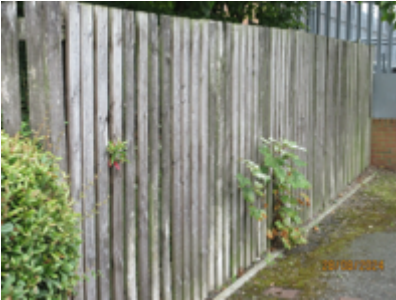
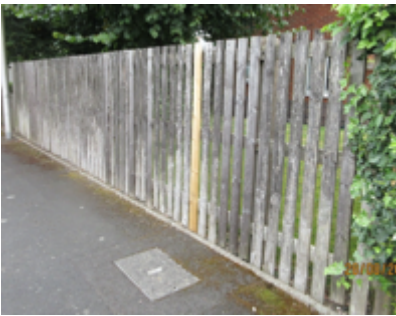
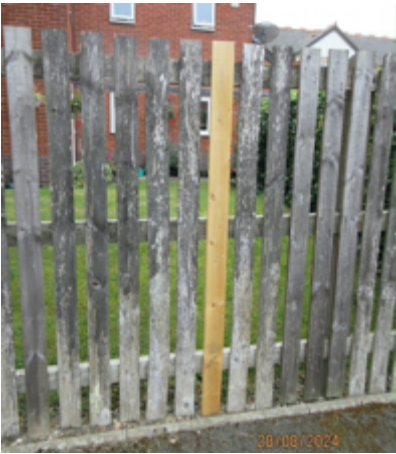
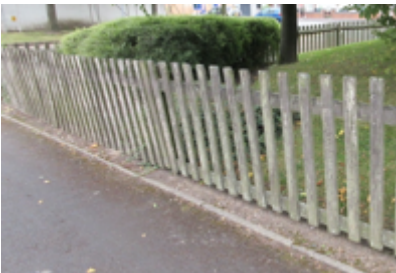
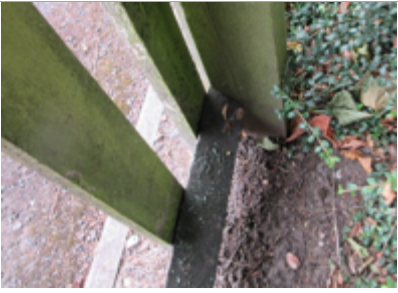
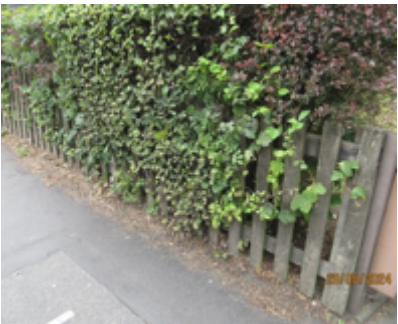
| | <p>Condition</p> | <p>The lower fence to Hume Street is leaning and the bottom of the post is rotten.</p> | |

| | Repair needs | Replace rotten post or add concrete godfather to post. | 2 |

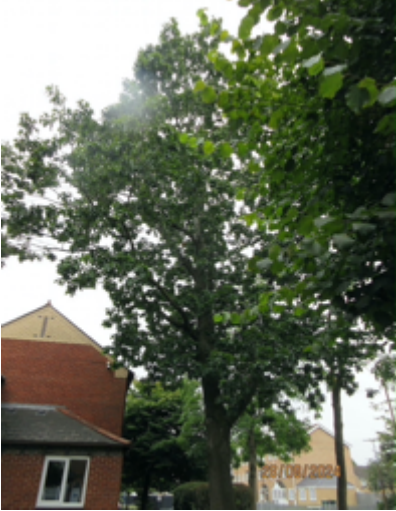
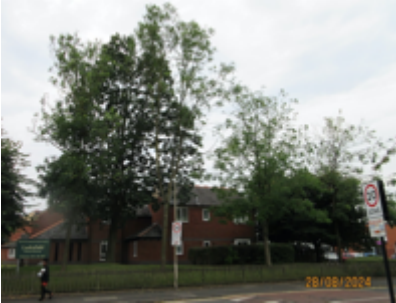
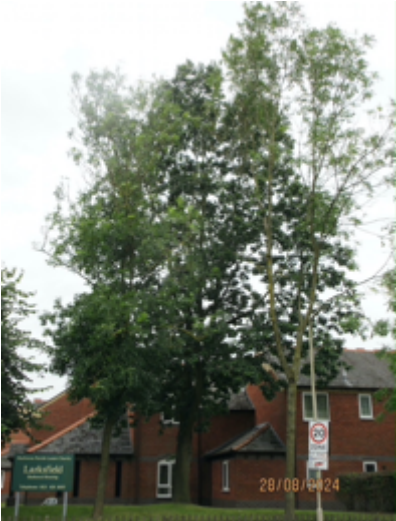
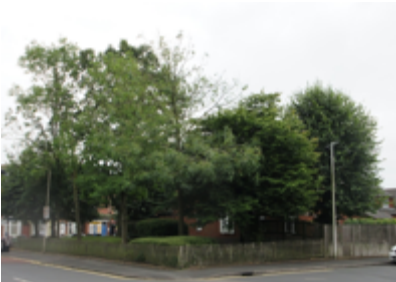
| | Condition<br><br><br><br> | <p>These are closer than the recommended "safe" distance but given the age of the building it appears that most of the trees pre-date it and it is assumed that reasonable allowances were made in the design of the foundations in order to overcome any potential problems.</p> <p>Some trees have further increased in size, one tree fell into the road since the last inspection.</p> <p>Whilst providing some shade and privacy the larger trees are also badly overhang the building and are causing problems with the roof and rainwater drainage. Some are several times the height of the building and quite severe thinning/reduction work would be beneficial.</p> | |

| | Repair needs | Reduce size of largest trees. | 2 |

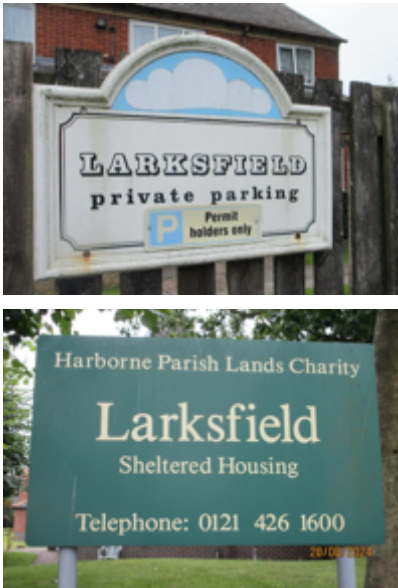
| | Condition<br> | Older signs show evidence of wear, screws are corroding. | |

| | Repair needs | Replace older signs. | 3 |

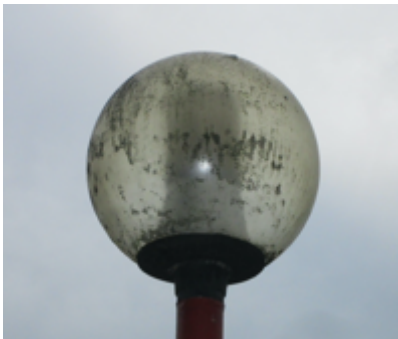
| | Condition<br> | As the inspection was carried out during daylight it was not possible to check the efficacy of the lighting.<br><br>Some of the globe fittings are showing signs of age. | |

| | Repair needs | Replace older fittings. | 3 |

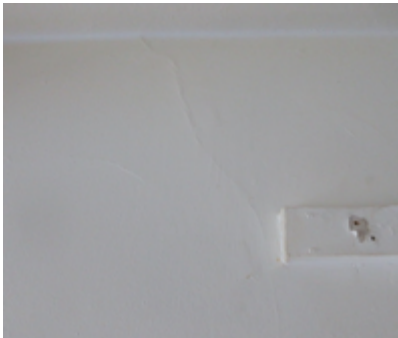
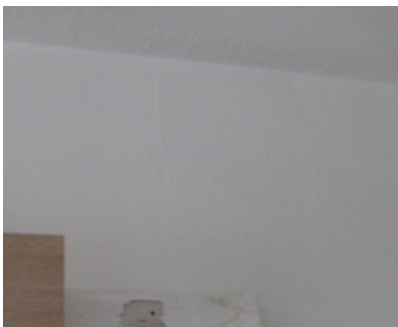
| | <p>Condition</p> <p>No. 4</p> <p>No. 10</p> | <p>Cracking was noted to No. 4 (kitchen), this appears to be nothing more than normal shrinkage.</p> <p>There is staining to the walls in No. 10 (hall), this is from a previous leak and all areas are now dry.</p> | |

| | Repair needs | <p>Fill cracks.</p> <p>Stainblock and redecorate water stained areas.</p> | <p>3</p> <p>3</p> |

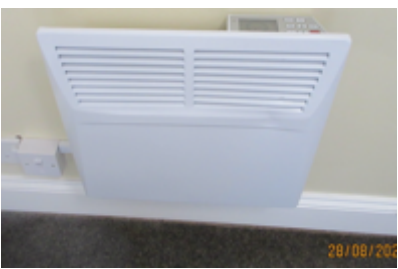
| | Condition<br> | The electric panel heater is dented slightly. | |

| | Repair needs | Replace cover or heater as necessary. | 4 |

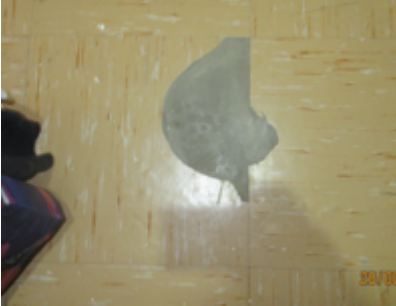
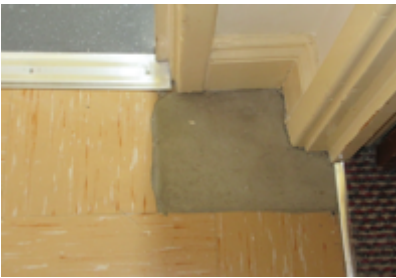
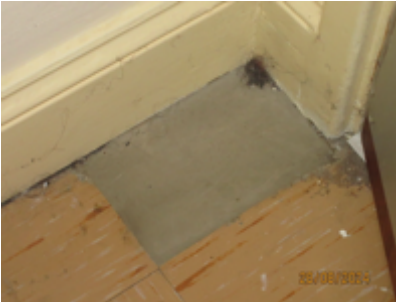
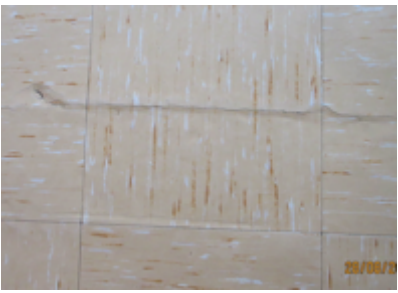
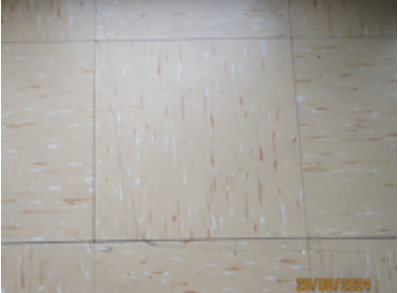
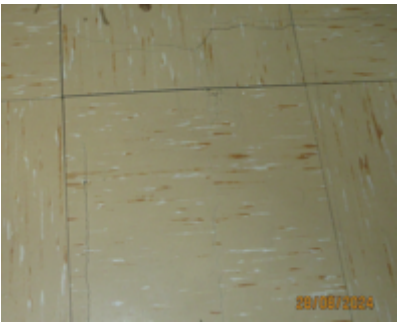
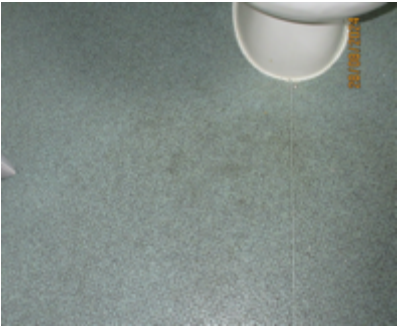
| | <p>Condition</p> <p>No. 1</p> | <p>The floor tiles in No. 1 (hall) are split and one area has been screeded over. The floor in the bathroom is dirty and marked).</p> <p>There is minor cracking to the floor tiles in No. 2 (hall). The vinyl tiles in the living room are cracked, some are chipped and one area is uneven. The vinyl tiles in the bedroom are marked.</p> <p>Note that these tiles are of a type that sometimes contained asbestos.</p> <p>The floor to the bathroom in No. 4 is slightly discoloured.</p> |

| | <p data-bbox="295 1668 486 1702">Repair needs</p> <p data-bbox="295 2027 359 2060">No. 4</p> | <p data-bbox="718 1668 1029 1702">Replace cracked tiles.</p> <p data-bbox="718 1747 917 1780">Replace vinyl.</p> | <p data-bbox="1404 1668 1428 1702">2</p> <p data-bbox="1404 1747 1428 1780">3</p> |

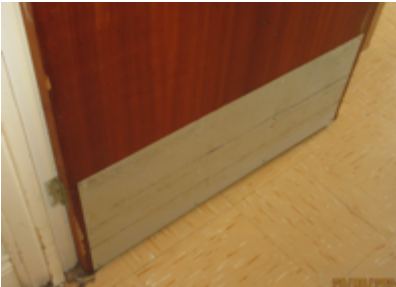
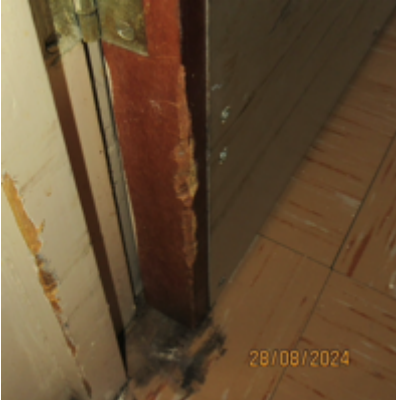
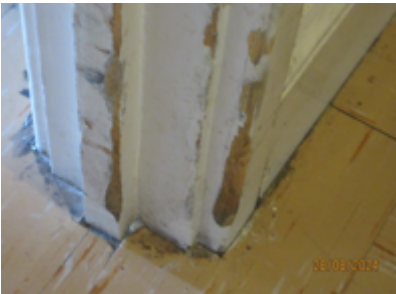
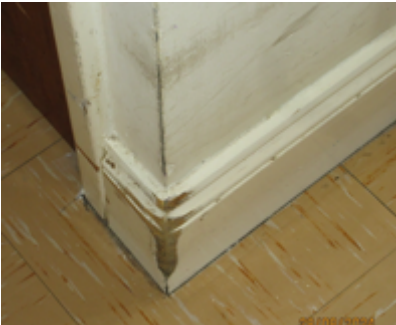
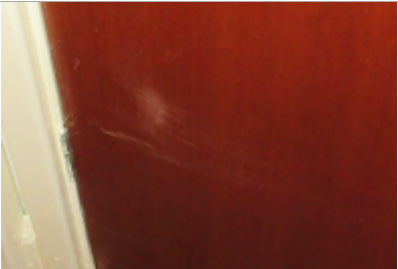
| | Condition<br><br><br><br><br>No. 2 | <p>The veneer is damaged to the door in No. 2 (hall and bathroom). The door handle is loose to the bathroom.</p> <p>There is a scratch to the laminate on the flush door in No. 3 (hall).</p> | |

| | Repair needs | Replace ironmongery/doors and make good damage. | 2 |

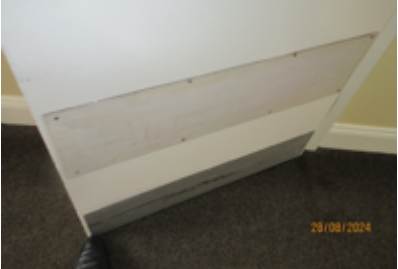
| | <p>Condition</p> | There are markings to the kickplates. | |

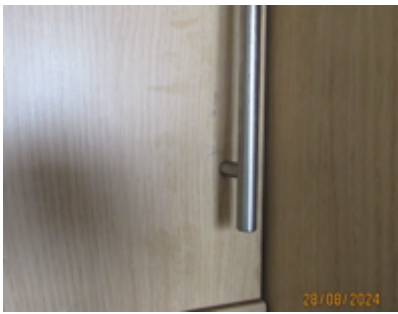
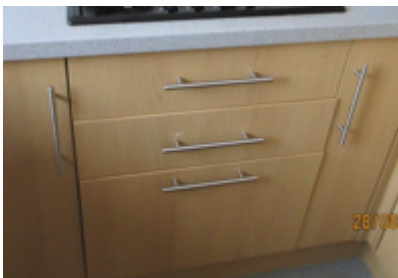
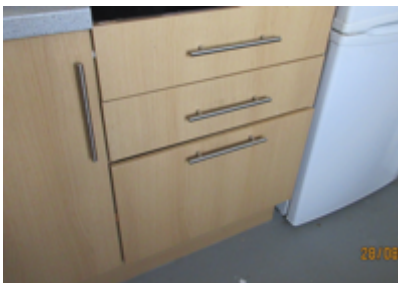
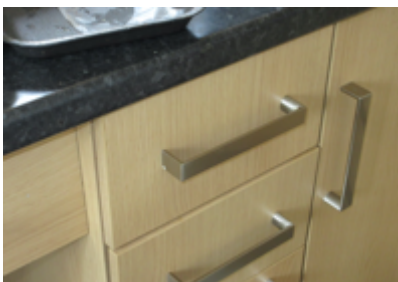
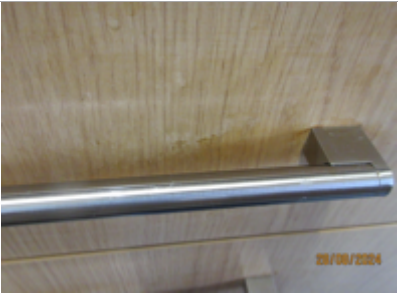
| | <p>Condition</p> <p>No. 3</p> <p>No. 4</p> | <p>All kitchens are in reasonable condition although a few show signs of wear.</p> <p>The units in No. 3 are marked and some doors are uneven and misaligned.</p> <p>One of the drawer fronts in No. 4 is slightly misaligned.</p> <p>There is minor wear to the unit doors in No. 10.</p> <p>Kitchens do not yet warrant replacement.</p> | |

| | Repair needs | Repair/replace doors and drawers. | 2 |

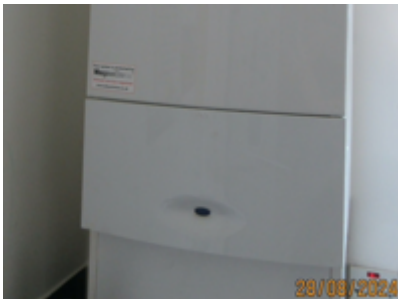
| | Condition<br><br>No. 4 | All appear to be in good condition. There is a programme of regular testing and certification in place.<br><br>Latest guidance from the HSE has confirmed that Legionella Risk Assessments are now needed for all non-residential premises whether or not they have stored water. See also Appendix 2.<br><br>The flap to the boiler in No. 4 is loose. | |

| | Repair needs | Replace loose boiler flap. | 3 |

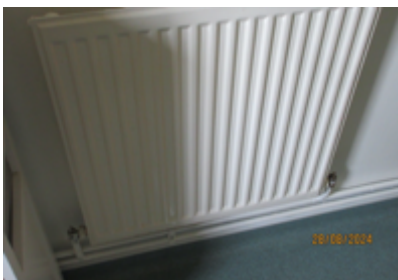
| | Condition<br> | The valves are missing off the radiator in No. 4 (bathroom). | |

| | Repair needs | Replace missing valves. | 2 |

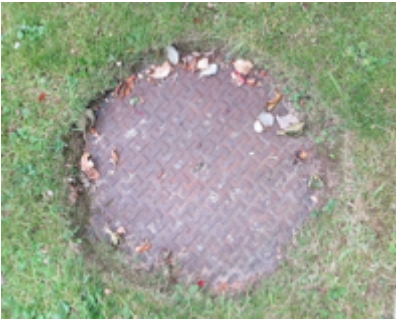
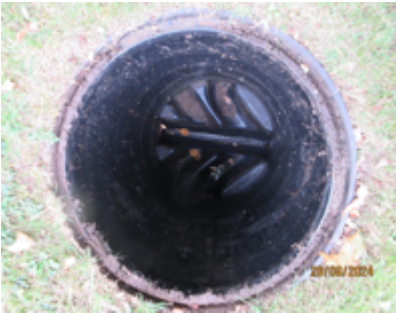
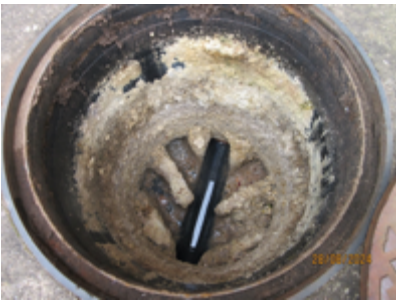
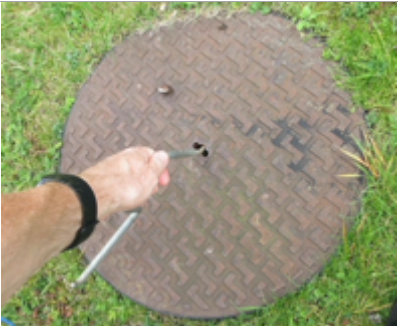
| | Condition | <p>One manhole cover to the Windmill Lane elevation is completely seized and could not be lifted.</p> <p>The manhole to the front of No. 5 has previously been blocked.</p> <p>Note that from the 1<sup>st</sup> October 2011, most sewers (drains shared with two or more properties) are now the responsibility of Severn Trent Water, this includes responsibility for clearing blockages.</p> | |

| | Repair needs | Manhole covers should be lifted, the channels cleaned out and covers set in grease.<br><br>Jet manhole. | 2<br><br>2 |
