Grade II * House Maidstone Kent Area

Brief Introduction to Property

Brief Outline of Instruction

We were approached by the client to look at the brick façade of the property, he had growing concerns as to its stability and was sure he had detected movement over the preceding six months

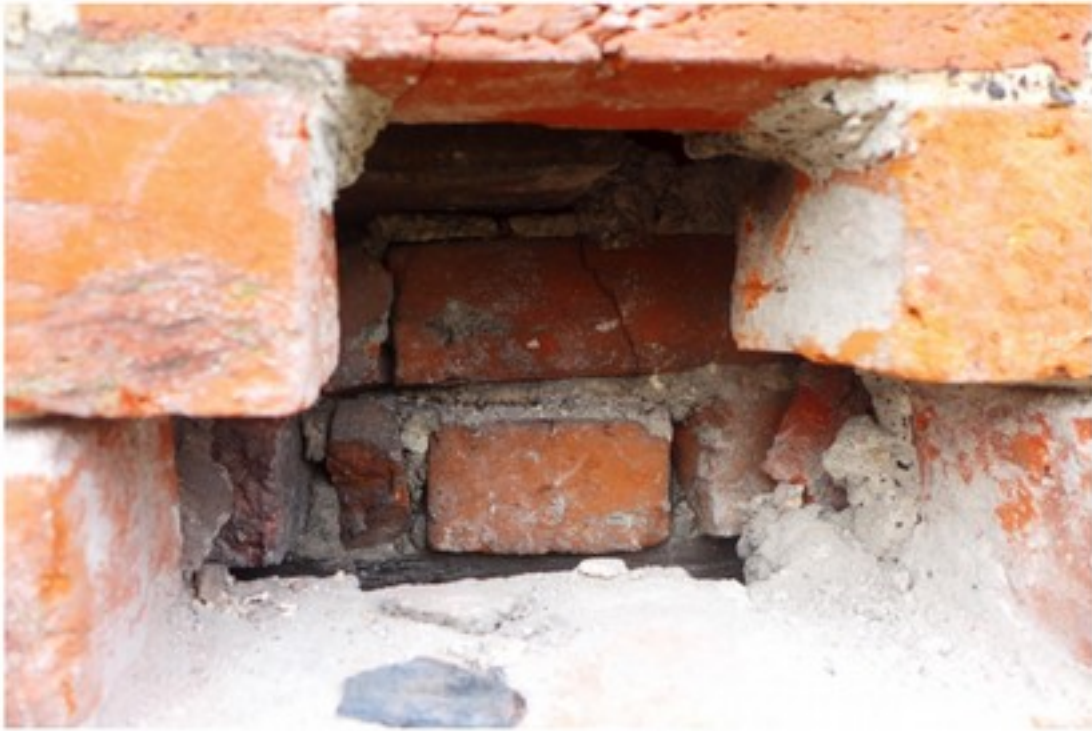
3. Sample opening up at front pier showing debonded outer leaf brickwork

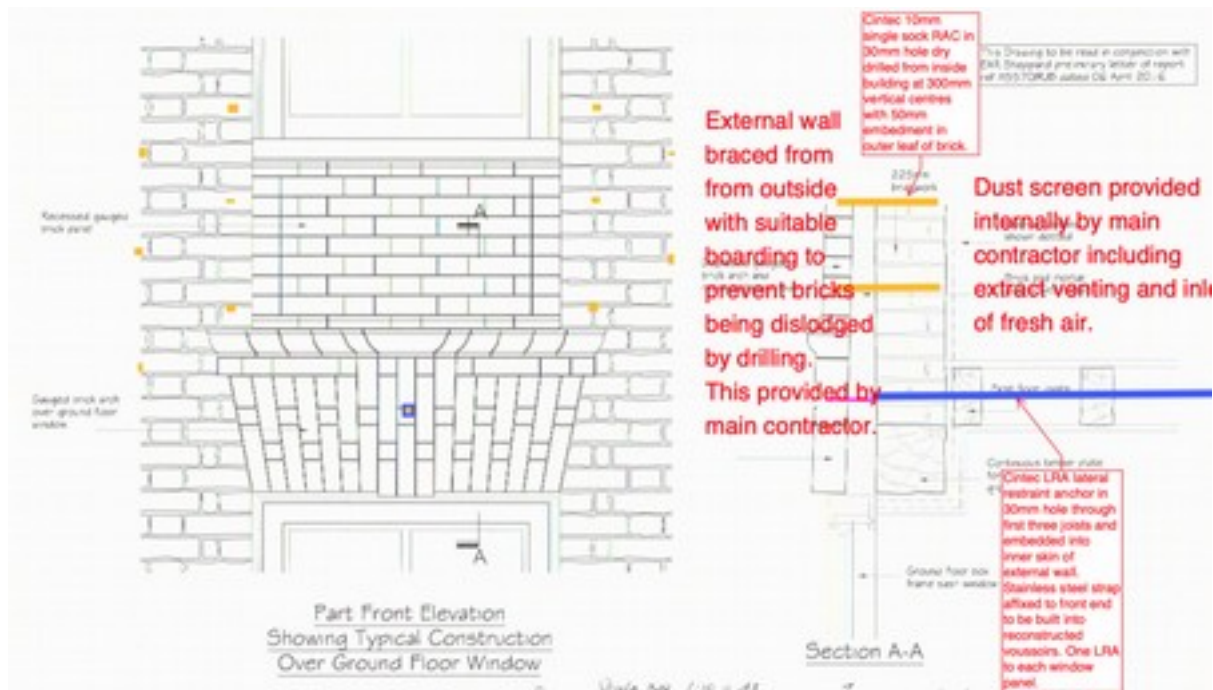
CINTEC Anchors proposed layout around openings note anchor to rubbed brick arch this Extended through three number joists at first floor level

- . CINTEX wall anchor system was also put forward as a possibility this would involve The precise drilling of the brickwork from the inside through the 225mm internal Skin to a depth of 50mm into the external brick skin inserting the anchor with a Cementitious skin in total 216Number each one having a different depth determined By the vertical level survey.

This method following a number of meetings with Historic England was approved As the least intrusive method of repair it did however mean agreement had To be reached for the removal and re-fixing of the historic internal panelling At Ground and First floor level also required were

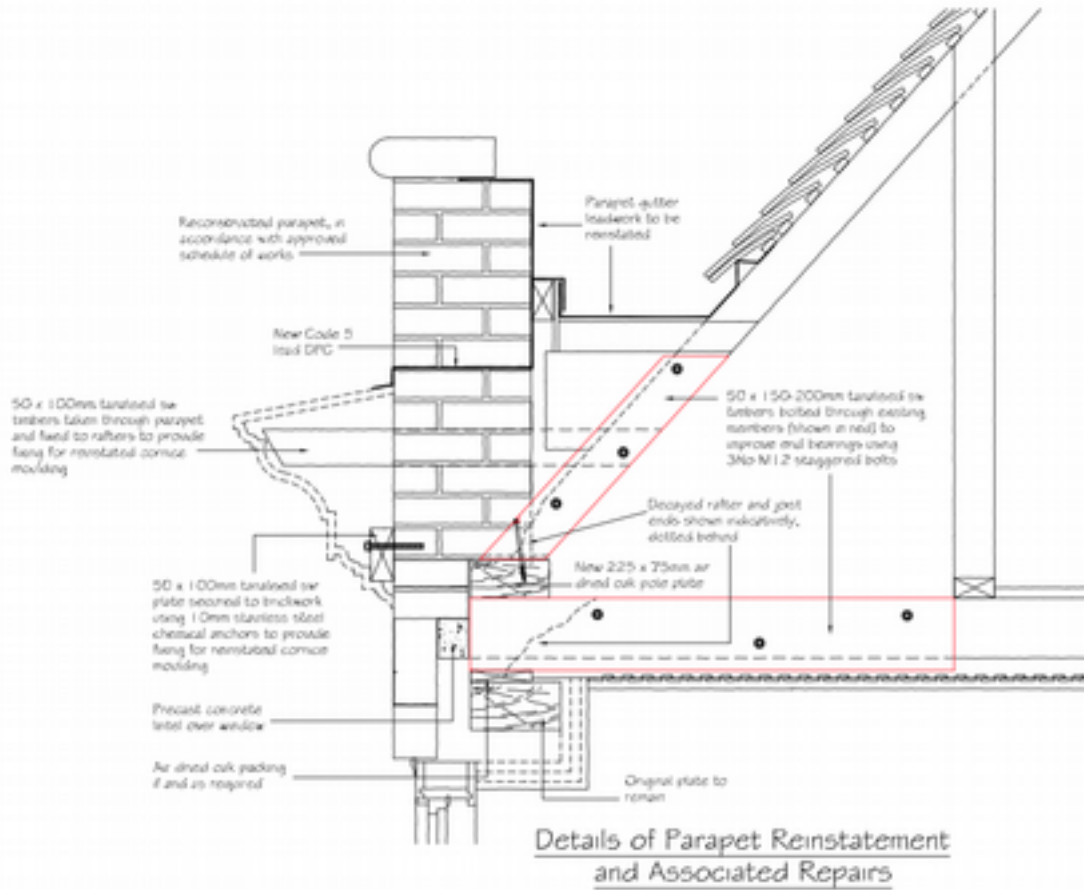
Detail of parapet repairs note the complete parapet was dismantled to gain access to the decayed timbers

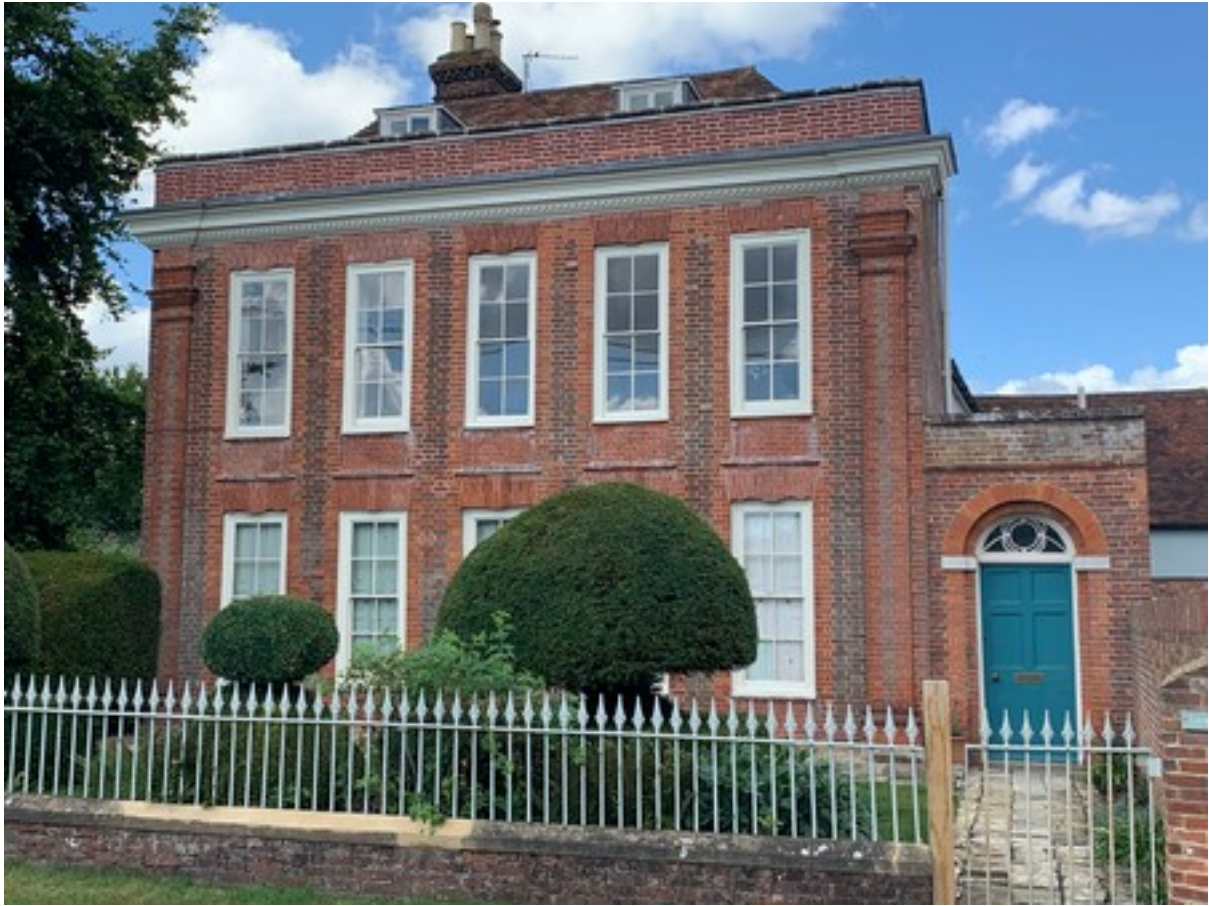
Following front façade restoration 2019

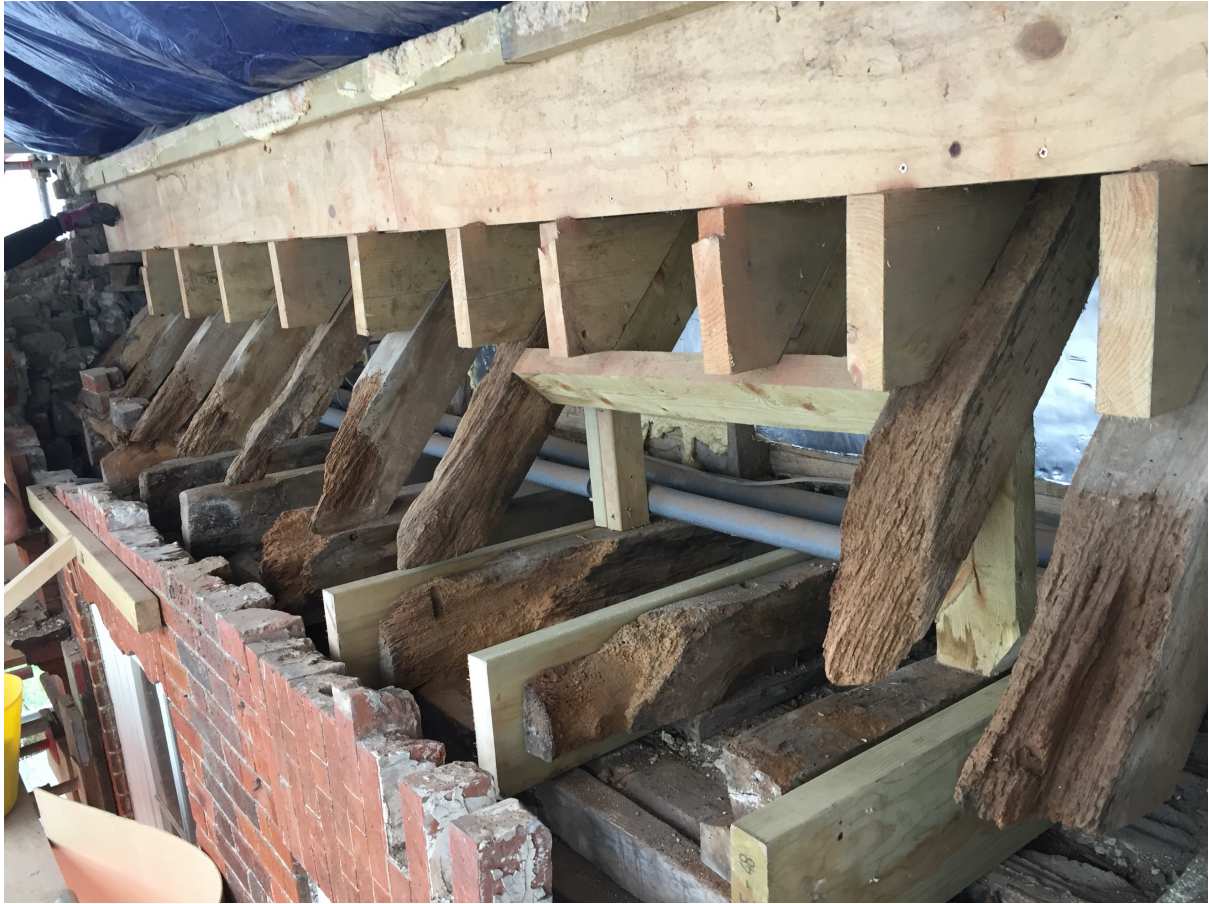
Whilst work was being undertaken on the parapet it became apparent that decayed timbers especially the pole plate were having an adverse impact on the stability of the brickwork. decisions were made on site at each stage of the works as to the extent of timber replacement especially in relation to how much of decayed rafters and floor joists should be retained.

Timber decay within parapet structure

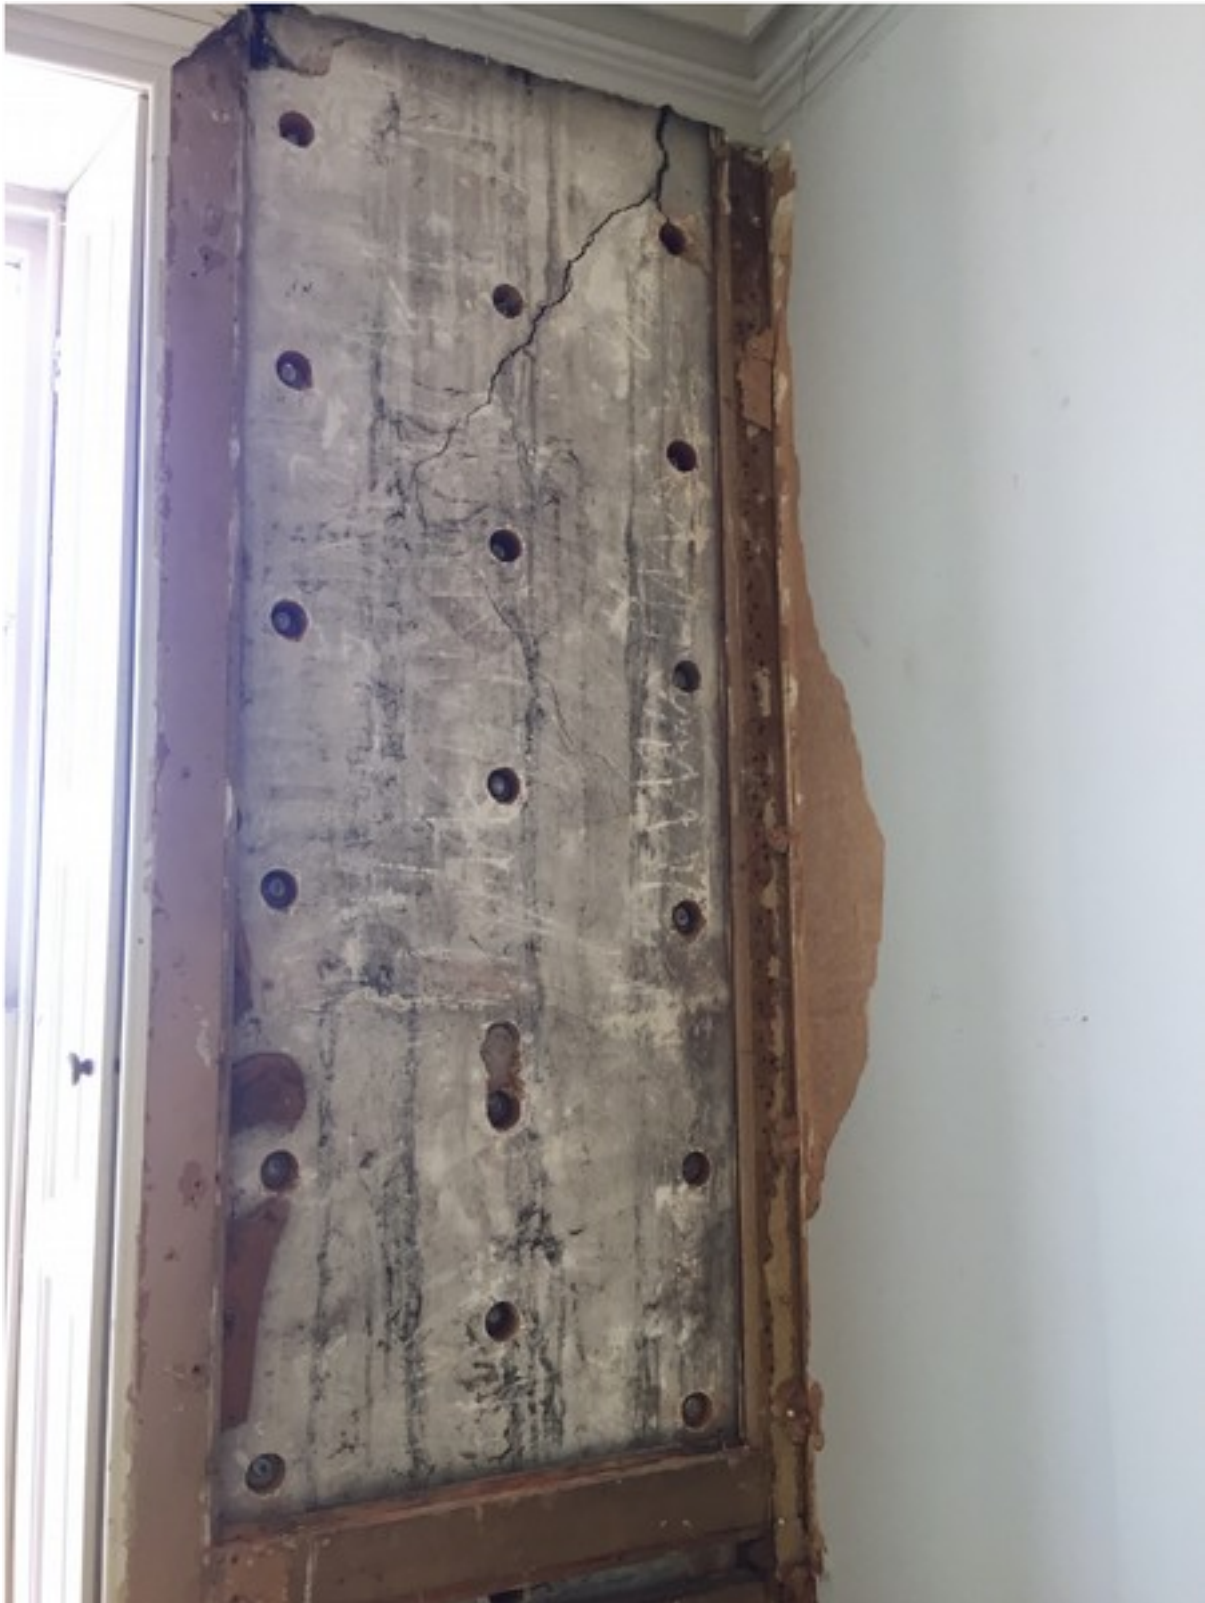
Following insertion of CINTEX anchors from internally note removal of linings to gain access to internal wall
