TEST SUMMARY
Building Research Establishment
BRE FIRE & BUILDING TECHNOLOGY GROUP

High Speed Wind Integrity Test
MicroLouvre K700 / 17 Screens

A MicroLouvre™ K700-17 screen was tested for wind integrity at the outlet of the No3 Boundary Layer Wind Tunnel located at the Building Research Establishment (BRE) London on 8th December 2016.

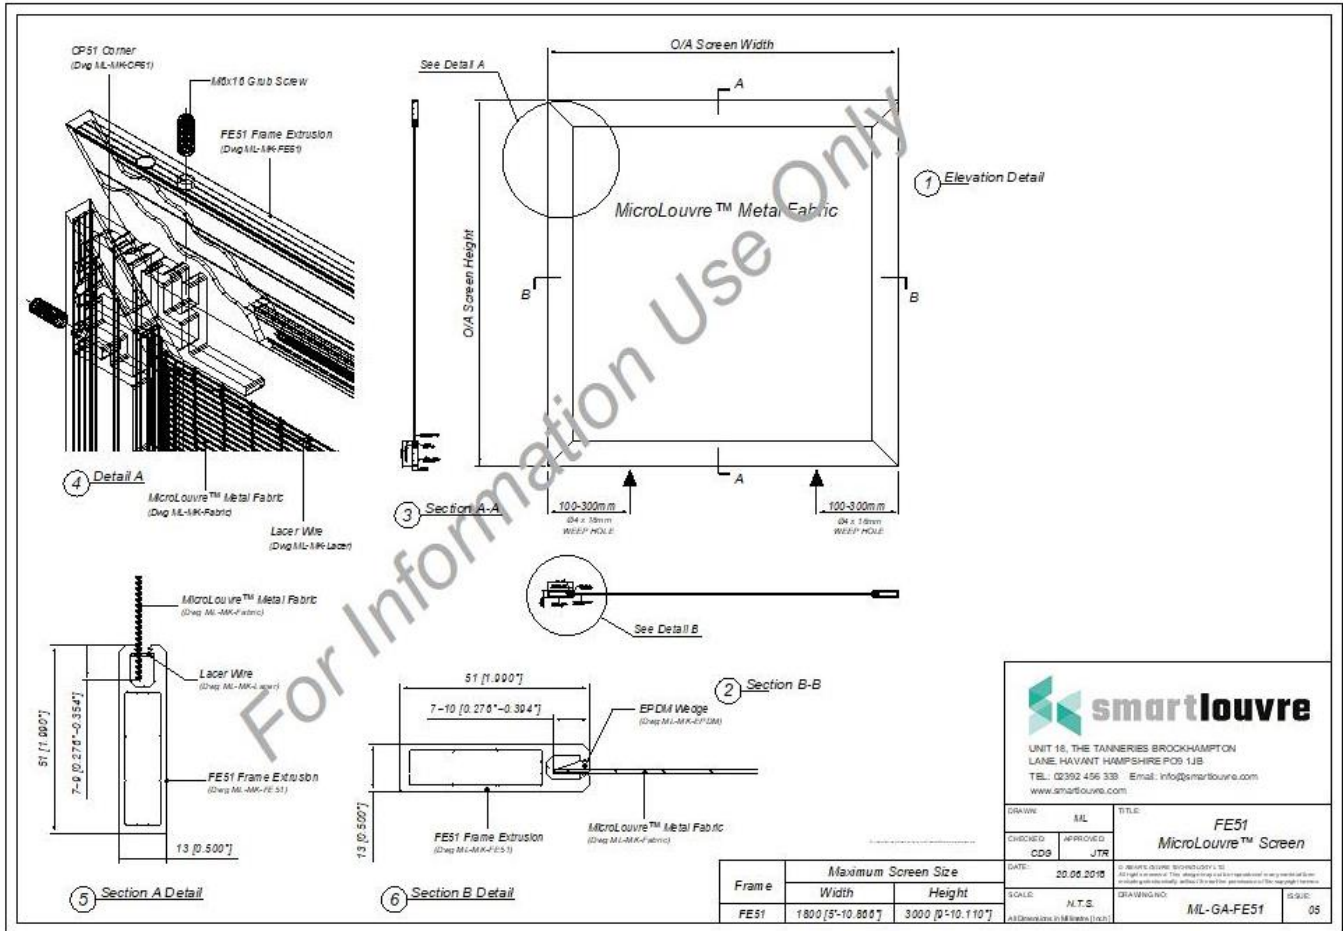
(Fig 1)

The 1000mm x 1000mm MicroLouvre™ K700-17 screen was fabricated (as Fig 1) from

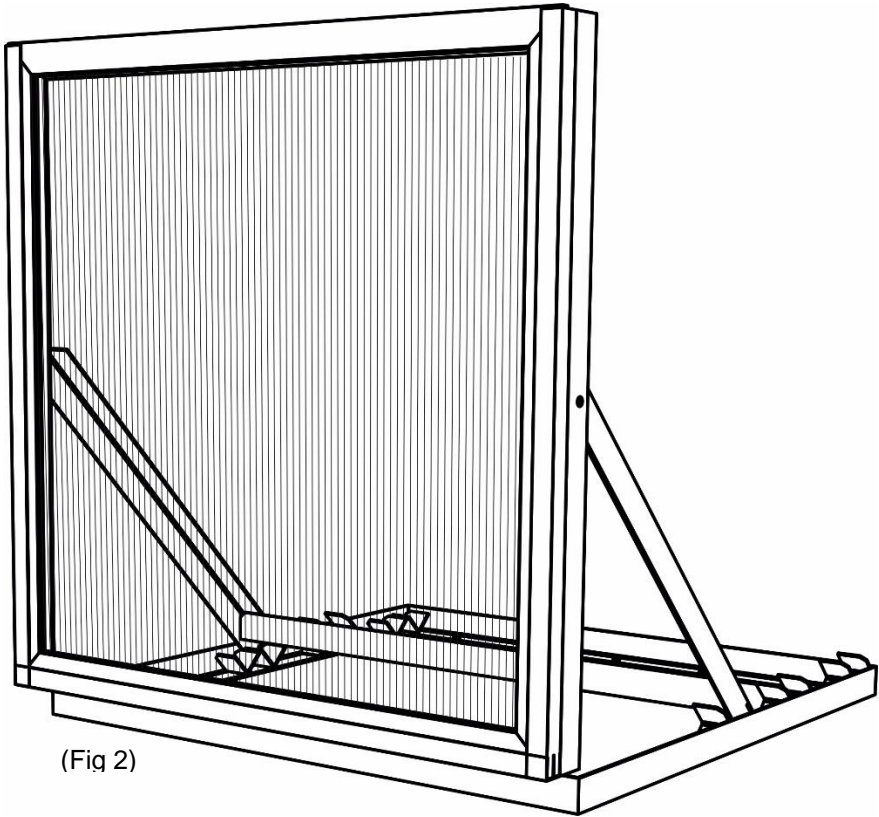
(Fig 2)

The frame was assembled and mounted in the test platform according to Fig: 2

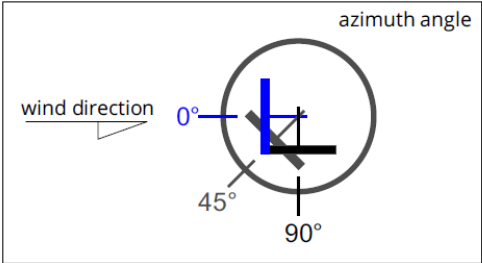
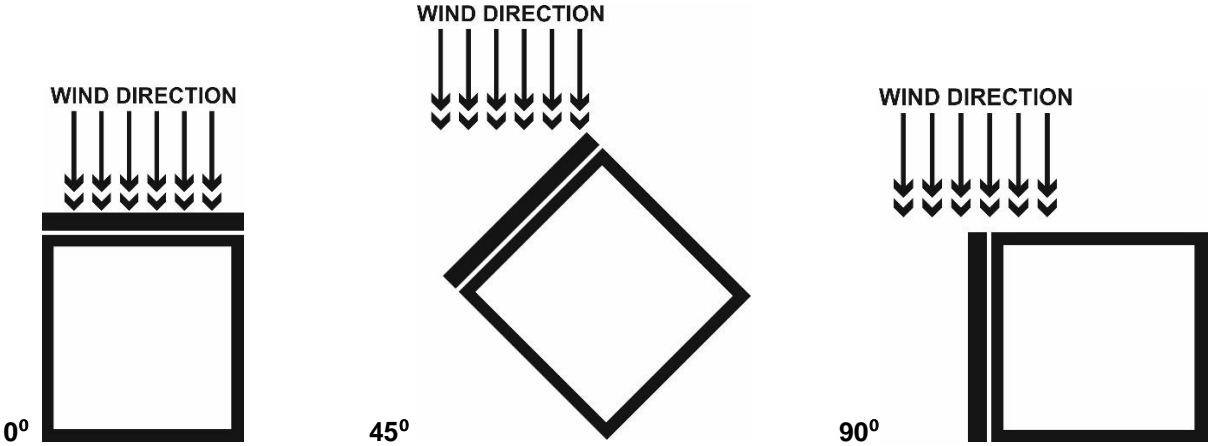
(Fig 3)

3 wind directions were tested (see Fig 3)

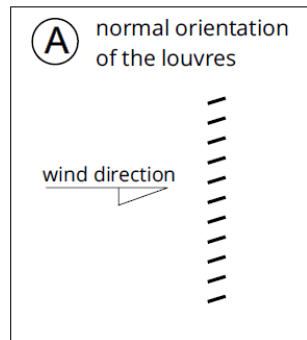
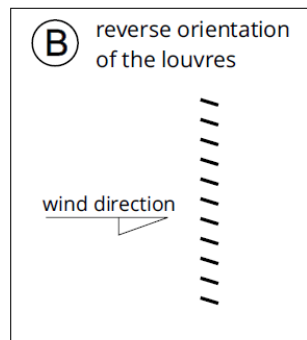
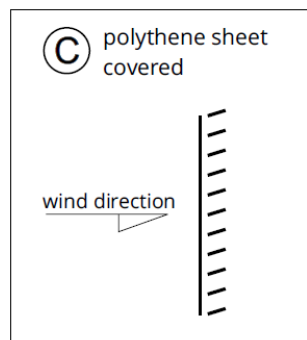
(Fig 4)

2 louvre orientations were tested (see Fig 4)

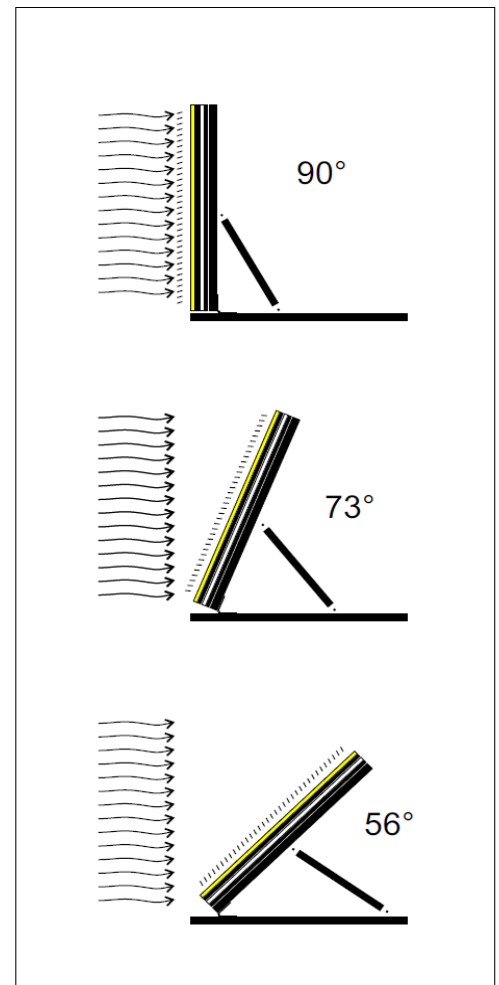
(Fig 5)

3 screen orientations were tested (see Fig 5)

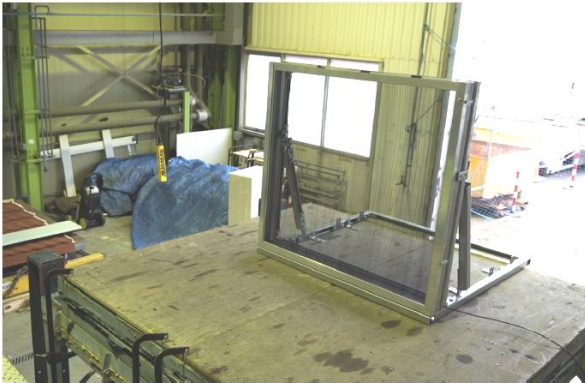
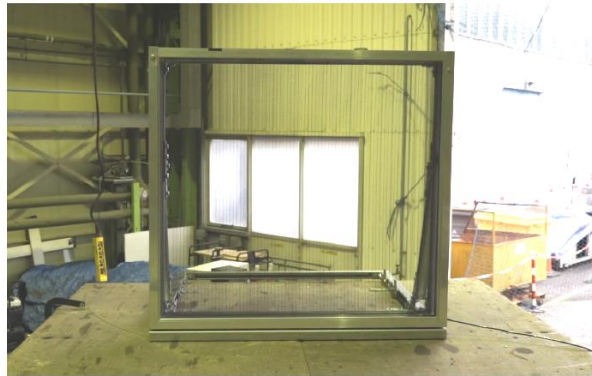
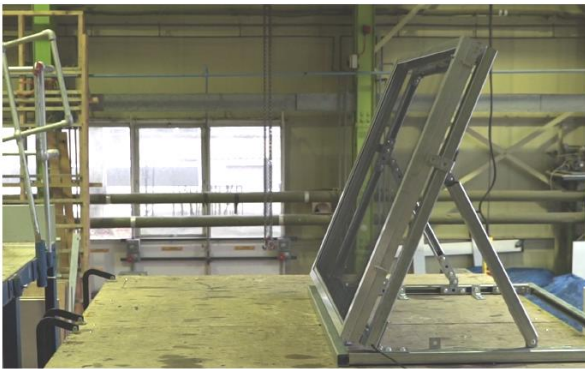
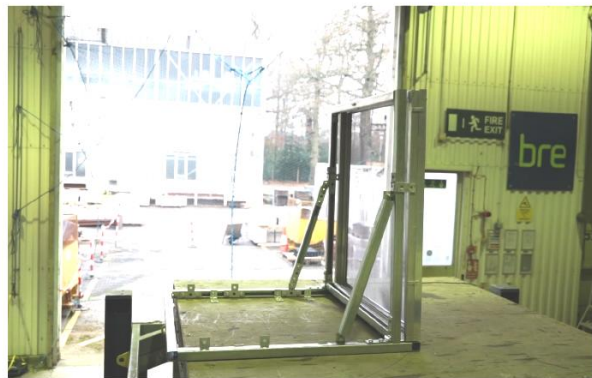
After the testing, the test product was examined for signs of damage.

No visible signs of damage were observed
