## Quinquennial Inspection Report

Dore House,  
56a Lordswood Road, Harborne,  
Birmingham B17 9DA

6<sup>th</sup> September 2024

Project number: 1253C-02

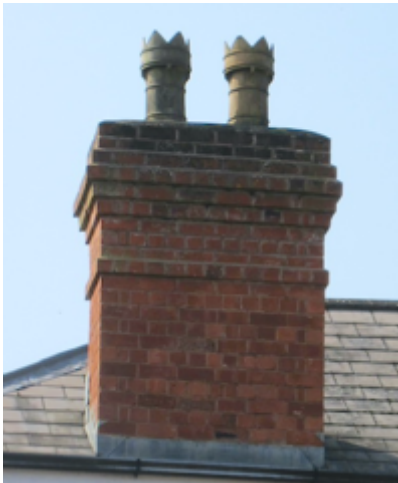
| | Condition | Good. | |

| | Repair needs | None. | |

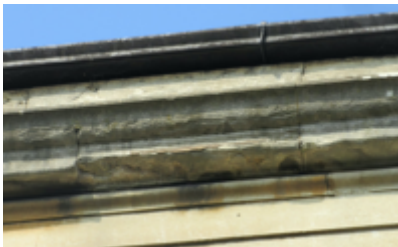
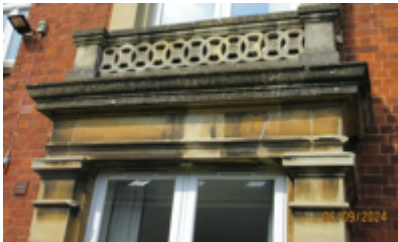
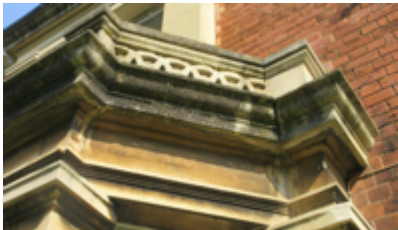
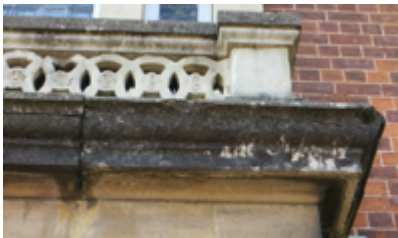
| | <p>Condition</p> | <p>A small section of stone finial has become detached from the top of one of the windows and fallen. Other stone features show signs of wear, some cracking and age related deterioration although without carrying out a physical 'hammer test' it is impossible to say how sound these are. From a visual survey only, any missing sections look to be in reasonable condition.</p> <p>Other stonework is blackened but cleaning is not a particular necessity.</p> <p>A few areas of stone are chipped and missing but most of this appears to be longstanding, there is delamination to some stone sills.</p> <p>A programme of stone cleaning and renewals would be desirable but not required at the present time.</p> <p>The situation is slightly worse than that seen on the previous Quinquennial Inspection.</p> | |

| Repair needs | | <p>Test areas of potentially loose stonework.</p> <p>A programme of stone cleaning and restoration is nevertheless recommended as a prudent measure.</p> | <p>2</p> <p>3</p> |

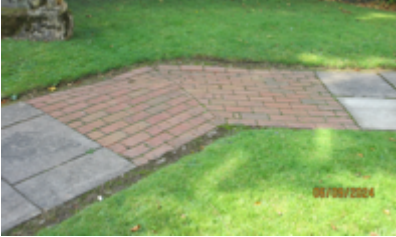
| | Condition<br> | Generally good although some areas of brick and concrete flag paving to the rear have sunk and are something of a trip hazard. | |

| | Repair needs | Take up and re-lay uneven flags and paved areas. | 1 |

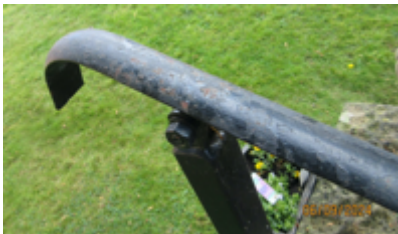
| | Condition<br> | <p>Fair; stone steps are original and show signs of wear.</p> <p>Handrails should not be 'cold to the touch', external metal handrails can become extremely cold. In these circumstances, some people may be reluctant to use the handrail (or involuntary let go of the handrail) if it is uncomfortably cold, representing a safety hazard.</p> <p>External decorations are considered in section 3.5.</p> | |

| | Repair needs | Consider replacing with nylon-coated or hardwood handrails. | 4 |

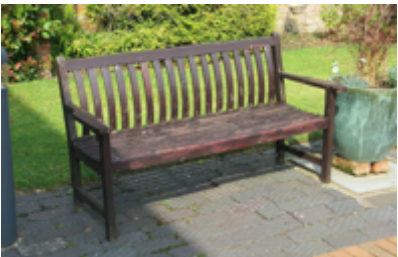
| 3.7.4 | Benches and street furniture | Various wood items. | |

| | Condition | Good.<br><br>External decorations are considered in section 3.5. | |

| | Repair needs | None. | |

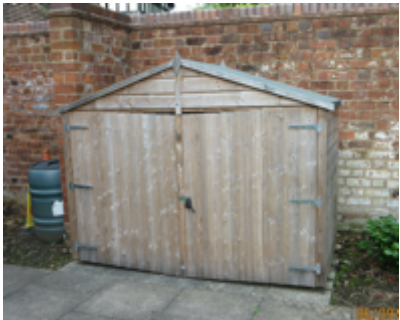
| 3.11.1 | Description | There are two timber sheds. | |

| | Condition<br> | Fair.<br><br>External decorations are considered in section 3.5. | |

| | Repair needs | None. | |

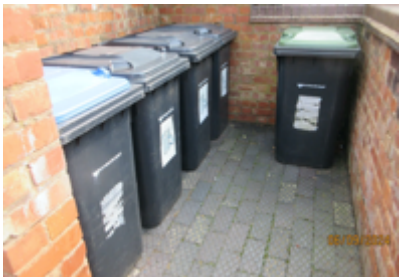
| 3.11.2 | Binstores | Brick binstore area. | |

| | Condition<br> | Good. | |

| | Repair needs | None. | |

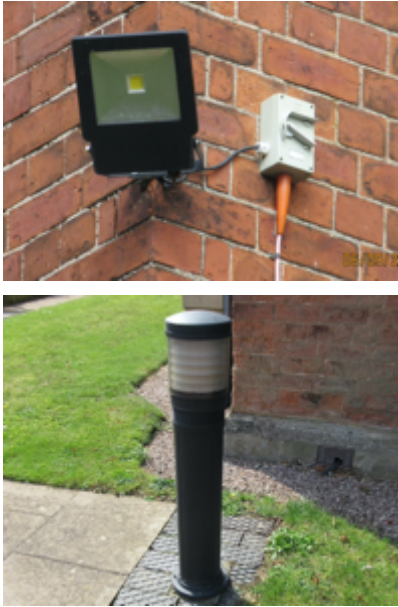
| 3.13.1 | Description | There are building mounted lighting and bollards around the site. | |

| | Condition<br> | Good. | |

| | Repair needs | None. | |

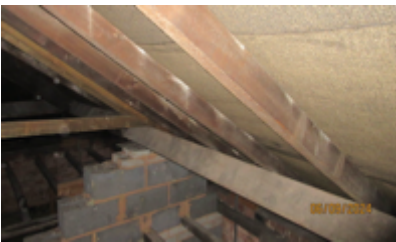
| | <p>Condition</p> | <p>Fire compartmentation between the units is compromised in several places and insulation is not present to some vertical elements, see also section 6.3.1.</p> <p>There is the remains of a birds nest to the rear right hand side of the roof. There is a large wasps' nest to the rear right hand side of the roof, see also section 6.5.2.</p> <p>A few areas of underfelt are torn and sagging.</p> | |

| | Repair needs | Repair underfelt. | 3 |

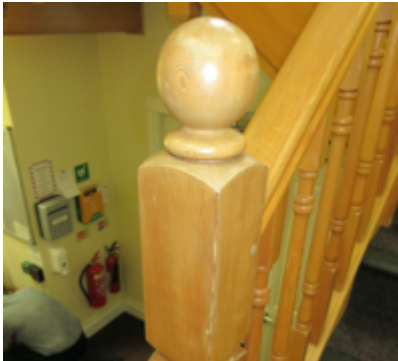
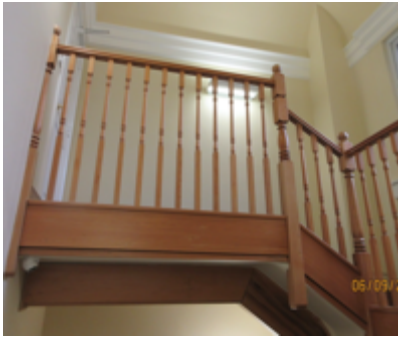
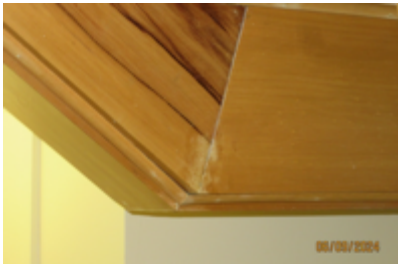
| | Condition<br><br><br> | <p>Carpet has been renewed and the stairs fitted with nosings since the last Quinquennial Inspection.</p> <p>Generally good. There is a split in the carriage piece although this does not appear to be causing any particular problems and has not significantly worsened since the previous Quinquennial Inspection.</p> | |

| | Repair needs | None. | |

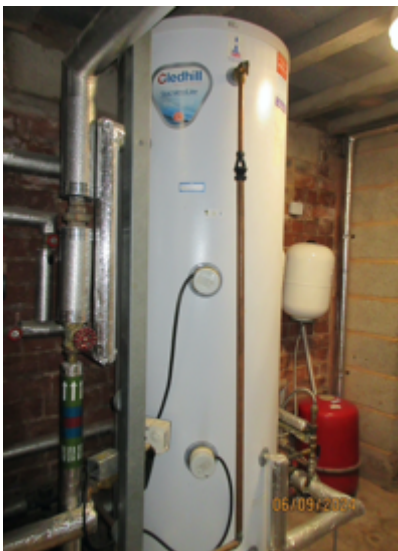
| 5.7.1 | Hot water | Hot water to the building is via a calorifier heated by the gas boiler. There are thermostatic mixer valve showers fitted. | |

| | Condition<br> | It is understood that a Legionella Risk Assessment is in place for the common areas and there is regular monitoring of water temperatures. | |

| | Repair needs | None. | |

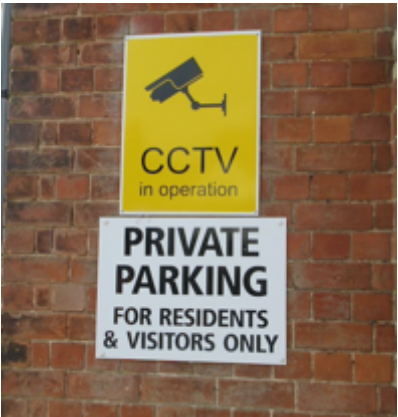
| 5.12.1 | Description | Doors have deadlocks, windows have lockable casement fasteners. There is CCTV and external lighting. | |

| | Condition | This is an above average level of security. | |

| | Repair needs | None. | |
