## Quinquennial Inspection Report

Harborne Cottages,  
Coopers Lane,  
Smethwick B67 7DL

20<sup>th</sup> August 2024

Project number: 1253C-04

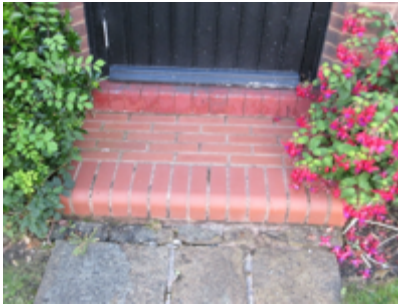
| 3.6.2 | Steps | Brick, stone, brick with concrete flag treads. | |

| | Condition<br> | Good. | |

| | Repair needs | None. | |

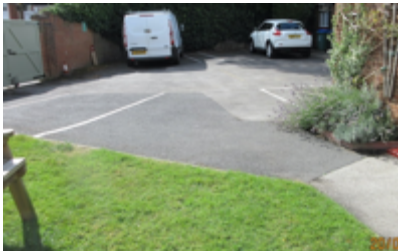
| 3.6.4 | Car parking | There is a tarmac car park to the rear of the site with white lines demarcating the bays. | |

| | Condition<br> | Fair. | |

| | Repair needs | None. | |

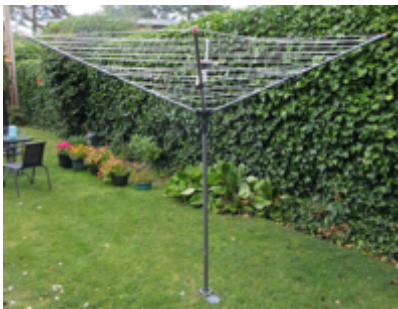
| 3.6.5 | Drying area | Rotary clothes dryers to the rear of the buildings. | |

| | Condition<br> | Good. | |

| | Repair needs | None. | |

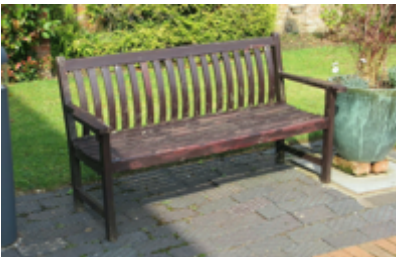
| | <p>Condition</p> | <p>Good.</p> <p>External decorations are considered in section 3.5.</p> | |

| | Repair needs | None. | |

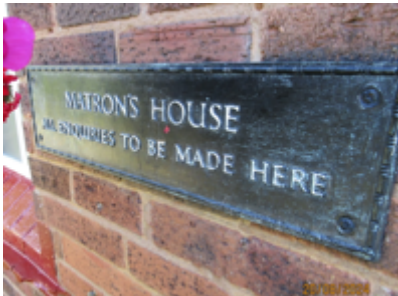
| | Condition | Fair. | |

| | Repair needs | None. | |

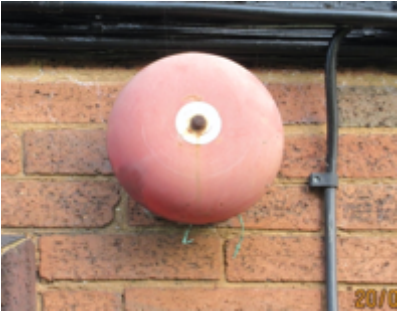
| 5.12.1 | Description | Doors have deadlocks, windows have lockable casement fasteners, there is an old alarm bell present. | |

| | Condition<br> | This is an average level of security. | |

| | Repair needs | None. | |
