## Quinquennial Inspection Report

Harborne House,  
Tibbets Lane, Harborne,  
Birmingham B17 0SX

6<sup>th</sup> September 2024

Project number: 1253C-01

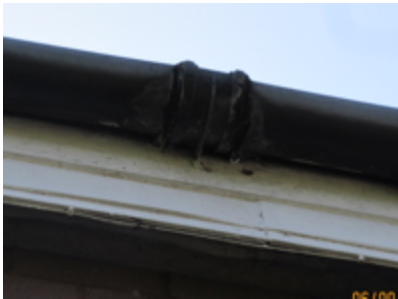
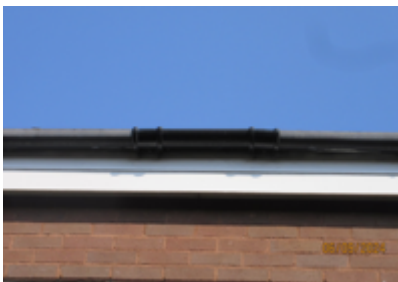
| | <p>Condition</p> | <p>Some of the older gutters are discoloured and faded. Some recent repairs have been carried out but one union to the above No. 15 appears to be leaking.</p> <p>There are other reported problems with gutters but as it was not raining at the time of the inspection it is not possible to confirm if the rainwater goods are effective.</p> <p>With ever heavier periods of extreme rainfall it is becoming increasingly common for gutters to be inadequate. Replacement with higher capacity elliptical deepflow items is often a solution.</p> | |

| | Repair needs | <p>Repair gutter union.</p> <p>Observe gutters during heavy rain.</p> <p>Consider replacement with deepflow items.</p> | <p>1</p> <p>2</p> <p>3</p> |

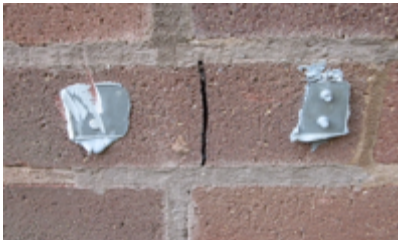
| | Condition<br><br><br> | <p>Monitoring put in place at the time of the previous Stock Condition Survey in 2012 indicated no further movement and these areas have been repointed. The remains of one tell-tale and a cracked brick are still present.</p> <p>There are also two minor areas of diagonal cracking remaining.</p> <p>There are quite a large number of isolated damaged bricks from careless installation of cables, although other cables have been neatly fitted with grommets (see section . . ).</p> <p>To the older part of the building the weep holes in the brickwork have been left open, there is evidence that insects are colonising these openings – cobwebs around the openings, they should be filled using proprietary plastic weep hole inserts to prevent future problems.</p> |

| | <p>Repair needs</p> | <p>Remove remains of tell-tale and repoint isolated areas.</p> <p>Replace cracked bricks.</p> <p>Fit proprietary plastic weep hole inserts.</p> | <p>2</p> <p>2</p> <p>2</p> |

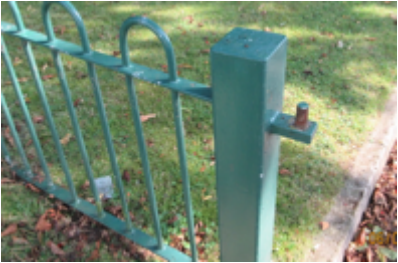
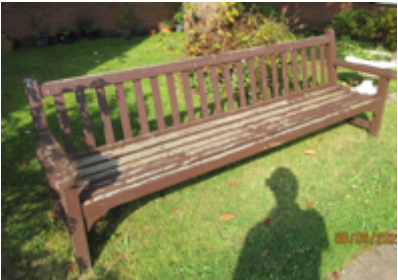
| | Condition<br><br> | <p>There is minor corrosion to some of the metal items, particularly the pins to the rear where gates have been removed. This should be treated prior to decoration.</p> <p>External woodwork and metalwork should be redecorated on a 5-7 year cycle.</p> | |

| | Repair needs | Treat corrosion. | 2 |
| | | Redecorate woodwork and metalwork. | 4 |

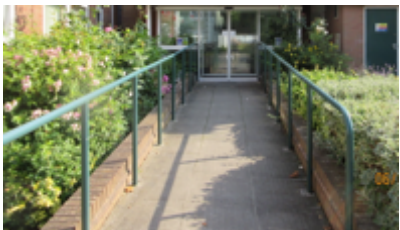
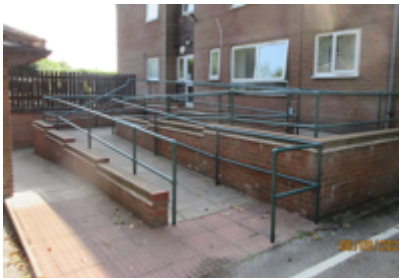
| | Condition<br><br> | <p>Handrails should not be 'cold to the touch', external metal handrails can become extremely cold. In these circumstances, some people may be reluctant to use the handrail (or involuntary let go of the handrail) if it is uncomfortably cold, representing a safety hazard.</p> <p>External decorations are considered in section 3.5.</p> | |

| | Repair needs | Consider replacing with nylon-coated or hardwood handrails. | 4 |

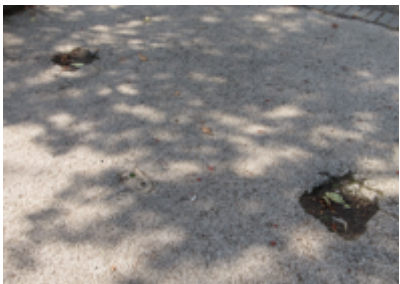
| | Condition<br><br> | <p>The front tarmac has been renewed recently.</p> <p>There are two small holes to the tarmac to the rear drive, the situation is likely to deteriorate.</p> | |

| | Repair needs | Patch repair holes in tarmac. | 2 |

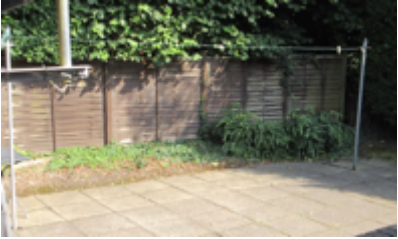
| | <p>Condition</p> | <p>Fences are in variable condition; some of the close boarded fences are bare of any decorative finish and are starting to rot at the bottom.</p> <p>Chain-link and security fences are in good condition.</p> | |

| | Repair needs | Replace minor areas of rotten boards. | 3 |

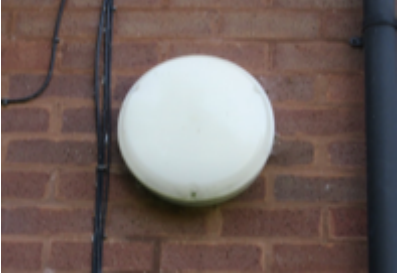
| | Condition<br> | As the inspection was carried out during daylight it was not possible to check the efficacy of the lighting. | |

| | Repair needs | Consider replacing the older lights with newer and more efficient LED lighting. | 3 |

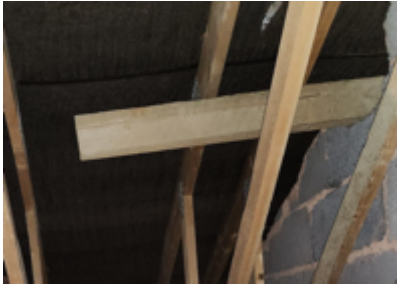
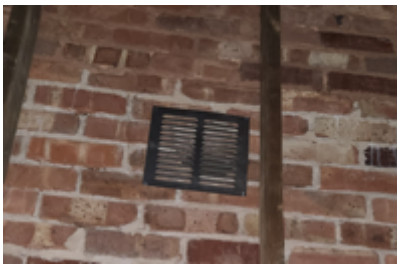
No.14

| | <p>Condition</p> <p>No. 11</p> | <p>Roofspaces are insulated with a variety of materials and thicknesses. The best of these is around 250mm fibreglass insulation.</p> <p>There is no diagonal bracing to trussed rafters in flat No. 11 (see section 3.1.1).</p> <p>Service penetrations in party wall (Compartment wall) without appropriate fire sleeving in flat No. 11.</p> <p>There is disturbed loft insulation to flat No. 11.</p> <p>Water stain marks to some timbers. Stain marks to ceiling below. Further investigation required as the stain marks may be historic. Check for adequate cross flow roof ventilation.</p> <p>Disturbed loft insulation to Flat No.14. Could give rise to condensation and mildew.</p> <p>In No. 14, there is no fire rated vent cover to the party wall, this is a fire risk. and there is insufficient cross bracing.</p> <p>In No. 14, there is a gap to party wall. Investigate if this is a compartment wall.</p> <p>The loft hatch has been painted shut in No. 15.</p> <p>Insufficient cross bracing to flat No. 28 (see section 3.1.1). No fire rated vent cover to party wall.</p> | |

| | Repair needs | Provide intumescent vent covers. | 1 |

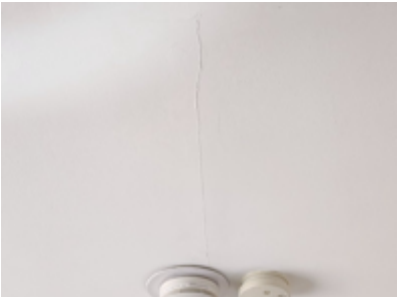
| | <p>Condition</p> <p>No. 11</p> <p>No. 15</p> <p>No. 19</p> | <p>Cracking was noted to No. 11 (hall, living room, kitchen, bedroom), No. 15 (living room, No. 19 (living room), No. 22 (bedroom).</p> <p>The most severe of this is Category 1 cracking and appears to be normal shrinkage to board joints.</p> <p>There is staining to the ceiling in No. 11 (living room), No. 19 (kitchen) and No. 28 (bedroom).</p> <p>Roof voids were inspected, but no obvious signs of water ingress were identified. Some rafters had staining on them. This need to be investigated further as it could be a result of inadequate ventilation or a roof leak.</p> | |

| | Repair needs | Fill cracks when redecorating.<br><br>Stainblock and redecorate. | 3<br><br>2 |

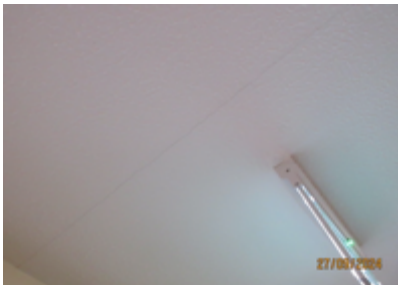
| | Condition<br><br> | Generally good, there is minor cracking to the board joints in places.<br><br>The most severe of this is Category 1 cracking and nothing more than normal shrinkage. | |

| | Repair needs | Fill cracks when redecorating. | 3 |

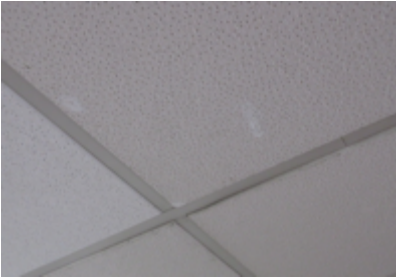
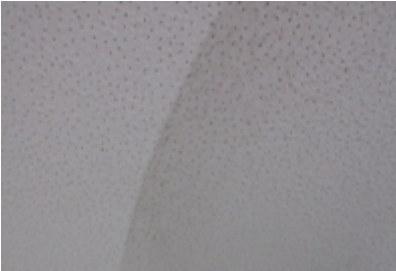
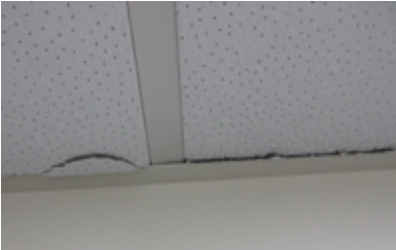
| | <p>Condition</p> | <p>Generally good, there are a few isolated damaged tiles. In one place the ceiling is too low and the top of the fire door is catching the ceiling tile and leading to wear.</p> | |

| | Repair needs | <p>Replace damaged tiles.</p> <p>Adjust ceiling grid to avoid it catching on the door.</p> | <p>3</p> <p>2</p> |

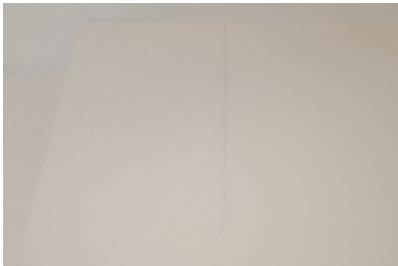
| | Condition<br><br>No. 11 | Cracking was noted to No. 11 (hall), No. 22 (hall).<br><br>The most severe of this is Category 1 cracking and appears to be normal shrinkage. | |

| | Repair needs | Fill cracks when redecorating. | 3 |

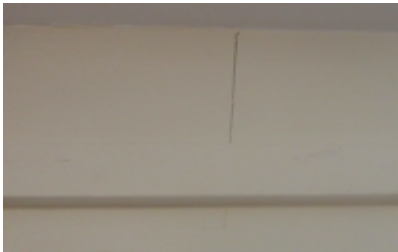
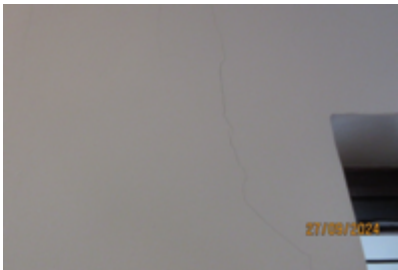
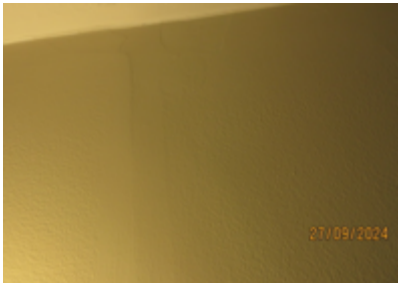
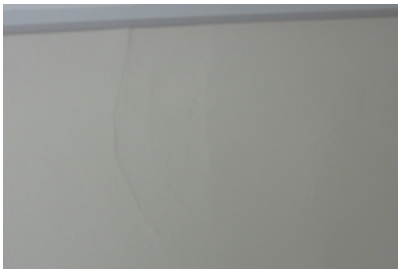
| | Condition<br><br><br><br> | There is minor vertical cracking to several isolated areas, the most severe of this is Category 1 cracking and appears to be normal shrinkage. | |

| | Repair needs | Fill cracks when redecorating. | 3 |

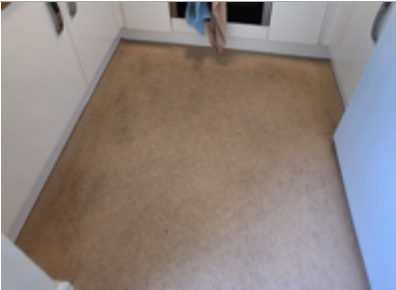
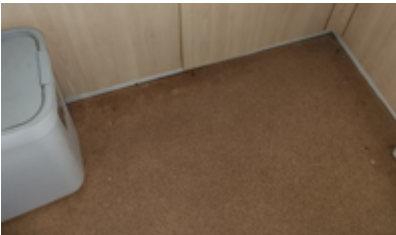
| <p>No. 15</p> <p>No.19</p> <p>No.22</p> | | <p>Possible asbestos floor finish to store of Flat No. 22. Stained vinyl floor finish to kitchen and no silicone seal to perimeter of vinyl floor in kitchen and bathroom.</p> <p>No. 15 &amp; 19 some staining to vinyl sheet floor covering. This isn't a defect but more of an aesthetic appeal. Silicone sealant to perimeter should be checked for deterioration.</p> | |

| | <p>Repair needs</p> | <p>Fit carpet throughout flat No.3 or remove carpet grippers and lay suitable floor finish.</p> <p>Vinyl sheet flooring cleaned.</p> <p>Apply silicone seal to perimeter of vinyl sheet floor in kitchen and bathrooms.</p> <p>Check asbestos record, if none available then commission asbestos survey of floor tiles.</p> | <p>1</p> <p>3</p> <p>2</p> <p>1</p> |

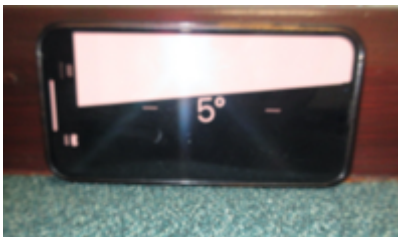
| | Condition<br> | <p>Good.</p> <p>There is an internal ramp to the link block. The gradient at 1 in 12 is steeper than recommended for the configuration although no problems have been reported.</p> | |

| | Repair needs | None. | |

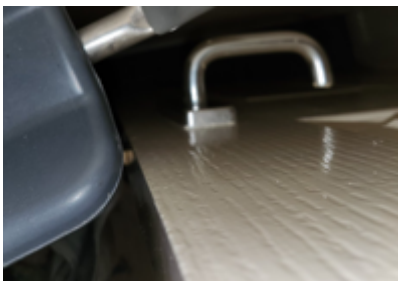
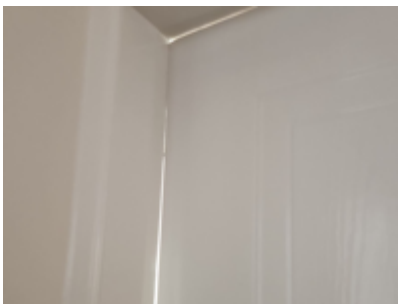
| | Condition<br><br>No. 8<br><br><br>No.11 | <p>There is no door stop to the front door of No. 3.</p> <p>There is no strike plate to the shower room door in flat No. 14.</p> <p>The door catch plate to the bedroom in No. 19 is incorrect.</p> <p>The viewer to the front door of No. 22 was missing at time of survey, however construction work was in progress and may have been fitted in the following days.</p> <p>Grease dripping from door hinge to flat No.22.</p> <p>Sliding door guide to flat No.22 is loose and is no longer performing as intended. The door will pull away from the wall.</p> <p>No door stop to flat No.8 the door handle could cause damage to wall if door was swung open quickly.</p> | |

| | <p>Repair needs</p> | <p>Fit door stops generally to all flats.</p> <p>Fit missing strike plate to shower room door of flat No.14.</p> <p>Remove redundant stay and fit correct strike plate to bedroom door of flat No.19.</p> <p>Install door viewer to flat No.22.</p> <p>Replace old and worn-out door hinges to flat No.22.</p> <p>Replace sliding door guide.</p> <p>Adjust hinge and re-align bathroom door to flat No.11.</p> <p>Adjust hinge and re-align door to provide correct gap (less than 4mm to top and sides of door) for fire door.</p> | <p>2</p> <p>2</p> <p>2</p> <p>1</p> <p>2</p> <p>1</p> <p>1</p> <p>1</p> |

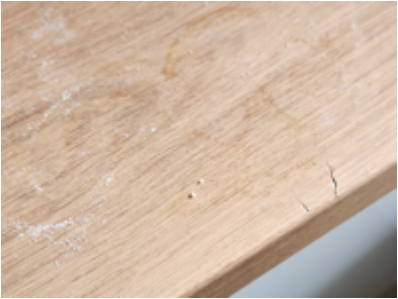
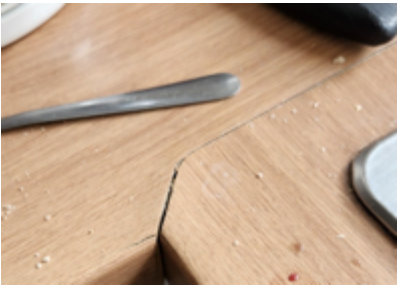
| <p>Condition</p> <p>No. 8</p> <p>No. 22</p> | | <p>The worktop in No. 8 is pitted and worn.</p> <p>The kitchen doors in No. 22 are loose and the worktop is worn.</p> <p>The unit doors are loose in No. 28. Silicone seal to sink is partly missing.</p> | |

| | Repair needs | <p>Replace worktop to flat No. 8.</p> <p>Replace kitchens to No. 22 &amp; 28.</p> | <p>2</p> <p>3</p> |

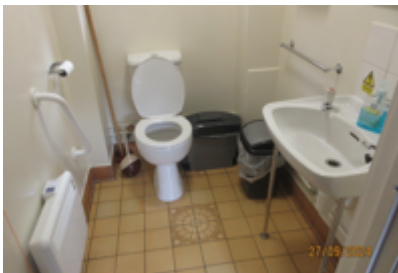
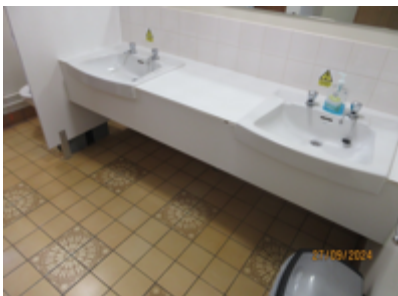
| | Condition<br><br> | <p>All of the fittings and tiling in the WC are white meaning colour contrast (for visually impaired people) is poor. This could be relatively easily improved by the use of coloured toilet seat and flush handle. Painting or applying transfers to the tiling would also help matters.</p> <p>There is no emergency pull cord alarm in the toilets.</p> | |

| | Repair needs | Consider improving visual contrast and adding a pull cord alarm. | 3 |

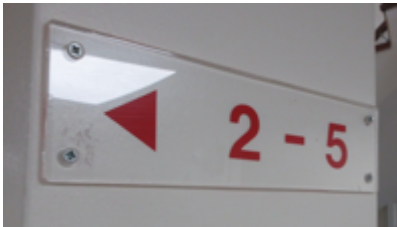
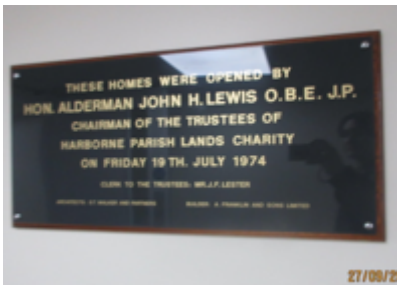
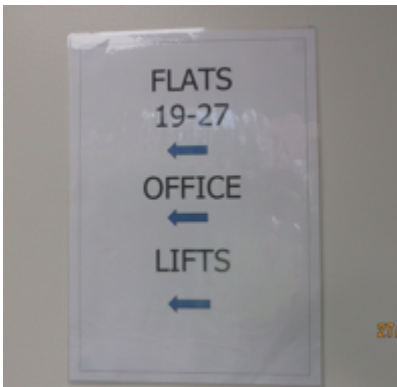
| | Condition<br><br><br> | Good.<br><br>Some additional printed paper signage is present. |

| | Repair needs | Consider replacing printed paper signs with permanent items. 4 |

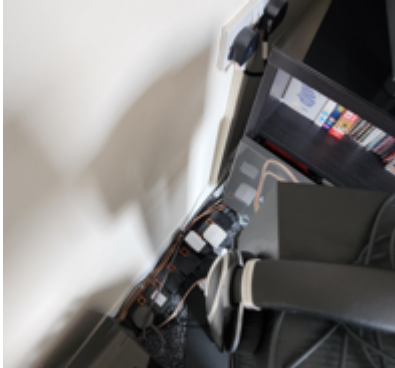
The number of sockets is insufficient in No. 8 (living room, bedroom), No. 11 (living room), No. 14 (bedroom).

| | Repair needs | Increase number of socket outlets. | 4 |

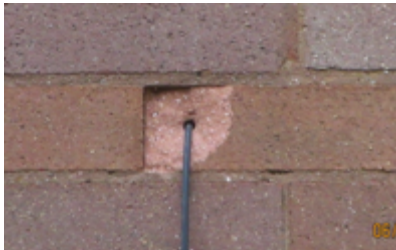
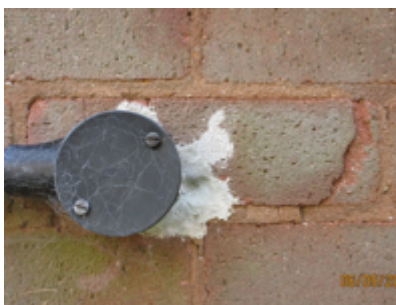
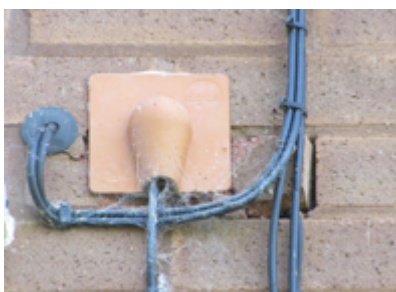
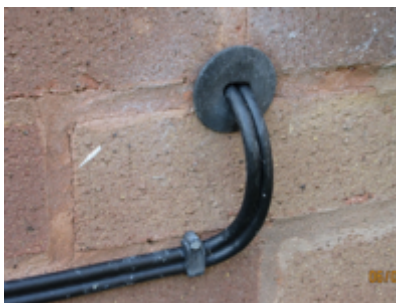
| | Condition<br> | Installation of external telephone cables is extremely messy and has been done very poorly in places with loose and redundant cables, damaged bricks and pointing and badly repaired bricks. In a few places the installation has been done neatly with holes drilled through joints rather than the middle of the bricks and grommets fitted but this is in the minority. | |

| | Repair needs | Remove redundant cables, repair bricks and pointing, fit grommets where possible. | 2 |
| | | Ensure future cables are fitted neatly. | 3 |

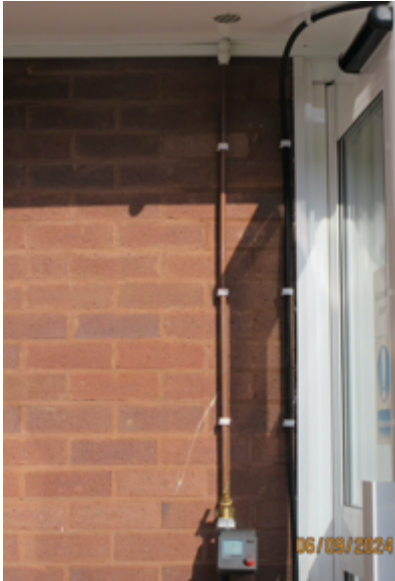
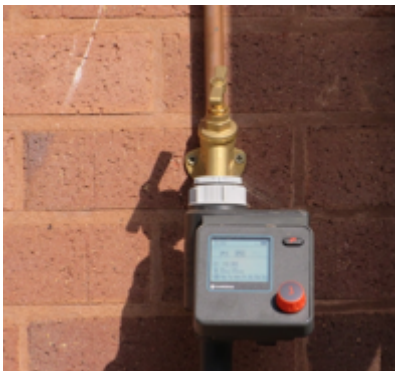
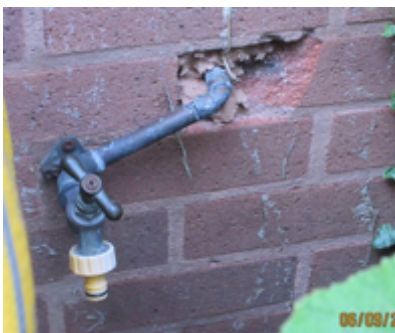
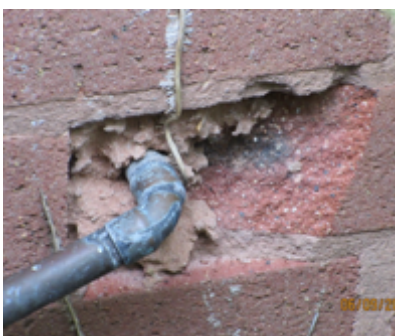
| | Condition | <p>Legionella Risk Assessments are not carried out on the flats. The last Risk Assessment carried out on the communal areas was 10<sup>th</sup> September 2020.</p> <p>Recent HSE guidance has clarified the need for all water supplies within buildings to be regularly risk assessed and not just areas with stored water. This means that domestic installations will need to be assessed as well.</p> <p>There is further advice and guidance available on the HSE website. This also states "This is especially important in residential buildings, where vulnerable people may be at risk, where the accommodation is provided specifically for a group who may be susceptible to legionellosis."</p> <p>There is regular monitoring of water temperatures.</p> | |

| | Repair needs | Carry out Legionella Risk Assessments for all flats. | 1 |

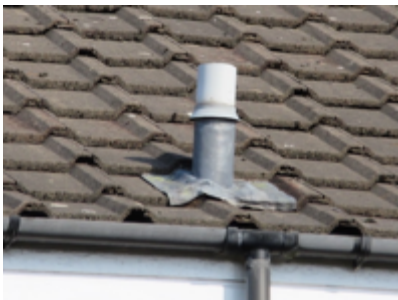
| | Condition<br> | There is no wire balloon or plastic grille to the top of the external soil stack, these stop birds dropping debris down the pipes. | |

| | Repair needs | Provide wire balloon to the top of the soil stack. | 3 |

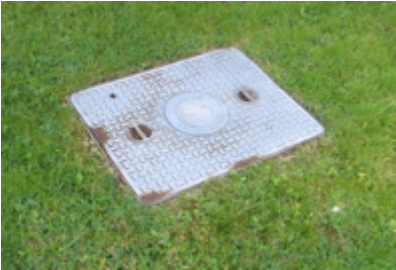
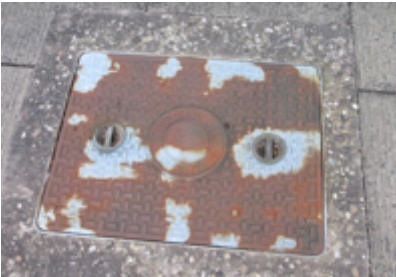
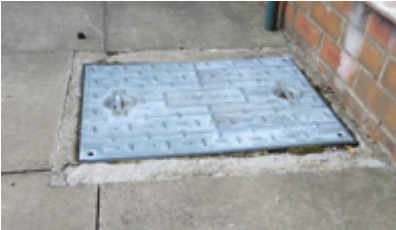
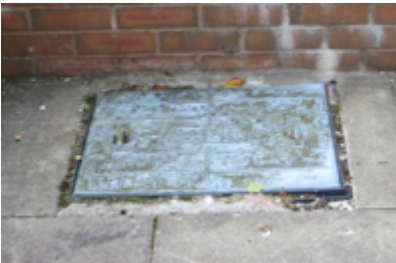
| | <p>Condition</p> | <p>A selection of accessible manhole covers were lifted.</p> <p>There is surface corrosion to a number of the covers; one of the drain access covers is loose. The surface corrosion has worsened since the last quinquennial inspection.</p> <p>Note that from the 1<sup>st</sup> October 2011, most sewers (drains shared with two or more properties) are now the responsibility of Severn Trent Water, this includes responsibility for clearing blockages.</p> |

| | Repair needs | Manhole covers should be lifted, the channels cleaned out and covers set in grease. | 2 |
| | | Consider painting corroded medium duty covers with a suitable paint. | 3 |
