## Quinquennial Inspection Report

Larksfield,  
Windmill Lane,  
Smethwick B66 3ET

28<sup>th</sup> August 2024

Project number: 1253C-07

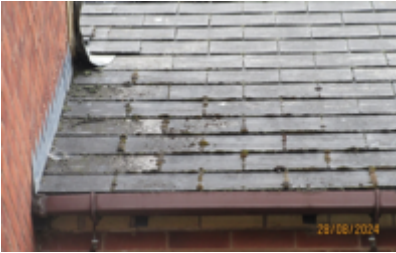
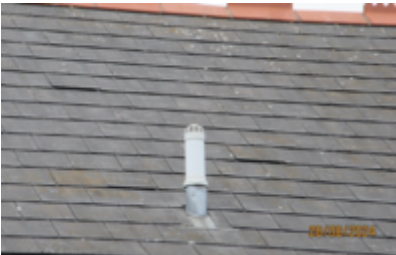
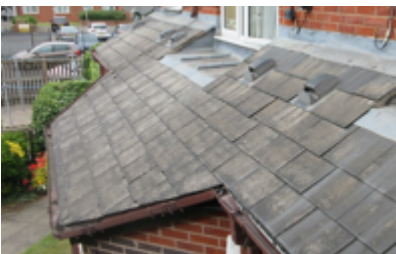
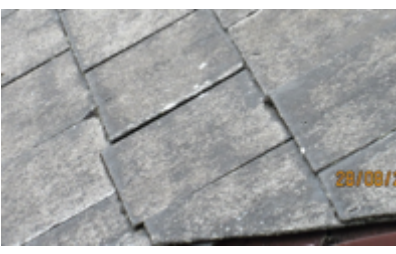
| | <p>Condition</p> | <p>Most slates have faded in colour, a very common phenomenon with this type and age of slate.</p> <p>There is some minor moss growth still present, mostly beneath the trees on the Suffrage Street elevation.</p> <p>The covering is deteriorating but will probably not need to be replaced for 5-10 years.</p> <p>A slate has slipped above No. 4, several slates to the Windmill Lane elevation have curled or slipped.</p> <p>There is evidence of birds nesting in the eaves above No. 10 rear elevation (see section 6.5.2).</p> <p>The cement mortar pointing to the front canopy verge is missing in places.</p> | |

| | Repair needs | <p>Clean moss growth.</p> <p>Attend to slipped slates.</p> <p>Repoint verges.</p> <p>Re-cover roof.</p> | <p>3</p> <p>3</p> <p>2</p> <p>4</p> |

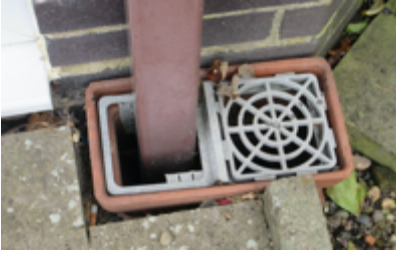
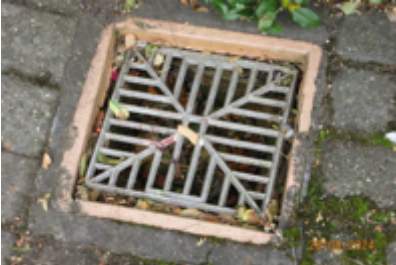
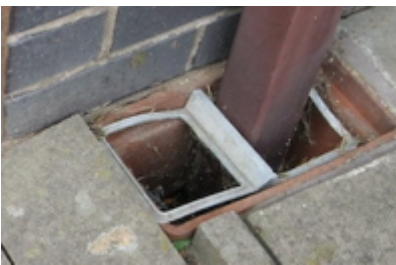
| | <p>Condition</p> | <p>Fair, a number of the grids are light plastic items and do not fit into the openings or are broken or missing, this allows debris into the below ground drainage installation.</p> | |

| | Repair needs | Replace missing / damaged grids. | 2 |

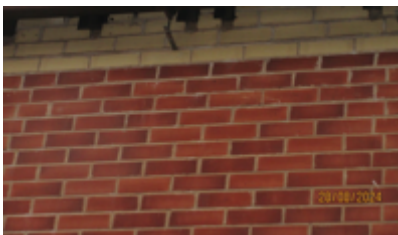
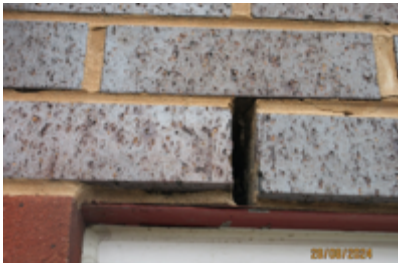
| | <p>Condition</p> | <p>There is cracking to the brickwork in places, particularly above lintels to the south elevation to Suffrage Lane and the north elevation to the garden. None of this is visible internally and it appears to be minor seasonal movement, although the excessively tall trees close to the building may be implicated as during hot, dry summers like in 2022 they will take large quantities of water out of the ground.</p> <p>One old boiler flue has been poorly filled with a plate and thick mortar, it looks unsightly and will crack and fall out.</p> | |

| | Repair needs | <p>Fill cracks.</p> <p>Build up old flue opening correctly using bricks and mortar.</p> | <p>3</p> <p>3</p> |

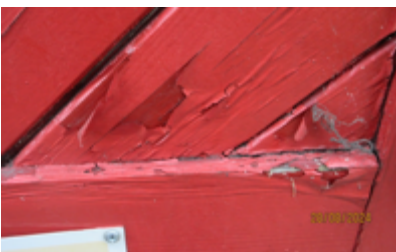
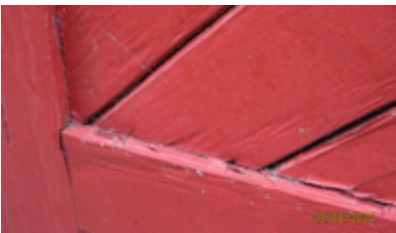
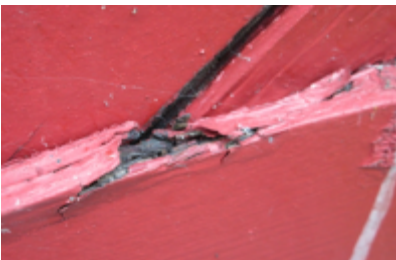
| | <p>Condition</p> | <p>Poor, there is rot to the bottom of the meter cupboard door and to a lesser extent above the mid-rail of the binstore door.</p> | |

| | Repair needs | Repair rot or replace doors. | 2 |

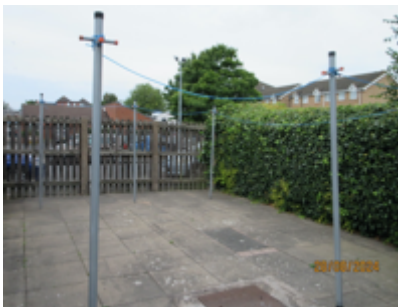
| 3.6.6 | Drying area | Concrete flag paved area with traditional clothes lines. | |

| | Condition<br> | Good. | |

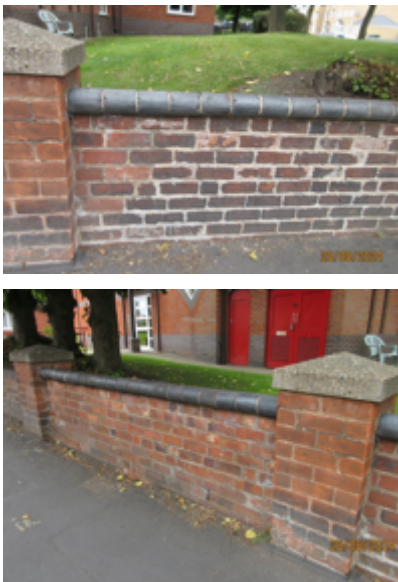
| 3.7.1 | Walls | Boundaries consist of small brick retaining walls to the Windmill Lane and Suffrage Street elevations. | |

| | Condition<br> | Fair. | |

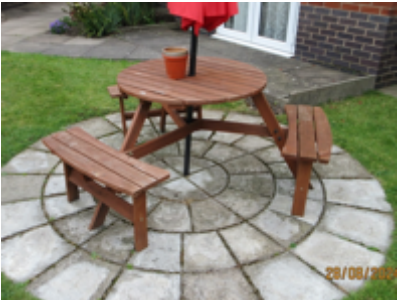
| 3.7.5 | Benches and street furniture | Wood items. | |

| | Condition<br> | Good.<br><br>External decorations are considered in section 3.5. | |

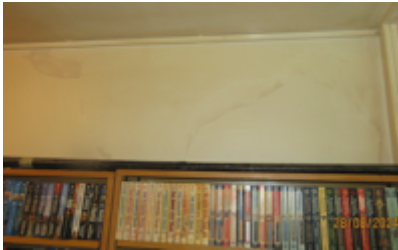
| | <p>Condition</p> <p>No. 4</p> <p>No. 10</p> | <p>Cracking was noted to No. 4 (kitchen), this appears to be nothing more than normal shrinkage.</p> <p>There is staining to the walls in No. 10 (hall), this is from a previous leak and all areas are now dry.</p> | |

| | Repair needs | <p>Fill cracks.</p> <p>Stainblock and redecorate water stained areas.</p> | <p>3</p> <p>3</p> |

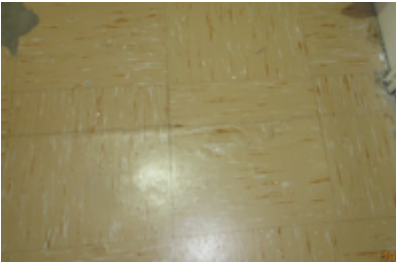
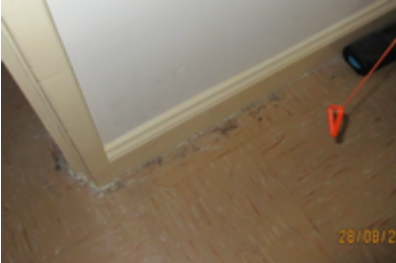
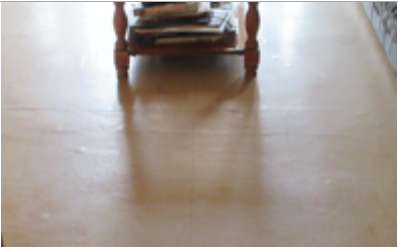
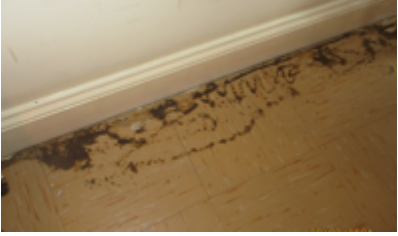
| | <p>Condition</p> <p>No. 1</p> | <p>The floor tiles in No. 1 (hall) are split and one area has been screeded over. The floor in the bathroom is dirty and marked).</p> <p>There is minor cracking to the floor tiles in No. 2 (hall). The vinyl tiles in the living room are cracked, some are chipped and one area is uneven. The vinyl tiles in the bedroom are marked.</p> <p>Note that these tiles are of a type that sometimes contained asbestos.</p> <p>The floor to the bathroom in No. 4 is slightly discoloured.</p> |

| | <p data-bbox="295 1668 486 1702">Repair needs</p> <p data-bbox="295 2027 359 2060">No. 4</p> | <p data-bbox="718 1668 1029 1702">Replace cracked tiles.</p> <p data-bbox="718 1747 917 1780">Replace vinyl.</p> | <p data-bbox="1404 1668 1428 1702">2</p> <p data-bbox="1404 1747 1428 1780">3</p> |

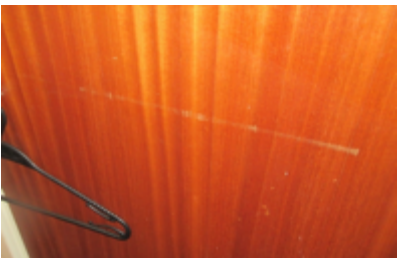
| | Condition<br><br><br><br><br>No. 2 | <p>The veneer is damaged to the door in No. 2 (hall and bathroom). The door handle is loose to the bathroom.</p> <p>There is a scratch to the laminate on the flush door in No. 3 (hall).</p> | |

| | Repair needs | Replace ironmongery/doors and make good damage. | 2 |

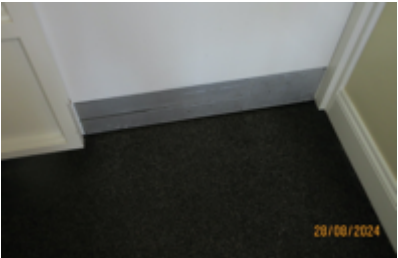
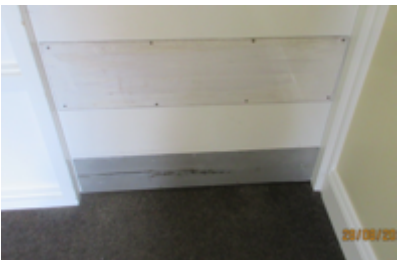
| | <p>Condition</p> | There are markings to the kickplates. | |

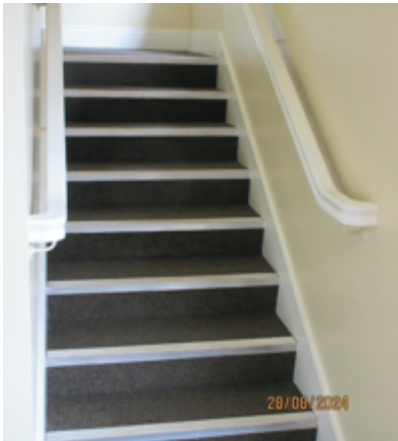
| 4.7.1 | Communal | Concrete staircase with a carpet finish. | |

| | Condition | Good. | |

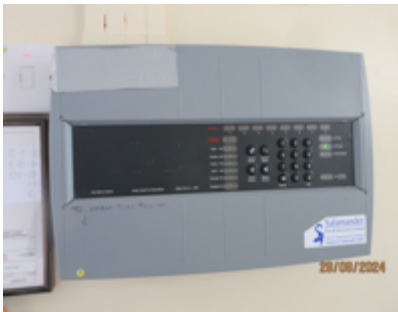
| | Condition<br> | <p>The last fire alarm service was on 22<sup>nd</sup> July 2024 and the last emergency lighting test was carried out on 18<sup>th</sup> January 2024. Functional testing of the alarm system on site is carried out weekly. Emergency lighting is subject to a 20-minute test every month.</p> <p>Portable firefighting equipment in common areas is becoming less common as some authorities recommend its removal unless residents are trained in its use.</p> | |
