# High Speed Wind Integrity Test

Building Research Establishment  
BRE FIRE & BUILDING TECHNOLOGY GROUP

High Speed Wind Integrity Test  
MicroLouvre K700 / 17 Screens

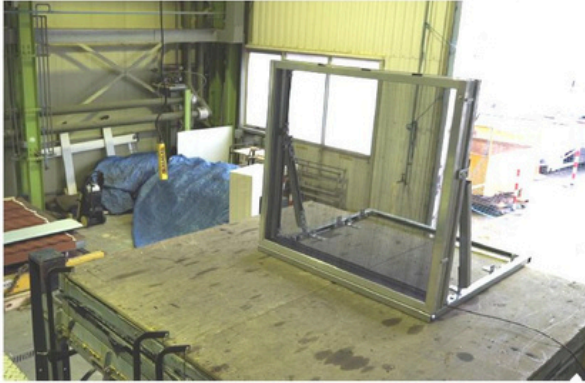
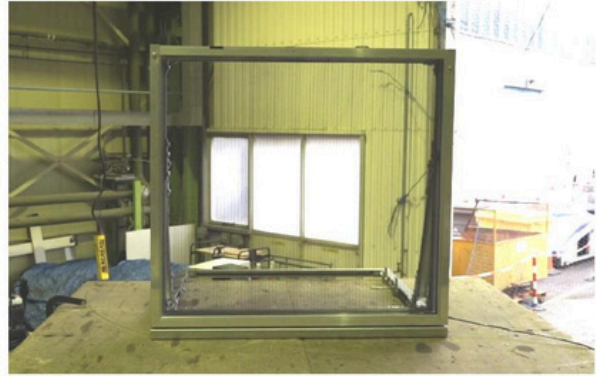
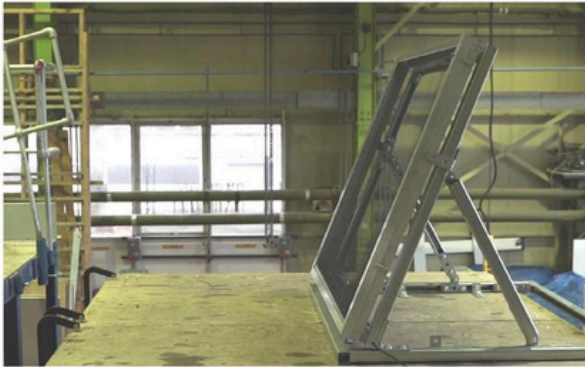
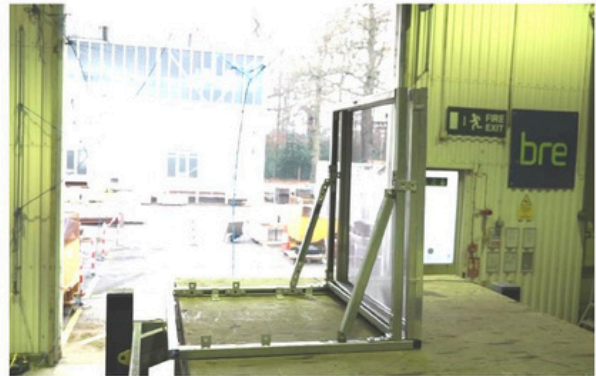
A photograph of the microlouvre™ solar control screen mounted in the BRE wind tunnel (looking downstream) is shown below.

The testing was undertaken at speeds up to 45.4m/s (102mph). Three wind directions were tested, i.e. perpendicular to face, parallel to face, and at 45° to the face. The louvre face was fixed at angles of 90°, 73° and 56°, relative to horizontal. The full range of the tests undertaken is shown overleaf.

After the testing the test product was examined for signs of damage. No visible signs of damage were observed.
