Restoration Works at The Elms 2018

Grade II * Listed Building

Restoration Works at The Elms 2015

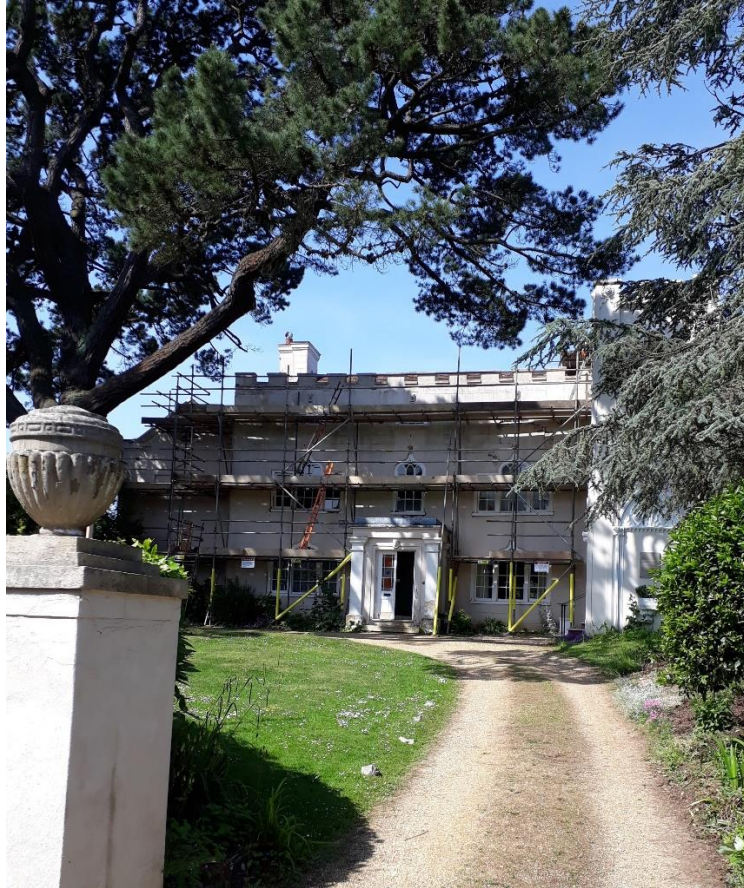
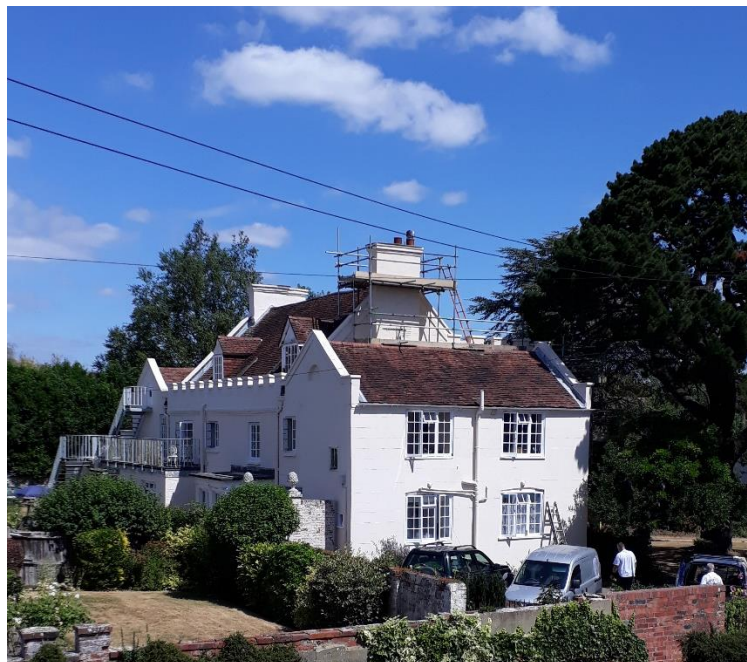
Scaffolding to the front elevations and south chimney

For repair and painting of the stucco, window frames and sills

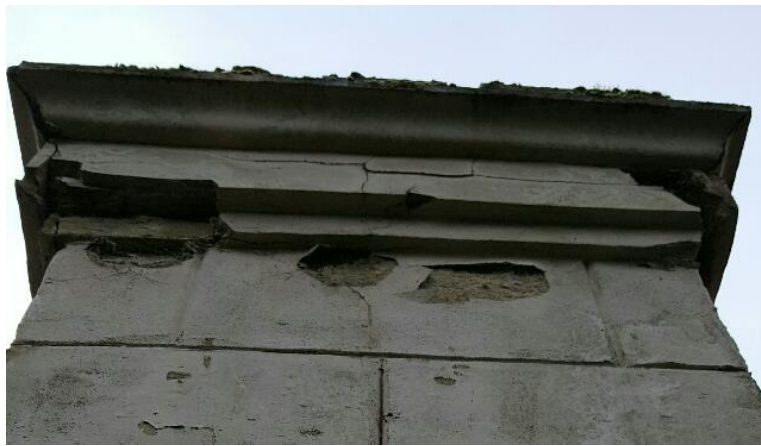
The Chimney to The Waterloo Room

The chimney is an interesting design with stylised ridges and borders build in Lime render work that through the years had begun to crumble and shed fragments of hard rock like render risking injury to anyone below.

The project was given to M Babbidge Property Maintenance who carried out the work in April into May 2018 and included a fresh coat of silicate paint, Beeck Renosil, to match the tower.

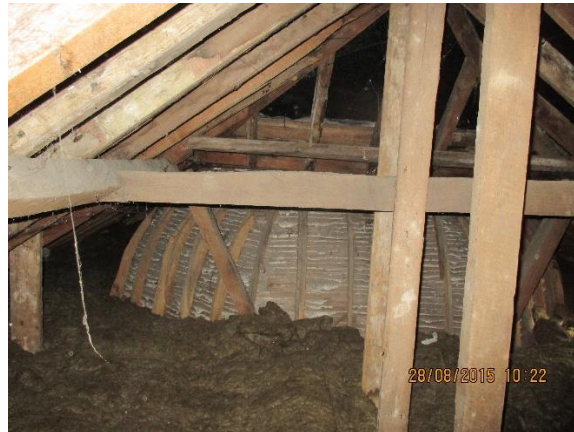
Picture shows the roof void with the outline of the dome of the lantern

so that the roof voids on each side of the roof lantern could be inspected for the health of the roof and ceiling timbers by Simon Lockyer of Timberwise at Sherborne who reported that the timbers needed no treatments.

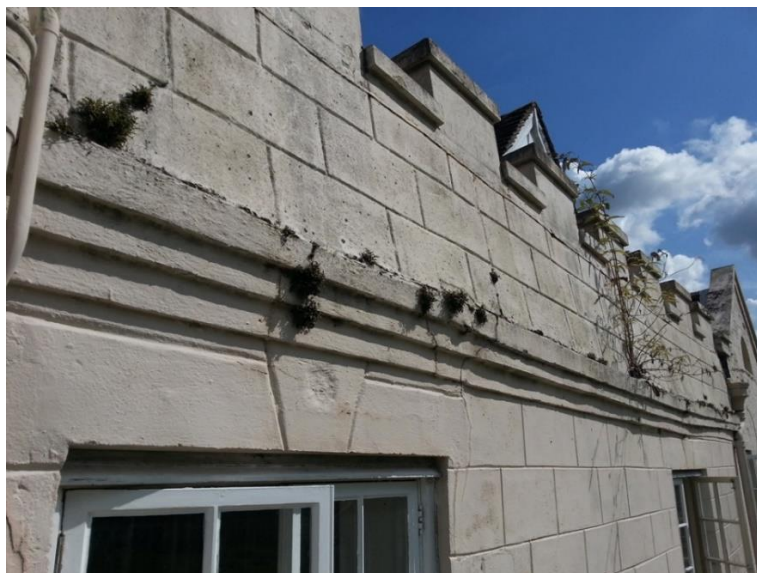
West elevations showing adventitious vegetation

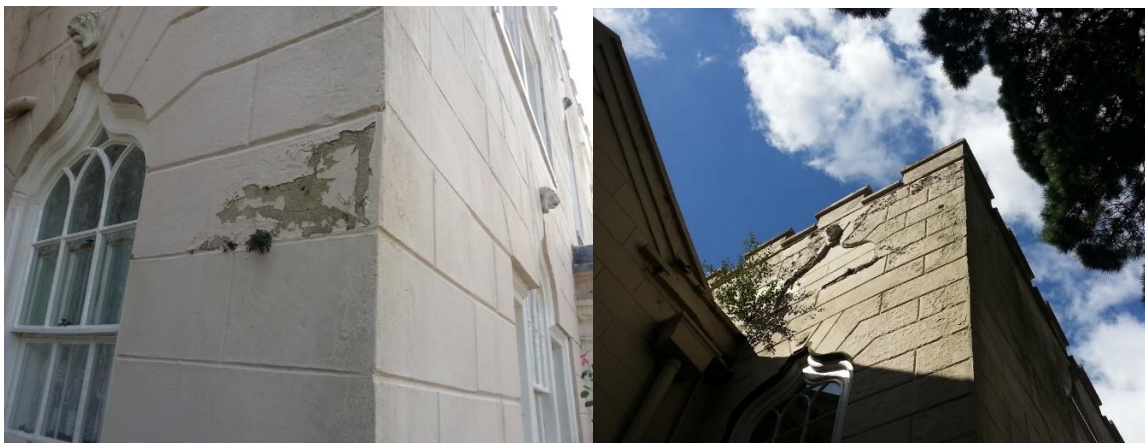
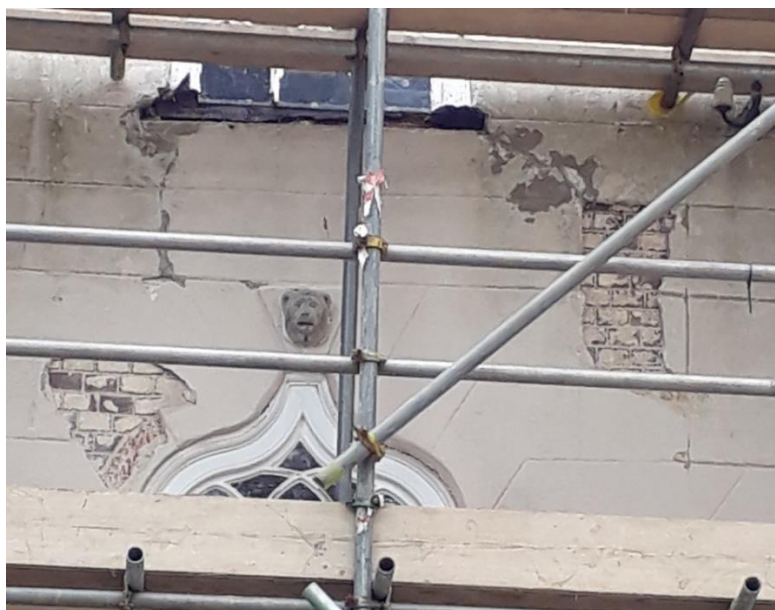
Pictures show render patches, bricks in header bond pattern, a rotted window sill and restored lionhead ready for painting

It is interesting to note that in consulting with Dr Duncan Philips an historic buildings advisor that the bare patches revealed the under-lying brick work to have been laid in a header bond pattern, indicating that at some time the elevations were not rendered, the bricks being considered a feature in themselves. Ah, well, So much for fashion.

The lionheads are moulded in Roman Cement and are to be painted white as a depicted feature, using white Beeckosil silicate paint.

The remaining and so the bulk of the wooden frames and sills repairs using Douglas Pine and English Oak, painting the wood as well as the painting with Beeck Renosil of the rendered elevations is being painted by Richardsons of Gosport who painted the Tower in 2015. Some patches of render had to be renewed and these were repaired by Chris Allen of Emsworth Plastering, whose team re-rendered the whole tower in 2015.

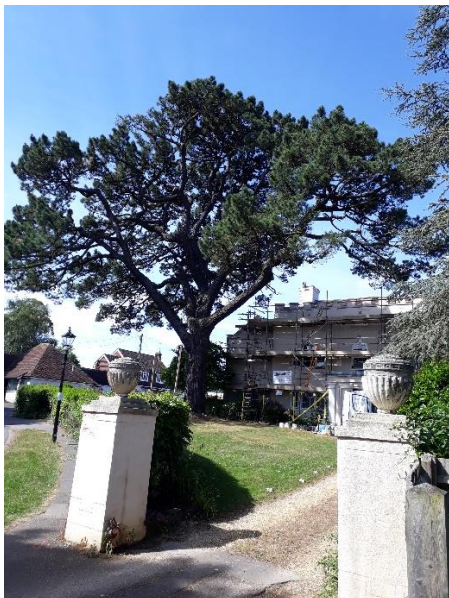
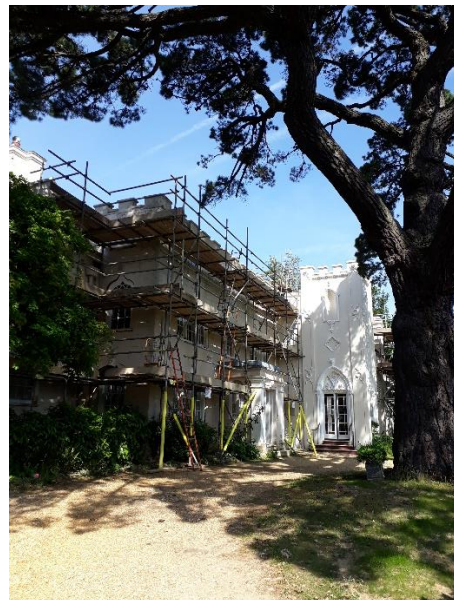
The tree is generally reckoned as being very old, probably over 100 years. Its girth has become such that it is over-hanging the elevations of the building and its greenish-grey fallout has stained the paint. To reduce this staining an application to reduce the girth of the tree was submitted in April, and these days the council can take up to 10 weeks or so to grant or deny the application.

In the meantime, the tree decided to shed a bough on its NE quadrant and in so doing it shed a second that was underneath the first. A similar bough was shed in the summer last year, 2017 and it became necessary to have this matter investigated professionally.

The tree is a Monterey Pine otherwise known as *Pinus Radiata* due to the patterning on its cones which tend to face downwards in trees and often stay on the tree over more than one season. It is also recognised by its very thick slab like bark with deep fissures between the slabs as well as the triple spines to each leaf and the colour and coning of the little buds in the leaf cluster.

Tree Consultants CBA Trees have been asked to inspect and make recommendations for any action that is needed for this land-mark feature to put to the TPO Team at Havant BC.

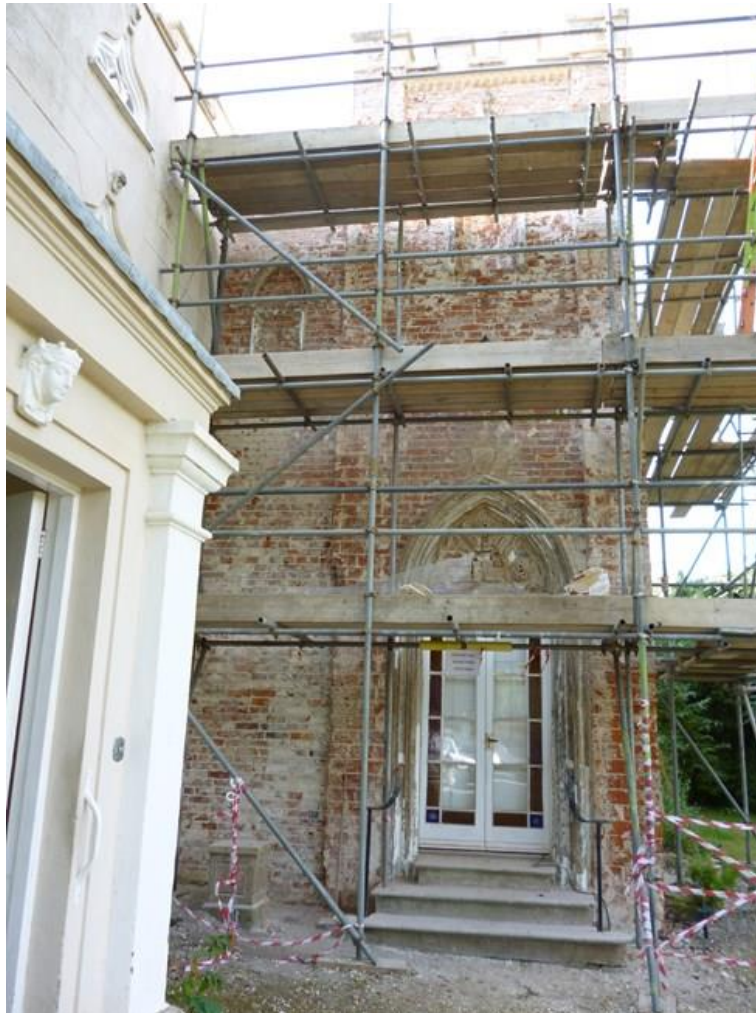
*The Tower all prepared for its first new coat of lime render
The Tower is 11 metres high and 2.5 metres wide, plus the smaller adjoining panel to the main
Elms building.
These pictures show the work that has started applying the new coats of lime render by Chris
Allen of Emsworth Plastering.*

There will be up to 28 days further 'curing' of the render and then the tower will be painted with silicate paints by a special painting process involving four treatment coats. The base wall colour will be as near a match for the rest of the property as possible, although any new paint colour can never match that which has been applied years ago. The features, the figurehead and the niches will be depicted in contrasting white as before.

The works are being carried out in line with the Conservation Authorities requirements using traditional building materials such as Roman cement on the figureheads and mouldings and lime render on the walls. All of the defective rendering will be removed and restored using new lime render. After that a special 'breathable' protective paint has to be applied

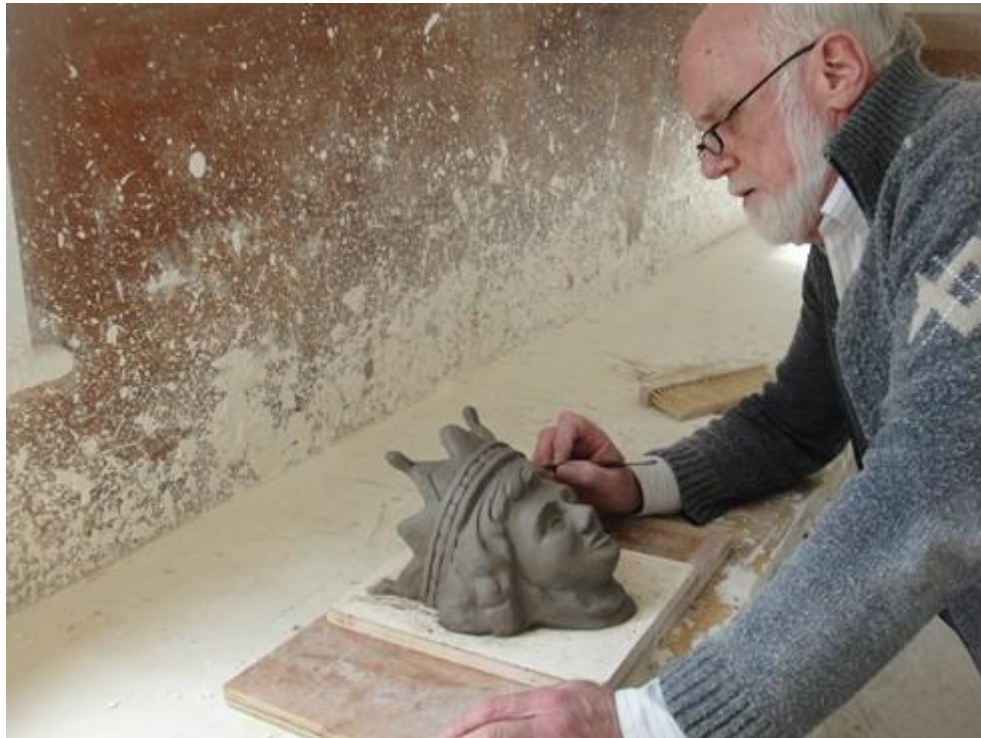
Alba Plastercraft busy remoulding the lost features of the figureheads on the Waterloo Room Tower before remounting them in their places on the Tower

The long planned conservation work on the mouldings on the exterior of the Tower was started at the beginning of May. The work is being ably done by Mr Alan Bailey of Alba Plastercraft of Lee-on-Solent.

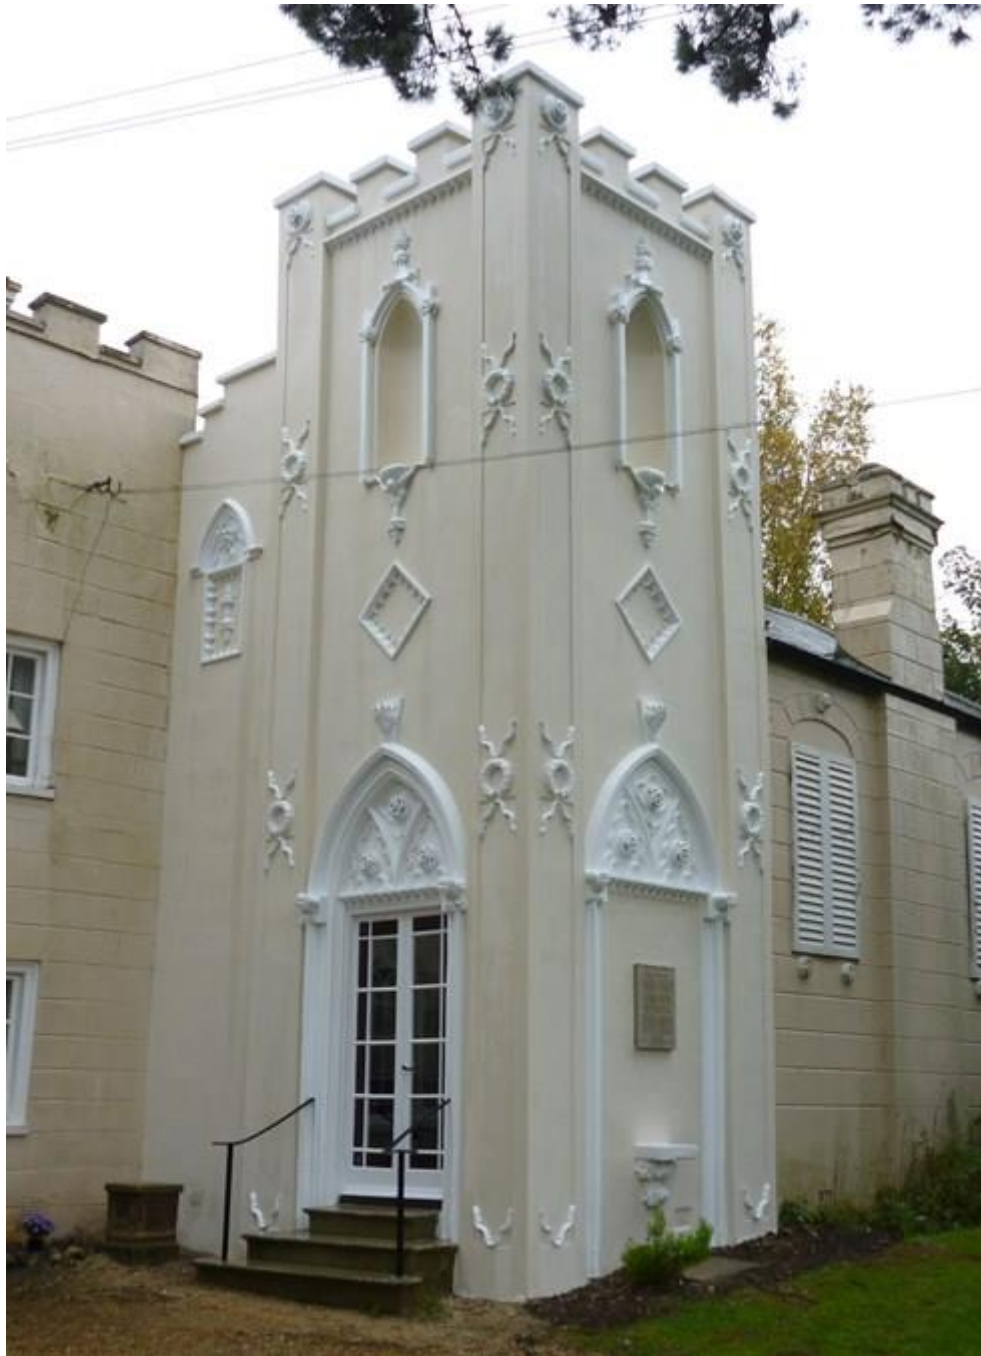
The restoration of the tower was finally completed on Saturday 10th October by putting the finishing touches to the painting of the moulds and features in white.
